Path of Knowledge for the Assessment of Structural Safety of the Pisan Tower of the Royal Palace of Palermo in Italy

# Path of Knowledge for the Assessment of Structural Safety of the Pisan Tower of the Royal Palace of Palermo in Italy

**Abstract:** This paper presents the path of knowledge developed for assessing the structural safety of the Norman-age Pisan Tower, which is mostly incorporated into the Royal Palace in Palermo, Italy. Historical, geomatic, and mechanical investigations were conducted and the most relevant results are herein collected and presented. The research path was addressed to specific tasks: identification of the building, geometric surveys, recognition of the sequence of phases of building transformation, detection of the components of the load-bearing structure, structural diagnostic surveys, and investigation of the subsoil and foundations. The explicit vulnerabilities found were mostly confined to the Piazza library floor, while implicit vulnerabilities were identified in the presence of false walls and in high loads and fillings on the vaults of the last levels. The results of the analyses allowed the individuation of the confidence factors to use in

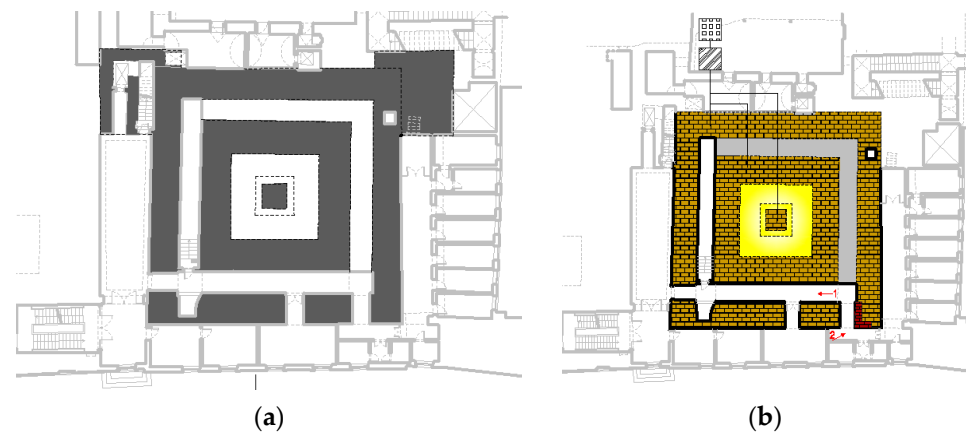
The surveys performed and the information collected at level B repeated and confirmed the same structural layout as the lower level, consisting of two homothetic quadrilaterals with wall widths above 2 m, in calcarenite ashlar, dry-placed and/or with mortar (Figure 16a). Today, as in the Norman layout, the south turret is mainly used for vertical connections. The structural layout of the Tower has been presumably subjected to modifications during the complex and intricate evolution of the Norman Palace. At this level, the wall, which is partly visible, consists of calcarenite ashlar and variable-width lime mortar joints. The performed tests showed that the ashlar have good mechanical properties; however, these were lower than the values found at the lower level. The infill of the core between the two masonry squares is heterogeneous and incoherent, while in the internal core it is constituted by crushed ashlar with variable size and resistance (Figure 16b).

**Figure 16.** Identification of the structure of the Tower on level B (height 8.40 m): (a) hypothesized vertical load-bearing structure; (b) hypothesized materials.

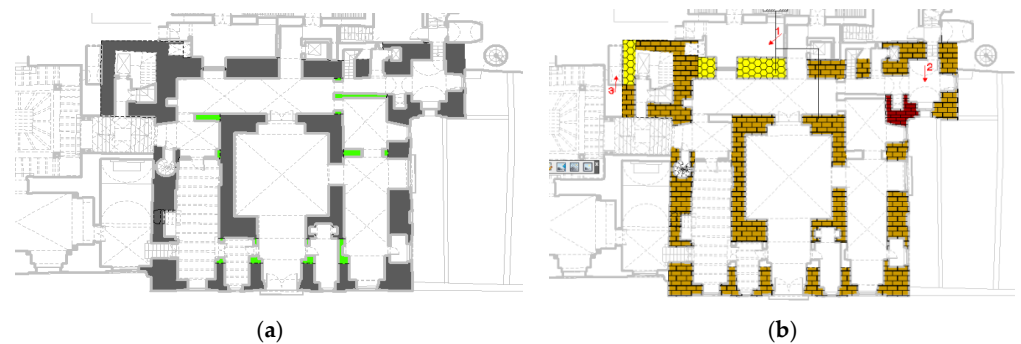
On levels D-E, the structural layout of the concentric quadrilaterals can be detected even if the walls are significantly set back from the lower level (Figure 18a). Moreover, the walls of the external square are intermitted by wide and numerous openings (doors, windows, rooms, and staircases). The President's Room has two different heights, while the other rooms are mainly double-height or have timber roofs. Superintendent Valenti, during the 1929 restoration intervention, performed several modifications to the structural layout. He demolished many mezzanine rooms, which had presumably been realized in the period of the Spanish Viceroyalty, and relocated some masonry walls to restore the Norman layout. The numerous performed interventions and the finishing with exposed faux masonry plaster were an obstacle to the precise definition of the wall typologies. Figure 18b shows a possible hypothesis, reconstructed solely on the basis of the historical documentation found.

**Figure 18.** Identification of the structure of the Tower on levels D-E (height 19.60 m): (a) hypothesized vertical load-bearing structure; (b) hypothesized materials.

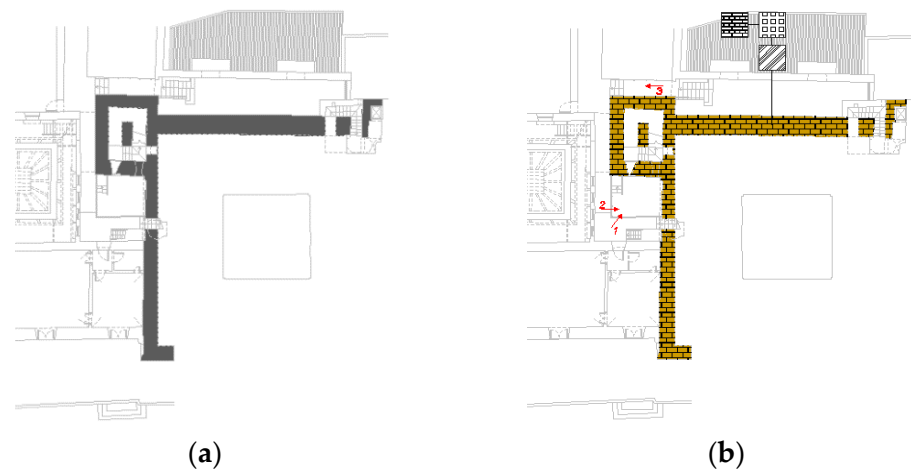
**Figure 20.** Identification of the structure of the Tower on level G (height 27.00 m): (a) hypothesized vertical load-bearing structure; (b) hypothesized materials.

Level G includes the rooms of the Astronomical Observatory adjacent to the south and west sides of the Tower. As has been mentioned, these were involved in the restoration intervention in the 1990s by Boscarino and Cottone. The intervention exposed the load-bearing structure on this level, allowing us to observe that it can be substantially associated with the original Norman construction (Figure 20a) and that it consists of large calcarenite ashlars and lime mortar (Figure 20b).

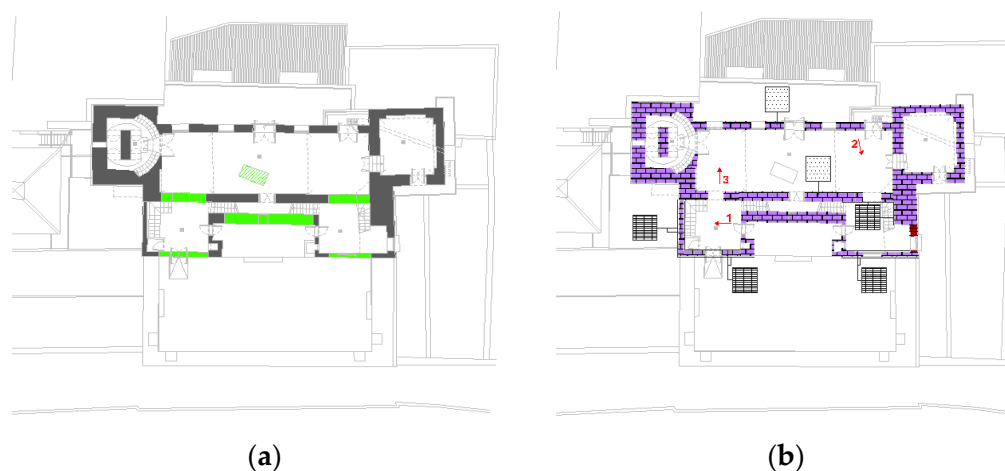
**Figure 22.** Identification of the structure of the Tower on level L (height 37.70 m): (a) hypothesized vertical load-bearing structure; (b) hypothesized materials.

it was subjected to several integrations, modifications, adaptations, and an extended and complete restoration intervention by Boscarino and Cottone, who restored the layout of the original Observatory. At this level, the structural layout no longer has a rigid system with two concentric quadrilaterals; instead, a single hall connects the south and the north turrets (Figure 22a). Boscarino and Cottone's intervention included the demolition of the partition walls in the main room, and the substitution and/or the reconstruction of all the floors of this and the upper level, in addition to the construction of a new dome based on an octagonal steel drum. Since the original construction, the walls had been almost entirely in masonry, with calcarenite ashlar and mortar joints (Figure 22b). They were then subjected to repeated reinforcement interventions, using the techniques common at the times of the interventions, including local rebuilding with aerated bricks, reinforced plaster with an electro-welded mesh on the two sides, re-pointing of mortar joints, substitution and/or realization of new steel lintels, and construction of new steel tie-rods. These interventions improved the masonry resistance, but they did not cure the vulnerabilities of the vertical load-bearing structural components at this level, which are mainly related to the presence of some transfer walls. Among these, the wall on the east side—which provides a basement for the drum of the central dome—must certainly be investigated. At the walking level of the museum (36.18 m), Cottone and Boscarino's intervention removed the infill and realized new floors in I-beams and hollow flooring blocks detached from the vaults, which then lost their load-bearing structural role. Instead, the vault of the central room was reinforced so as to support the equatorial telescope. At the upper level, that is, the roof covering of the museum of the Observatory, the pre-existing timber roofs were substituted with new slabs, steel I-beams, and hollow flooring blocks.

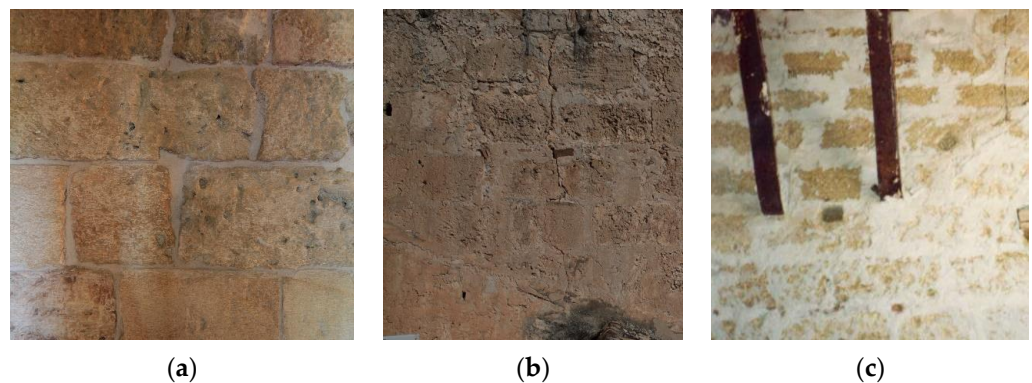
**Figure 23.** Masonry typologies: (a) Norman era; (b) Spanish era; (c) 19th century.

- Masonry in soft stone ashlar (tuff, calcarenite, etc.) of the Norman period (Figure 23a);
- Masonry in soft stone ashlar (tuff, calcarenite, etc.) of the period of the Spanish Viceroyalty (Figure 23b);
- Masonry in soft stone ashlar (tuff, calcarenite, etc.)—19th century—Astronomical Observatory (Figure 23c).

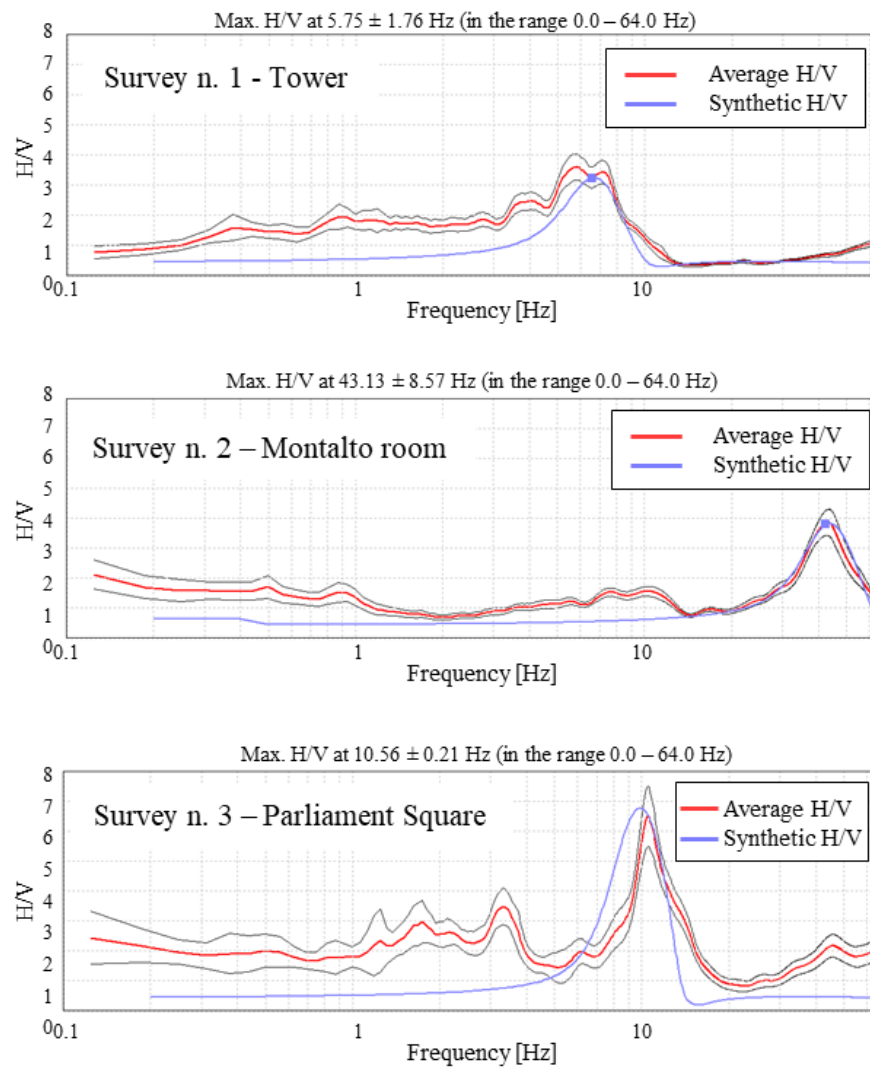
Figure 28. Results of single-station passive seismic tests.

In accordance with chapter 3 of *Guidelines*, which defines seismic action with reference to Section 3.2.2 of NTC2018, and hence according to the value of  $V_{S,30}$  obtained in the three tests, the soil class to be assumed for the definition of the response spectra was Class C—coarse-grained, medium-dense soil deposits or fine-grained soils with a medium consistency, thicker than 30 m, characterized by a gradual improvement of mechanical properties along with the depth, and by values for  $V_{S,30}$  between 180 m/s and 360 m/s (that is,  $15 < N_{SPT,30} < 50$  in coarse-grained soils and  $70 < c_{u,30} < 250 \text{ kPa}$  in fine-grained soils). Figure 28 shows the details of the interpretations of the experimental data obtained.

Depth [m]	Thickness [m]	$V_s$ [m/s]	Poisson's Ratio
<b>Survey n. 1 – Tower</b>			
8.00	8.00	209	0.40
inf.	inf.	445	0.35
<b>Survey n. 2 – Montalto room</b>			
1.00	1.00	168	0.40
inf.	inf.	358	0.35
<b>Survey n. 3 – Parliament Square</b>			
5.00	5.00	180	0.42
inf.	inf.	436	0.35
