Path of Knowledge for the Assessment of Structural Safety of the Pisan Tower of the Royal Palace of Palermo in Italy / La Mendola, L.; Accardi, M.; Agnello, F.; Monaco, A.. - In: HERITAGE. - ISSN 2571-9408. - 6:8(2023), pp. 5818-5847. [10.3390/heritage6080306]

Path of Knowledge for the Assessment of Structural Safety of the Pisan Tower of the Royal Palace of Palermo in Italy

Lidia La Mendola ¹, Matteo Accardi ², Fabrizio Agnello ³

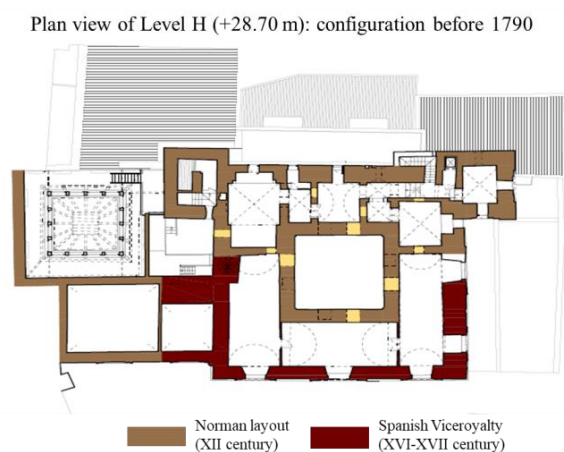
Figure 8. Conceptual reconstruction of the current floor of the Piazzzi Library in the age of the Spanish Viceroyalty.

This reconstruction was also inferred from the integrative surveys carried out in the framework of this study. It suggests that a considerable mass had been built over the pre-existing Norman structure; this mass was even greater due to the significant filling layer (a width of over 150 cm) detected through integrative endoscopic surveys. Consequently, the load excess could be one of the concurring causes that have contributed to the generation of cracks in the vaults of the underlying rooms, now part of the President's Room.

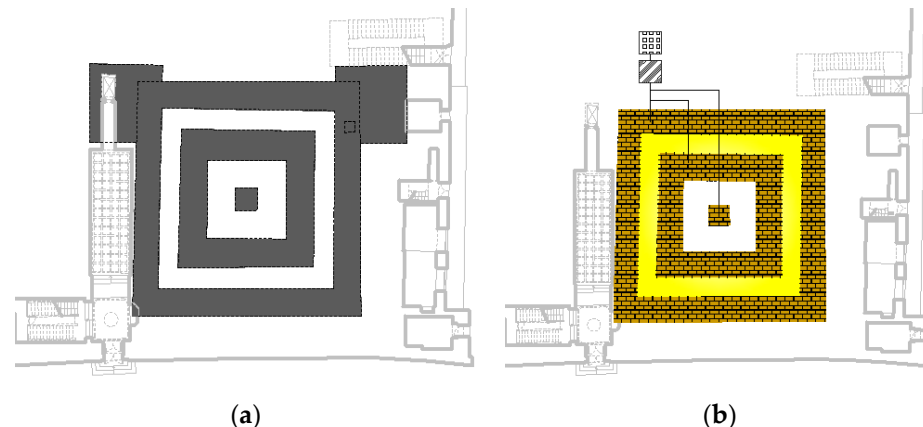
The surveys performed and the information collected showed that the vertical load-bearing structure of the Tower consists, on level A, of two concentric quadrilaterals in the planimetry, with walls wider than 2 m, and two turrets at the vertices of the west side of the Tower, as represented in Figure 15a. These walls have been realized with a wall in large (70–100 cm) calcarenite ashlar, dry-placed and/or with low-width mortar joints. The wall was considered to show good workmanship and the ashlar have excellent mechanical properties, as shown by the high value of the compression strength of the extracted core samples. The material between the two squares of the Tower can be associated with an infill, mainly constituted by crushed ashlar, masonry with scarce mechanical properties, and incoherent materials (Figure 15b).

Figure 15. Identification of the structure of the Tower on level A (height 2.90 m); (a) hypothesized vertical load-bearing structure; (b) hypothesized materials.

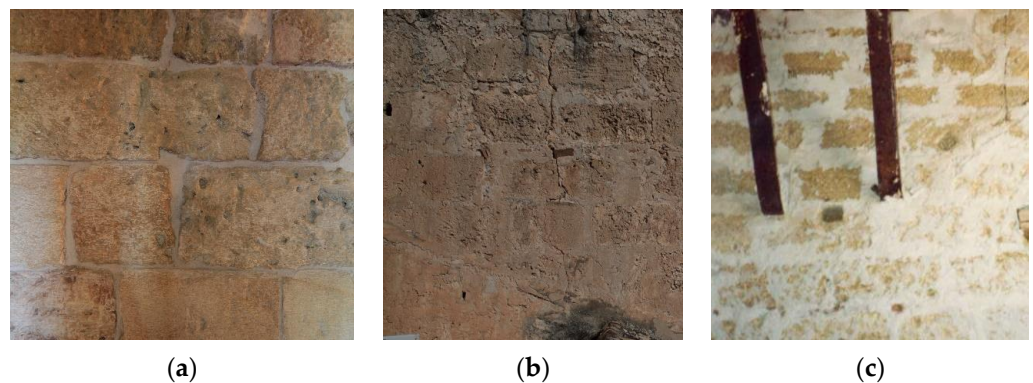
Figure 23. Masonry typologies: (a) Norman era; (b) Spanish era; (c) 19th century.

- Masonry in soft stone ashlar (tuff, calcarenite, etc.) of the Norman period (Figure 23a);
- Masonry in soft stone ashlar (tuff, calcarenite, etc.) of the period of the Spanish Viceroyalty (Figure 23b);
- Masonry in soft stone ashlar (tuff, calcarenite, etc.)—19th century—Astronomical Observatory (Figure 23c).
