# Path of Knowledge for the Assessment of Structural Safety of the Pisan Tower of the Royal Palace of Palermo in Italy

**Abstract:** This paper presents the path of knowledge developed for assessing the structural safety of the Norman-age Pisan Tower, which is mostly incorporated into the Royal Palace in Palermo, Italy. Historical, geomatic, and mechanical investigations were conducted and the most relevant results are herein collected and presented. The research path was addressed to specific tasks: identification of the building, geometric surveys, recognition of the sequence of phases of building transformation, detection of the components of the load-bearing structure, structural diagnostic surveys, and investigation of the subsoil and foundations. The explicit vulnerabilities found were mostly confined to the Piazza library floor, while implicit vulnerabilities were identified in the presence of false walls and in high loads and fillings on the vaults of the last levels. The results of the analyses allowed the individuation of the confidence factors to use in structural analysis models aimed at the assessment of the seismic safety of the building.

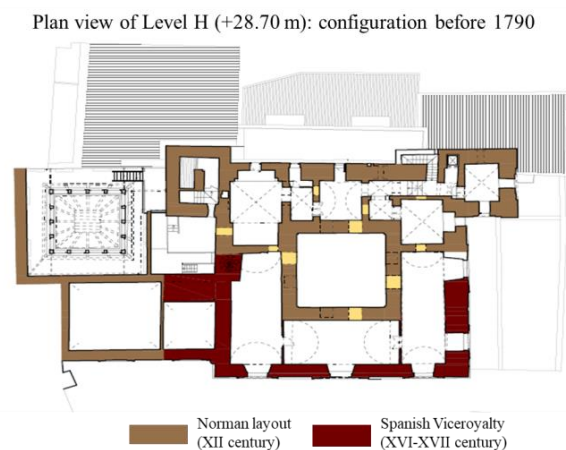
**Figure 8.** Conceptual reconstruction of the current floor of the Piazzì Library in the age of the Spanish Viceroyalty.

This reconstruction was also inferred from the integrative surveys carried out in the framework of this study. It suggests that a considerable mass had been built over the pre-existing Norman structure; this mass was even greater due to the significant filling layer (a width of over 150 cm) detected through integrative endoscopic surveys. Consequently, the load excess could be one of the concurring causes that have contributed to the generation of cracks in the vaults of the underlying rooms, now part of the President's Room.

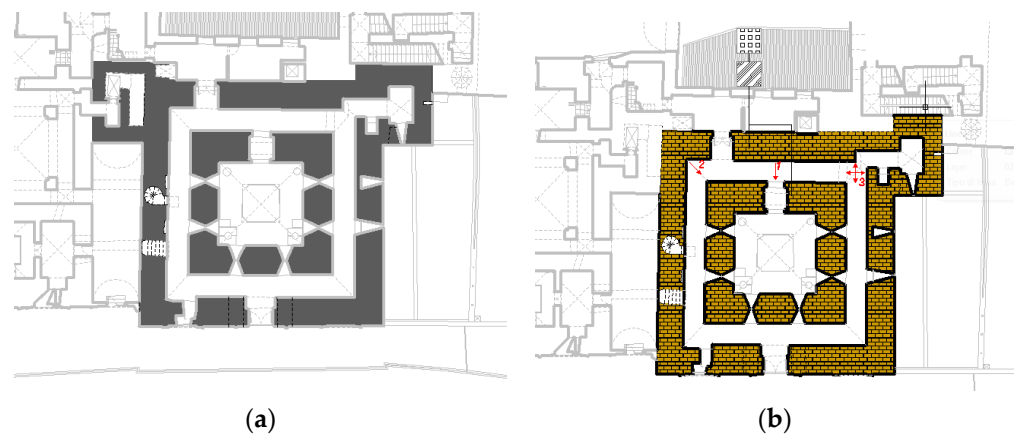
Level C has a completely exposed structural layout, consisting of two concentric quadrilaterals, divided by an ambulatory with a barrel vault covering and two side turrets (Figure 17a). The masonry walls are in large calcarenite ashlar and lime mortar. The mechanical parameters of the ashlars were only available for the exterior of the east wall, and the resistance values were aligned with those of the lower level. The values for the operating tension of the masonry wall of the external square were very high; this is probably incompatible with the resistance of the masonry (Figure 17b).

**Figure 17.** Identification of the structure of the Tower on level C (height 13.00 m): (a) hypothesized vertical load-bearing structure; (b) hypothesized materials.

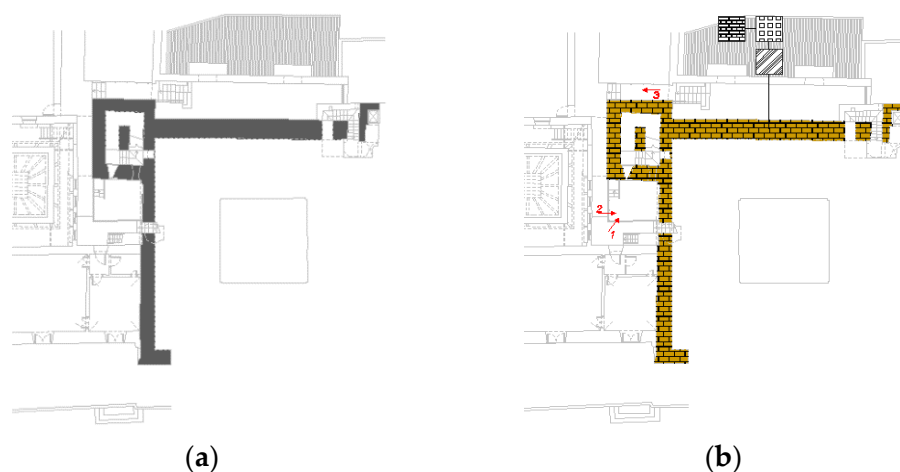
**Figure 20.** Identification of the structure of the Tower on level G (height 27.00 m): (a) hypothesized vertical load-bearing structure; (b) hypothesized materials.

Level G includes the rooms of the Astronomical Observatory adjacent to the south and west sides of the Tower. As has been mentioned, these were involved in the restoration intervention in the 1990s by Boscarino and Cottone. The intervention exposed the load-bearing structure on this level, allowing us to observe that it can be substantially associated with the original Norman construction (Figure 20a) and that it consists of large calcarenite ashlars and lime mortar (Figure 20b).
