# Geophysical Characterization of an Instable Rock Mass

C. Colombero & C. Comina

**ABSTRACT:** A pre-requisite in rock mass stability analysis is to obtain the internal structure and the mechanical properties of the investigated rock mass with a reasonable degree of uncertainty. In this respect, geophysical methods can be profitably used as an imaging and characterization tool. Seismic methods are often more suitable because the measurements depend on the mechanical properties of the rock mass. The present paper presents the use of cross-hole seismic tomography in a site (Madonna del Sasso - NW Italy) affected by a rock instability phenomenon, highlighted by episodes of slow deformation recorded by standard measurement devices. Geophysical tests have been fundamental in imaging the fracturing state and the relative variation of seismic velocities between intact and altered rock and in defining the seismic velocity field of the rock mass, a basic prerequisite for the future planned microseismic monitoring step.

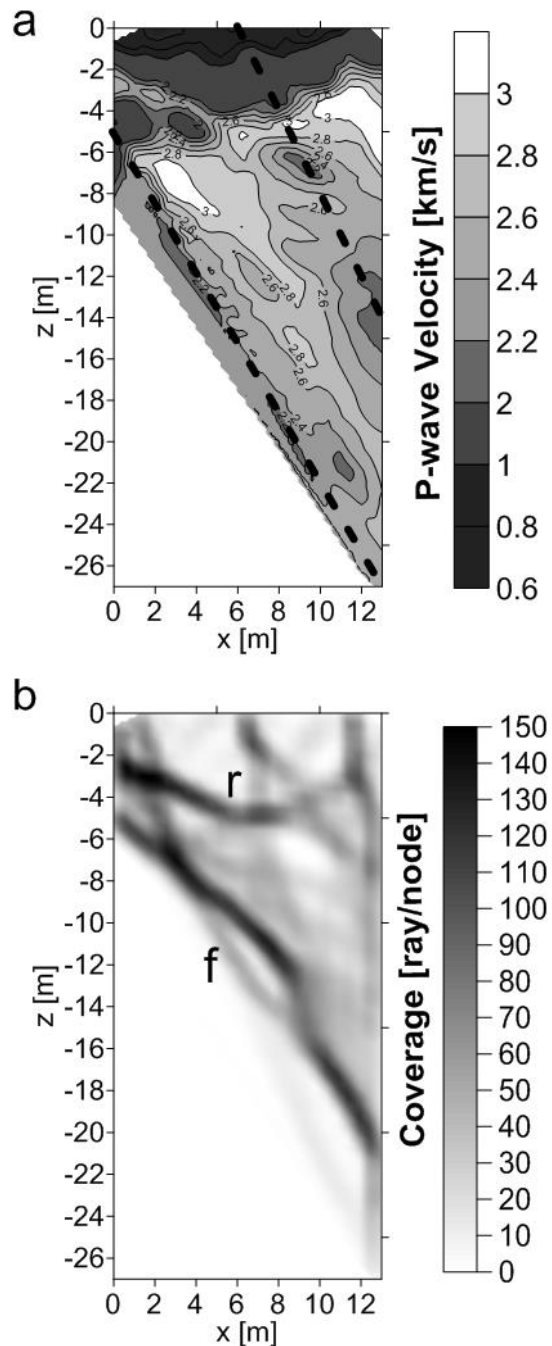
Figure 3. Results of the cross-hole seismic tomography for P waves: velocity (a) and ray coverage (b) sections.

The P- and S-wave velocity images obtained from cross-hole seismic tomography are reported in Figure 3 and 4, together with the ray coverage resulting from the inversion.

In both P and S section a shallow coverage of low velocity materials of about 2 m (top soil and highly altered/fractured granite, as also resulting from core logs) is evidenced. A clear refraction boundary (r in Figure 3b and 4b) is noticed below this zone revealing an interface with a high-velocity but non-homogeneous granite formation. Intact granite velocity reaches about 2.6-3.0 km/s for P waves and 1.6-2.0 km/s for S waves.

Two main low-velocity zones (about 2.2-2.4 km/s for P waves and 1.4-1.2 m/s for S waves) are also evidenced in both seismic sections within the massive granite formation. Dip and inclination of these zones (approximated dashed lines in Figure 3a and 4a) compare

In both images the first (deepest one) of these low velocity zones is at the border of the investigated volume, in a low ray density zone, so that it has to be considered not completely reliable. Nevertheless it can be evidenced from the ray coverage that do not reach the deepest area of investigation, but concentrate above the same, evidencing the presence of a high ray density zone (f in Figure 3b and 4b). The second zone is instead located between the two
