Non-destructive inspection technologies for repair assessment in materials and structures

## Non-destructive inspection technologies for repair assessment in materials and structures

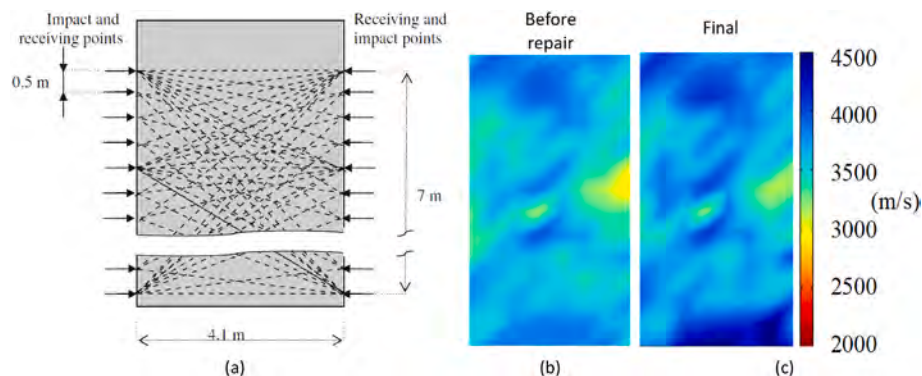
Fig. 3. (a) Schematic representation of concrete cross section with elastic wave paths, (b) wave velocity tomograms before and (c) after repair through grout injection (Shiotani et al., 2009).

condition and the repair effectiveness of grouting (through a certain predefined grid) in pylons of a water intake facility (Shiotani et al., 2009). The final modulus of the cementitious grout was nominally 21.5 GPa, while the one of the original concrete was evaluated at 35 GPa. After grouting was performed and allowing the necessary curing period, through-thickness elastic wave testing was conducted (Fig. 3(a)) and compared to the results of the reference investigation before repair. The excitation was conducted with a pneumatic impact hammer, and low frequency accelerometers (up to 40 kHz) were used to capture the response from opposite sides of the structure. Low frequencies were necessary due to the large size and long propagation distances, while stacking of approximately 800 individual excitations was also applied to enhance the signal-to-noise ratio of the waveforms. Combining the transit time of all different wave paths, tomography results showed the distribution of reference damage (Fig. 3(b)), while after injection and hardening of the grout (Fig. 3(c)), there was an overall velocity increase of approximately 5–10 % (Shiotani et al., 2009), with specific regions showing greater or limited restoration.

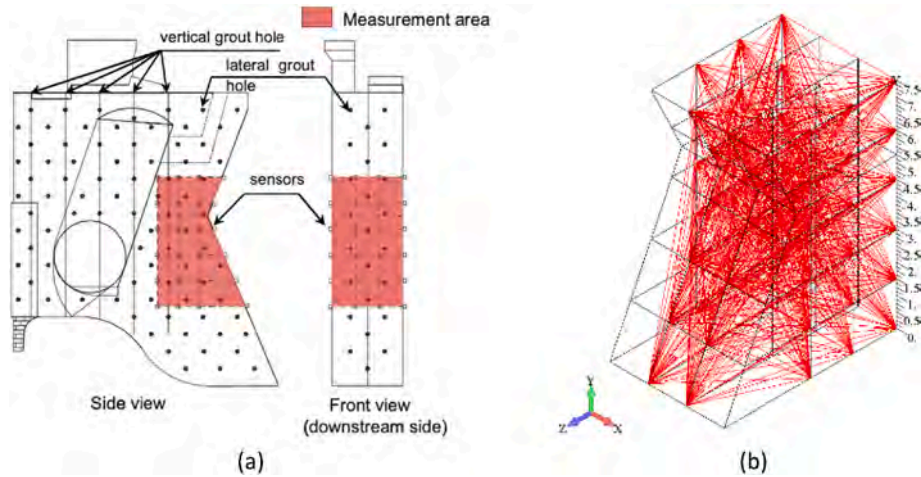
Fig. 4. Application of three-dimensional elastic wave tomography: (a) accelerometer placement, (b) ray path distribution (Momoki et al., 2013).

In an extended work at the same water intake facility which required validation of the repair effectiveness of other concrete pylons, three-dimensional elastic wave tomography was developed and applied (Momoki et al., 2013). For measuring the elastic waves' travel time, 48 accelerometers with a maximum frequency of 40 kHz, as in the above case, were instrumented on three sides of each pylon as shown in Fig. 4 (a). The arrangement created altogether 1512 potential "ray paths" for elastic wave through-the-thickness transmissions, as indicated in Fig. 4 (b). The longest straight-line distance between two accelerometers was 9.7 m. Elastic waves were excited by two different mechanical means: manual steel ball hammer impact and electro-pneumatic hammer impact to cater for comparison purpose on the effectiveness of signal generation and acquisition. The travel time tomography results are exemplified in Fig. 5(a) from measuring one of the pylons. The three-dimensional tomographic reconstruction has allowed for the visualization of any cross sections (i.e. Fig. 5(b)) of interest internally without the need to repeat measurements. This feature further adds to the technique's versatility for use in evaluating the repair efficiency of materials and structures of practical scales.

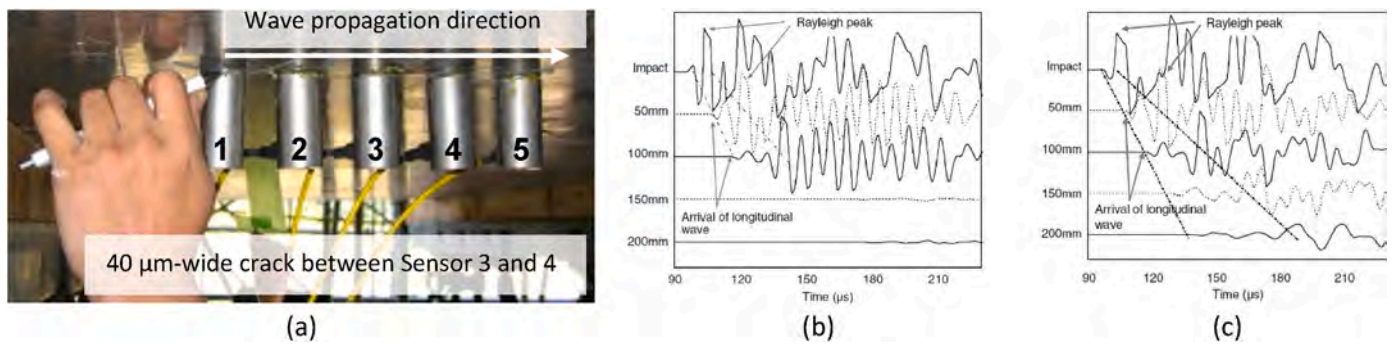
Fig. 7. (a) Sensor arrangement for surface wave measurement, (b) waveforms before repair, (c) waveforms after repair with epoxy injection (Aggelis and Shiotani, 2007).

In case access to both sides is not feasible, ultrasonic inspection can be conducted by one-sided measurements and based on the surface or Rayleigh waves. These surface waves propagate only through the top surface layer at a depth roughly equal to their wavelength (Jacobs and Owino, 2000, Carino, 2003). Therefore, the waves are sensitive to the presence of a crack and its possible repair/filling up to the maximum depth of their propagation. The example of Fig. 7(a) shows the five-sensor arrangement (with separation 50 mm distance) mounted on a concrete slab with the pencil lead break excitation. This excitation is casually applied as it results in the introduction of a broad band of frequencies and is described by ASTM E976. Fig. 7(b) shows the waveforms received after wave excitation adjacent to sensor 1. It is obvious that the discontinuity of the crack (between Sensor 3 and 4) does not allow the wave energy to pass after sensor 3, with the waveforms of sensor 4 (150 mm) and sensor 5 (200 mm) showing practically no content. However, the energy at the last two sensors is substantially increased after the epoxy injection (Fig. 7(c)). The onset became clearly distinguishable while the strong Rayleigh peak appeared again allowing the measurement of longitudinal and Rayleigh wave velocities (Aggelis and Shiotani, 2007).

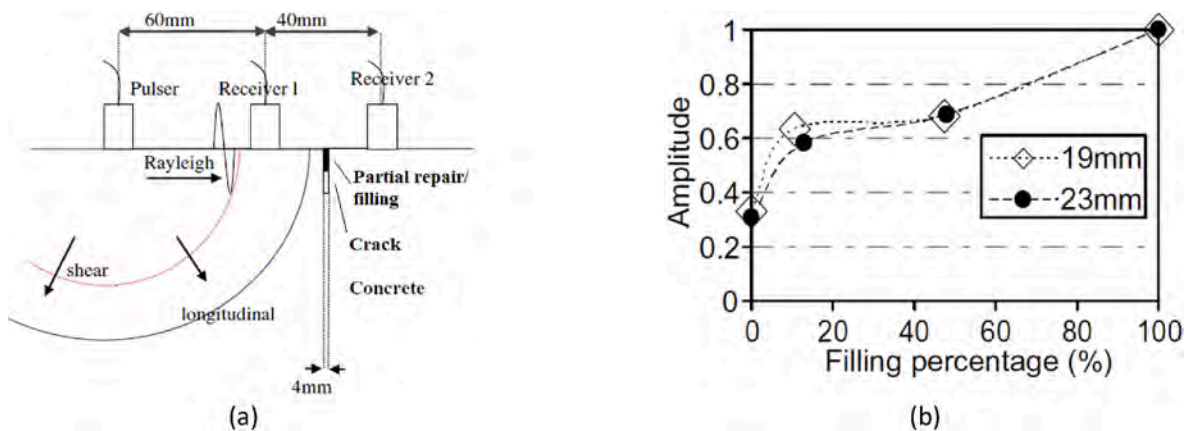
Fig. 8. (a) Schematic representation of testing geometry for repair assessment through Rayleigh waves, (b) Wave amplitude normalized to maximum vs. the filling percentage of cracks (Aggelis et al., 2009a).

In an effort to quantify the filling degree, experiments and simulations were conducted on concrete beams with manufactured slots (one with depth of 19 mm and another with depth of 23 mm) and partially or fully repaired by epoxy injection (Fig. 8(a)). The amplitude of the Rayleigh wave was monotonically correlated to the filling degree. Specifically, for an empty slot (or 0% filling, Fig. 8(b)), the Rayleigh amplitude starts at approximately 35% of the maximum (corresponding to full filling). The initial layer filling of a few mm, corresponding to 15% of the entire slot depth (see Fig. 8(b)), restores the amplitude already to 60% of maximum, while at 50% of crack filling, the wave amplitude was restored to almost 70% of the maximum. The results concern a main excitation of 115 kHz, resulting in a nominal Rayleigh wavelength of approximately 25 mm, which is longer than the slot's

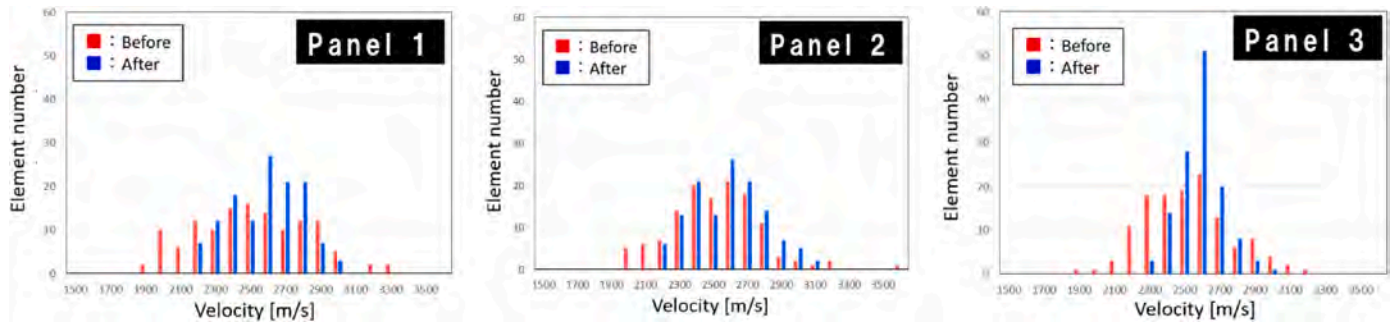
Fig. 12. Histograms of velocities obtained in all three elements before and after repair.

AE tomography results show that in all slab panels, the velocity after repair increased compared to before repair. Fig. 12 shows the histograms of velocities obtained in all the panels. For all slab panels, it is evident that the velocities clearly shift to higher values after repair. Due to the effectiveness of injected material in filling cracks and defects, deviations and distortions in the propagation paths of elastic waves are (partially) eliminated and the distribution of apparent velocities are increased. Low velocities, below 2500 m/s are still observed even after repair, which is reasonable because of the existence of independent voids due to air-entraining agent and limited injection in fine cracks. In addition, the propagation was partially done through the asphalt layer which exhibits a wave velocity of about 2800 m/s. This seems to contribute to the relatively low absolute values, but it is highlighted that the importance lies in the relative improvement before and after repair, while the very low values close or below 2000 m/s were totally eliminated.

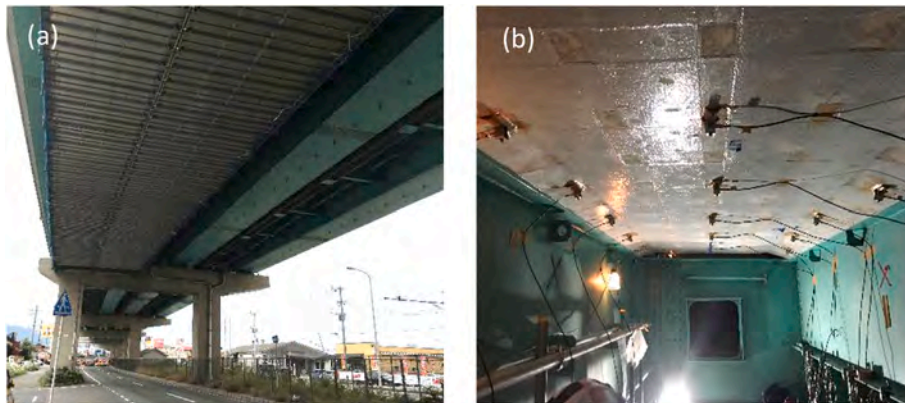
Fig. 13. (a) Tested highway bridge, (b) sensor arrangement for the measurement before repair.

The effect of repair by epoxy injection on an RC slab of a highway bridge was visualized (Takamine et al., 2018). The results before and after repair were compared to visualize the soundness based on the elastic wave source distribution by measuring the elastic waves generated by the traffic. Fig. 13 shows an overview of the measurement. The bridge of interest is a highway bridge in service, and elastic waves generated by vehicle traffic were measured for the RC slab. The target panel had cracks which were visible from the underside and was reinforced with CFRP sheets. Eighteen AE sensors were installed in a grid pattern of  $3 \times 6$  on the underside of the deck. The sensor spacing was 780 mm in the bridge axis direction and 700 mm in the direction perpendicular to the bridge axis.

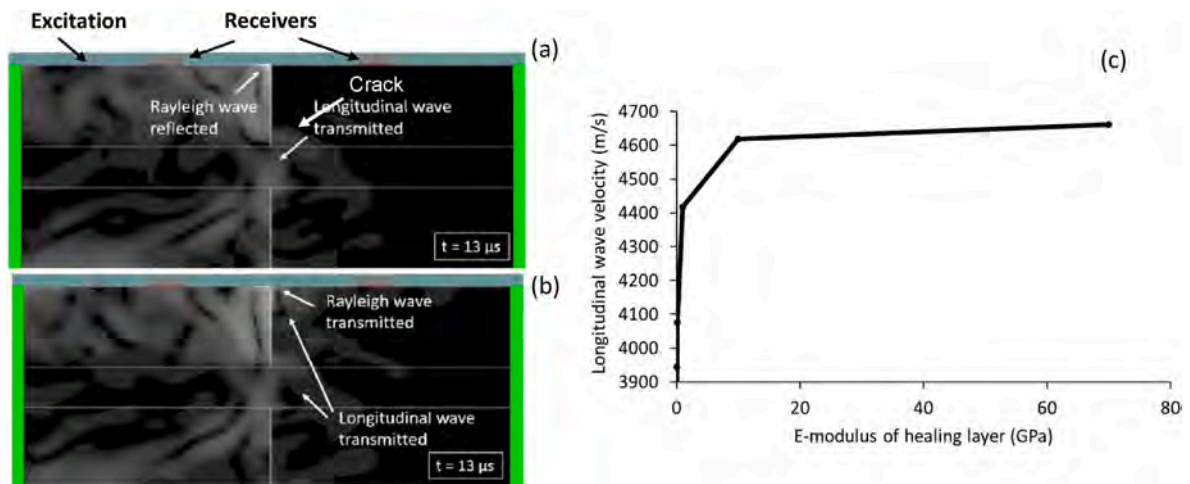
Fig. 16. Simulated wave displacement field in mortar (a) in the presence of crack (b) with healing agent in the crack, (c) simulation of wave velocity dependence on E-modulus of healing material (Lefever et al., 2022a).

The restoration degree of the pulse velocity or attenuation gives a measure to quantify the self-healing. However, this applies to the wave parameters and is not directly translated into mechanical properties restoration. In an effort to better relate the restoration of wave parameters (amplitude, wave velocity) to the stiffness of the healing products, a numerical study was recently reported (Fig. 16(a) (Lefever et al., 2022a)). There, the equivalent stiffness of the healing material was varied to check its effect on the macroscopically measured pulse velocity and attenuation. At zero stiffness, the Rayleigh wave is not transmitted through the crack and is completely reflected as shown in Fig. 16(a). In the case of a material with considerable stiffness inside the crack, the Rayleigh wave is partially transmitted (Fig. 16(b)). It was found that the early healing (i.e. increase of the Young's modulus of the healing product from 0 to 1 GPa) is already responsible for approximately 60% of the restoration of the wave velocity and amplitude while further hardening of the healing layer, has a smaller effect, see Fig. 16(c). Therefore, surface ultrasound is sensitive to healing and especially the initial crucial stage of healing product formation, which makes the difference between the discontinuity (empty crack) and an elastic medium that can support elastic waves, showing a minimum of mechanical properties. Considering that the experimental restoration of the wave velocity and amplitude was also at approximately 60% (Lefever et al., 2022a), it was concluded that the healing products were of the order of 1 GPa after 28 days of healing.

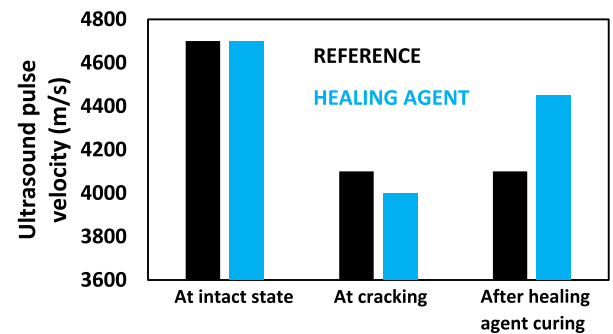
Fig. 18. Ultrasound pulse velocity for reference mortar and mortar with encapsulated healing agent (Vangansbeke et al., 2023).

Another self-healing approach that has gained the attention of the scientific committee over the last decade is the autonomous self-healing, which involves the use of healing agent carriers that are encapsulated in concrete during casting and would break under mechanical stresses as a crack propagates through the capsule to cause release of sealant that fills the crack. Elastic wave inspection plays a key role in the assessment of concrete repair after the healing activation. Specifically, Van Tittelboom et al. (2012) proposed the embedment of glass capsules in concrete that would carry a polymeric agent that, upon breakage, would fill up the crack. The UPV appeared to be a direct and reliable tool for the repair efficacy assessment (Muhammad et al., 2016). As pointed out in Fig. 18, the UPV, as measured in transmission mode through concrete beams cracked under three-point bending with crack openings up to 0.3 mm, is significantly recovered after the healing agent release and curing of the agent up to 24 h in ambient conditions (Vangansbeke et al., 2023).

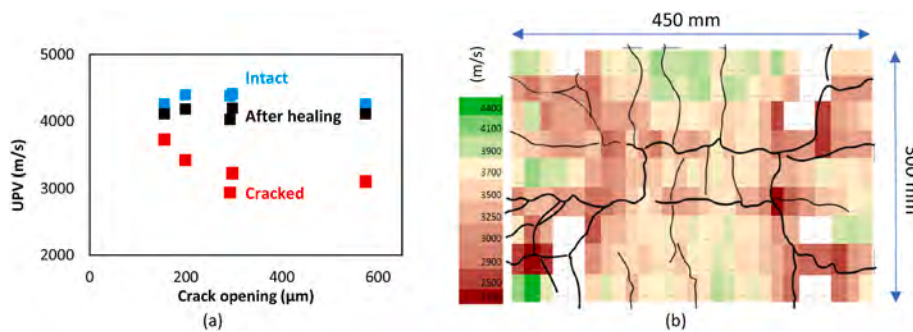
Fig. 19. (a) UPV measured through transmission in several concrete beams loaded in four-point bending and healed by agent distributed through a linear tubes network, (b) Ultrasound mapping of a concrete slab healed by agent distributed through vascular networks of 3D printed polymeric tubes (Tsangouri et al., 2022). The thickness of the slab is 55 mm and it is reinforced by four  $\Phi 8$  ribbed steel rebars.

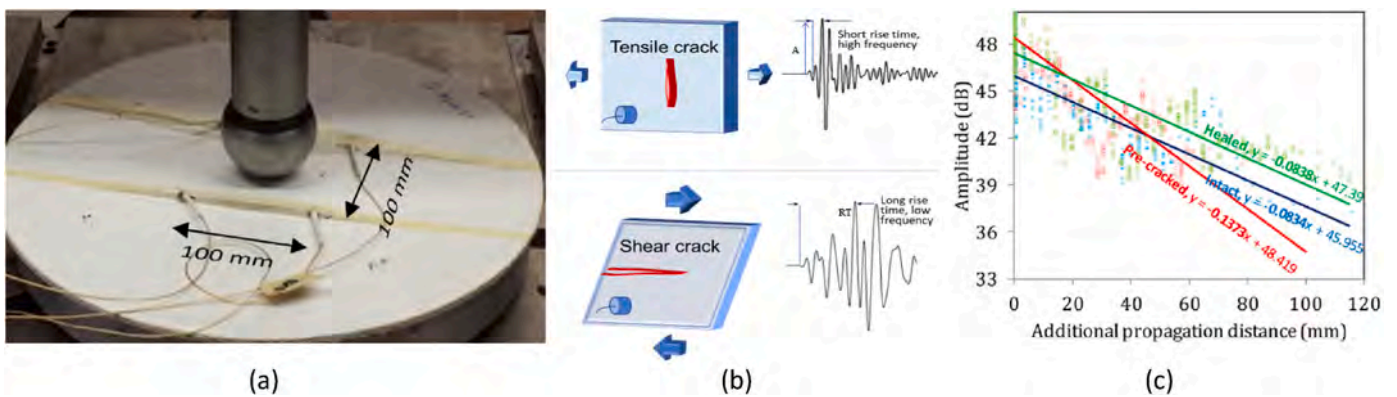
Fig. 21. (a) Circular TRC plate under point loading with four AE “pico” sensors, (b) different fracture modes with corresponding AE waveforms (cracking and debonding) as measured by piezoelectric sensors attached on the surface, (c) amplitude vs. distance of AE signals for different material conditions (El Kadi et al., 2017).

Continuing in cases related to self-healing, Textile Reinforced Cement (TRC) plates with and without healing polymer powder were first thermally cracked and later mechanically loaded in bending (Fig. 21(a)). Exposure to high temperature led to extensive cracking, one of the basic damage mechanisms for this material, while the others are debonding between successive plies and fiber pull-out. When cracking is already saturated (in the thermally cracked specimens), the debonding phase is accelerated, resulting in a much different AE behavior. This is due to the different micro-displacement of the crack sides. In case of debonding, shear stresses emit most of the energy in the slower shear wave mode than the longitudinal waves that are mostly emitted by the tensile cracking. Therefore, for debonding associated signals most of the energy arrives later in the waveform, increasing the rise time (RT, Fig. 21(b)), as well as the overall signal duration, while it inversely decreases the frequency content. However, in the specimens with healing polymer (El Kadi et al., 2017), an almost-complete restoration of the AE properties towards the reference specimens was observed. Indicatively, the intact specimens exhibited RA-value (calculated as rise time, RT, over Amplitude, A, see Fig. 21(b)) of less than 600  $\mu\text{s}/\text{V}$ , while that of the thermally cracked specimen achieved almost 1500  $\mu\text{s}/\text{V}$ . The healed specimen exhibited less than 800  $\mu\text{s}/\text{V}$  in RA-value, much closer to the original value. Similar was the restoration of the frequency content, indicating that cracking was again the dominant mechanism and that the behavior of the healed specimens was closer to the intact ones rather than the thermally damaged ones. The reason was that although the high temperatures produced distributed cracking in the matrix, at the same time, melted the polymer powder directly filling or repairing these cracks. Wave transmission was also indicative since thermal cracking increased the attenuation coefficient from 0.084 dB/mm to 0.137 dB/mm, while the healed material was restored to the levels of intact (Fig. 21(c)).

As aforementioned and shown in Fig. 21(b), the shape of the AE waveforms is typical of the fracture mode, with shear events, characterized by longer rise times, and lower frequencies than the waveforms related to tensile mode fracture. Through the analysis, it was possible to identify a first phase of the test in which a fracture of mode I for traction prevails (AF values up to 300 kHz), followed by a shift to mode II for shear load during the delamination process (events with frequency of approximately 100 kHz). This study is more related to the evaluation of compatibility (similarity in mechanical characteristics) and durability over time when subjected to fatigue cycles and is not directly connected to the successful application of the repair. However, it is included in this report to show how relevant the interface bond compatibility is for a broader interpretation of repair on masonry and for assessing of the

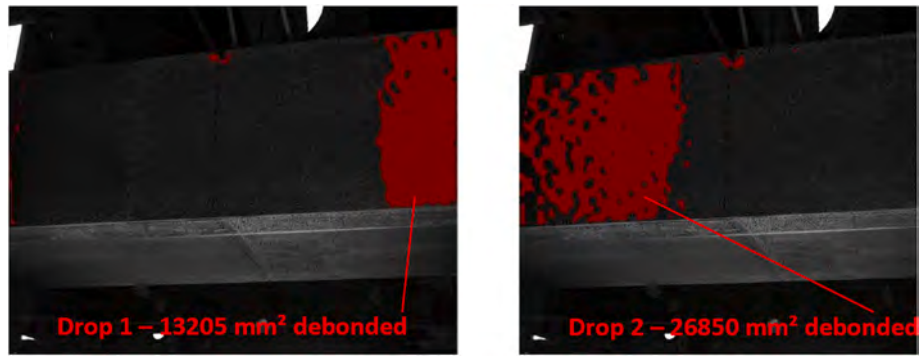
Fig. 22. Quantification of the debonding area of repairing TRC patch from concrete substrate by DIC strain difference before and after two load drops (Aggelis et al., 2016).

In addition, the AE parameters showed distinct differences, especially at the transient load drops. For the reference beams, parameters did not show big changes implying that the fracture mechanism was essentially the same throughout loading (i.e. matrix cracking), while for the externally retrofitted beams, during the transient load drops the RT and RA values were approximately double, indicating that at that moment, debonding of the patches was happening. This was confirmed by DIC showing a sudden release of strain on the debonded patch areas, allowing the determination of the exact area where the repair/retrofitting layer was debonded (Fig. 22, Aggelis et al., 2016).

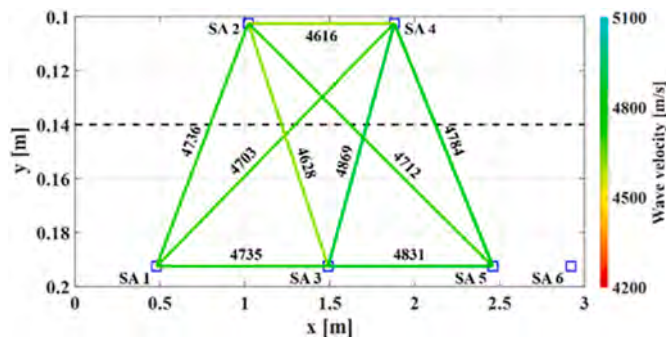
Fig. 23. Wave velocity in each ray path on the 757th day (Cheng et al., 2022).

newly-cast concrete. The sensors formed ray paths across the old and new concrete and their interfaces. Potential changes in wave velocity between the ray paths across the interfaces would indicate potential delamination. Over a two-year period, measurements were taken, and the comparison of wave velocities in different ray paths did not indicate any delamination in the newly applied concrete cover (Fig. 23). The method is demonstrated to be effective for long term monitoring of repair patches.

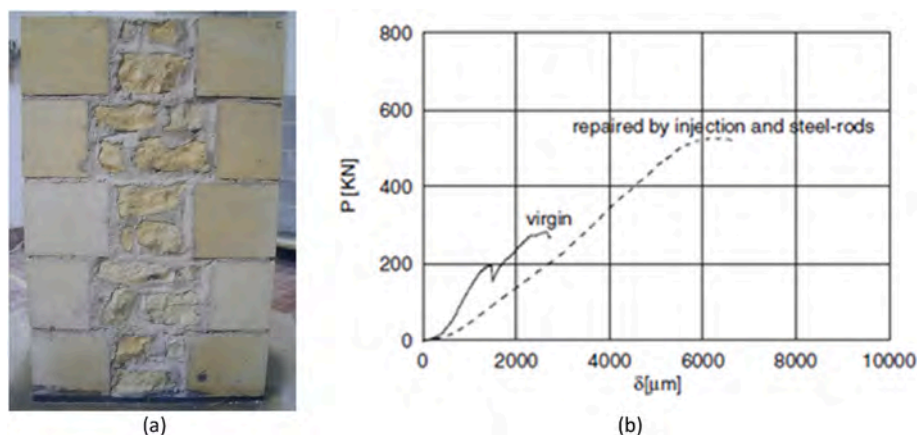
Fig. 24. (a) Typical geometry of the tested walls, (b) Load-displacement curves of masonry wall component (PN4) in Noto stone (reference and reinforced by mortar injections and steel rods) (Anzani et al., 2008).

(Anzani et al., 2008). The test specimens (see Fig. 24(a)) were instrumented with 6 AE sensors, which allowed to localize the points of initiation of the cracks and interpret their trend during loading. After repair, masonry test specimens reinforced by steel rods, mortar injection, or a combination of both (Fig. 24(b)) were monitored with AE throughout the loading test. Samples were loaded under stress control, imposing constant speed of displacement. Cumulative AE counts increase slowly in the first load phase, after which they increase proportionally to the load, reaching a peak close to the test failure load (Fig. 25(a)). The function representing the count rate (AE counts number per minute) reaches its maximum value in the ascending branch of the load-displacement curves and is then reduced to zero in the proximity of the final load. It is, therefore, possible to identify two phases during testing: a first phase during which the largest cracks are formed and the material reaches a critical damage condition (Phase 1), and a second phase during which the material tends to exhaust its load capacity (Phase 2). For the repaired specimen with mortar injection and steel rods, the cumulative AE activity was notably lower (less than one third of the reference) (Fig. 25(b)).

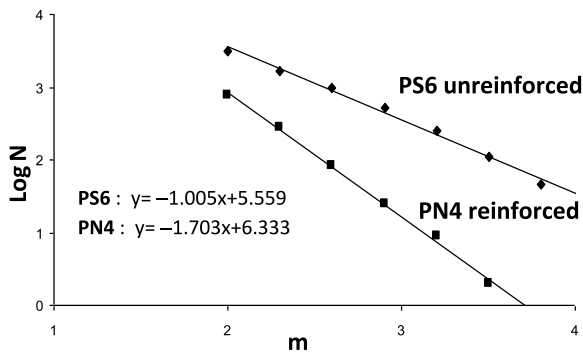
Fig. 26. Determination of “b-value” at the end of the loading test on the two specimens (Anzani et al., 2008).

In the AE field, the “b-value” is calculated by analogy with seismic phenomena. It stands for the proportion of low-intensity events over the high energy events and is calculated as the slope of the inverse cumulative amplitude distribution (Fig. 26). Low absolute b-values indicate the progress of the fracture towards larger scale events that occur at the limit of the load-bearing capacity of the component (Carpinteri et al., 2009, 2011). This parameter changes systematically at different stages in the course of the damage process and, therefore, can be used to estimate damage evolution modalities. By applying these concepts to different specimens, unreinforced (PS6) and reinforced with mortar injection and steel rods (PN4), it can be seen that the former exhausted its bearing capacity during the load test, with the formation of cracks of a size comparable to that of the specimen, forming along the interface between the filler and the outer wall (b-value  $\cong 1$ ), and the latter, characterized by a widespread cracking pattern, still has a reserve of strength before reaching the final collapse (b-value  $\cong 1.7$ ). The determination of the “b-values” for the two specimens is shown in Fig. 26, which is based on calculating the gradient of linear regressions obtained from Log N versus m plots. In seismicity N is the cumulative number of earthquakes with magnitude  $\geq m$  in a given area and a specific time-space. While in AE analysis N is the cumulative number of AE signals whose magnitude is calculated as  $m \propto \text{Log } 10 A_{\text{max}}$ ,  $A_{\text{max}}$  being the maximum amplitude of the signals (Anzani et al., 2008).

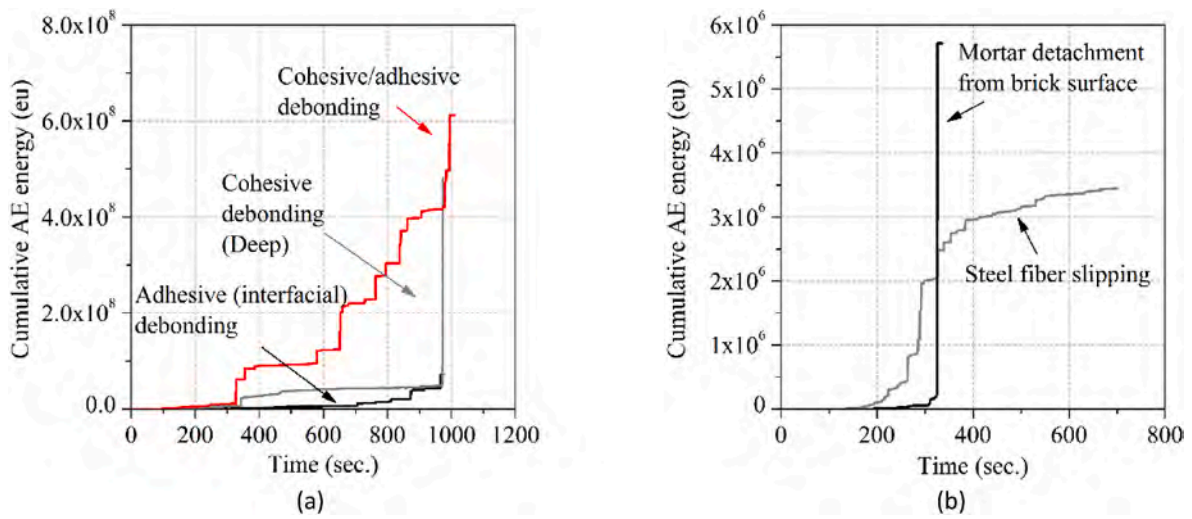
Fig. 28. (a) Representative results of cumulative AE energy measured during shear bond tests on brick specimens with FRP-strengthening and (b) SRG-strengthening (Verstrynge et al., 2016).

and strengthening interventions, it is also important to be able to detect possible failure of the strengthening techniques (Saidi et al., 2022). Therefore, the AE technique was used to investigate damage in composite masonry strengthening systems with a polymer- or mortar-based matrix (Ghiassi et al., 2014; Verstryngne et al., 2016). More specifically, clay bricks were strengthened with Glass Fibre Reinforced Polymer (GFRP) and with Steel Reinforced Grout (SRG) and were tested during single-lap shear bond tests (Fig. 27). It was observed, based on localized AE events, that delamination started at the loaded end and moved downward during testing, according to the expected movement of the debonded area. A clear distinction based on the AE energy was found between specimens showing different failure modes, i.e. GFRP cohesive or adhesive failure (Fig. 28(a)) and SRG brick/mortar detachment or fibres slipping (Fig. 28(b)). It can be concluded from these tests that the AE technique can characterize the failure mode of GFRP- and SRG-strengthening debonding.

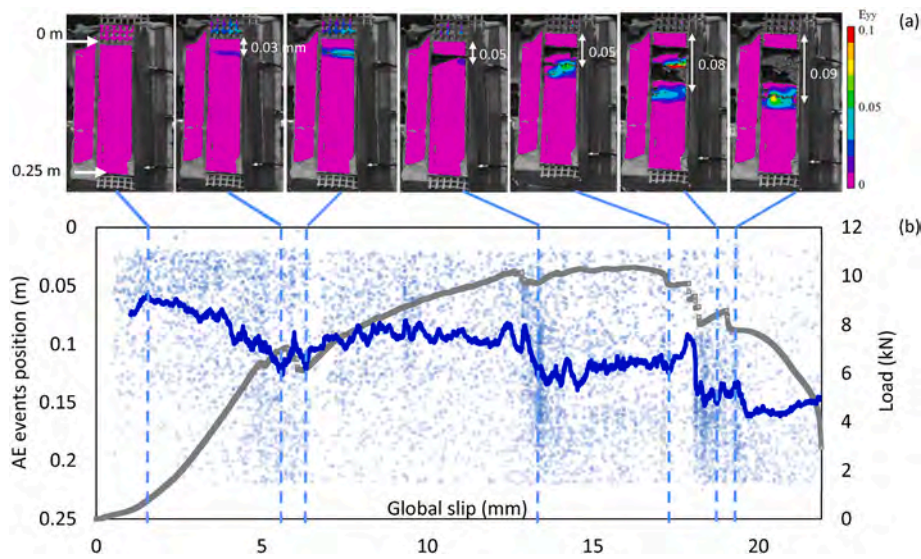
Fig. 29. Carbon TRC retrofit patch on masonry brick under single-lap shear test: (a) DIC Eyy strain maps, and (b) AE events localized in a vertical line along the TRC layer, as projected on the load-slip curve (Linn et al., 2022).

In a similar study, the progressive failure under shear bond testing of carbon TRC retrofitting layer mounted on brick masonry is tracked with AE source localization method in correlation to DIC as illustrated in Fig. 29 (Linn et al., 2022). The vertical Eyy strains were mapped at different loading stages as multiple cracks progressively form along the TRC retrofitting patch, while, below, the AE events distribution along the vertical axis are plotted as well at the same loading stages. For both the visual DIC analysis and the AE events localization tracking method, the cracks (associated with AE events) initiated at the top side of the patch and propagated towards the bottom of the TRC patch. It was evident that AE can accurately monitor the damage evolution and precisely pinpoint the damage front at any moment during a single-lap shear test.

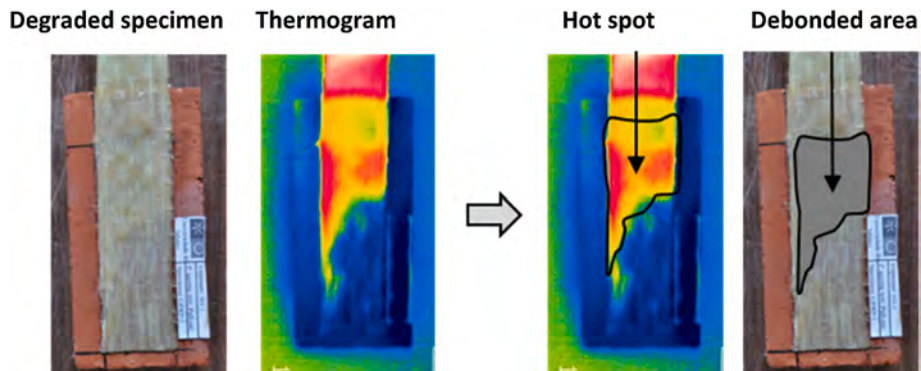
Fig. 30. Debonding detection with infrared thermography (Ghiassi et al., 2013; Verstrynge et al., 2016).

the specimens. The existence of discontinuities, such as interfacial defects or delaminations, affects the thermal properties. The temperature decay in degraded areas is altered, which can be identified as hot spots in the thermal images, as exemplified in Fig. 30. This test provides a picture of the potential detachments. However, high thermal conductivity (carbon or steel fibres) or high matrix thicknesses could limit the detectability of the test.

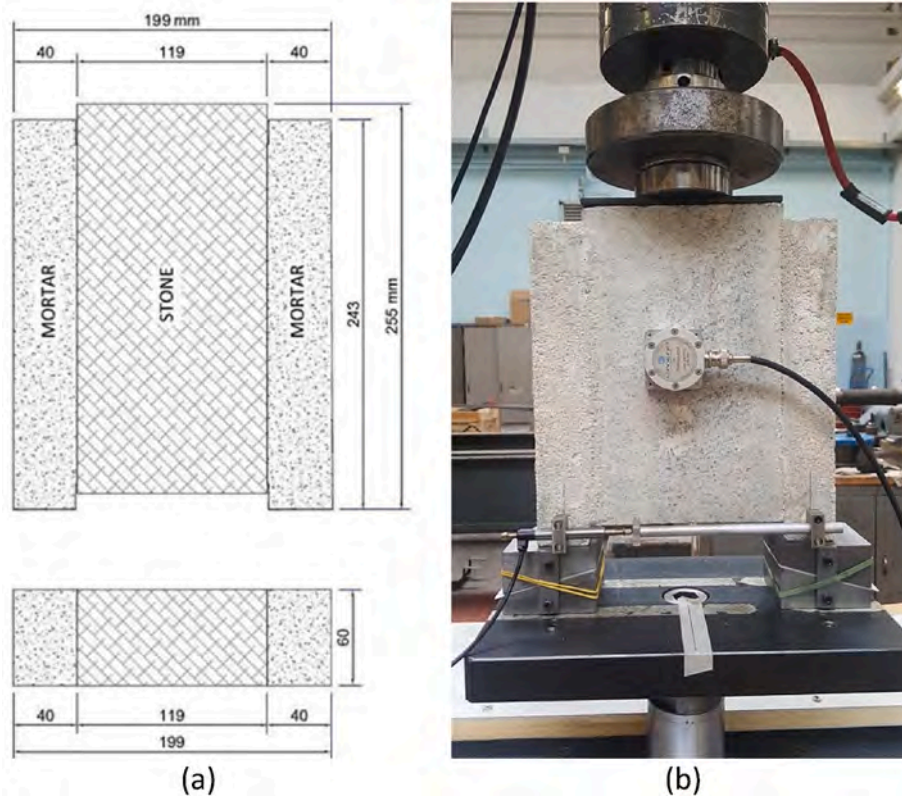
Fig. 31. (a) Side and top view of composite specimen, (b) test setup (Grazzini et al., 2020).

In order to examine the bonding conditions and the general mechanical behavior in coupled materials consisting of stone and repair plaster, “triplet” specimens were subjected to compression with the concurrent acquisition of AE (Fig. 31(a and b)). This way, the fracture mode at the interface between the two materials can be examined (Grazzini et al., 2020). The test is helpful in assessing the compatibility of new repair mortars against the historic masonry support, to whose interface often stresses arise due to the excessive rigidity of the repair mortars when they are stressed by thermal or mechanical cycles.

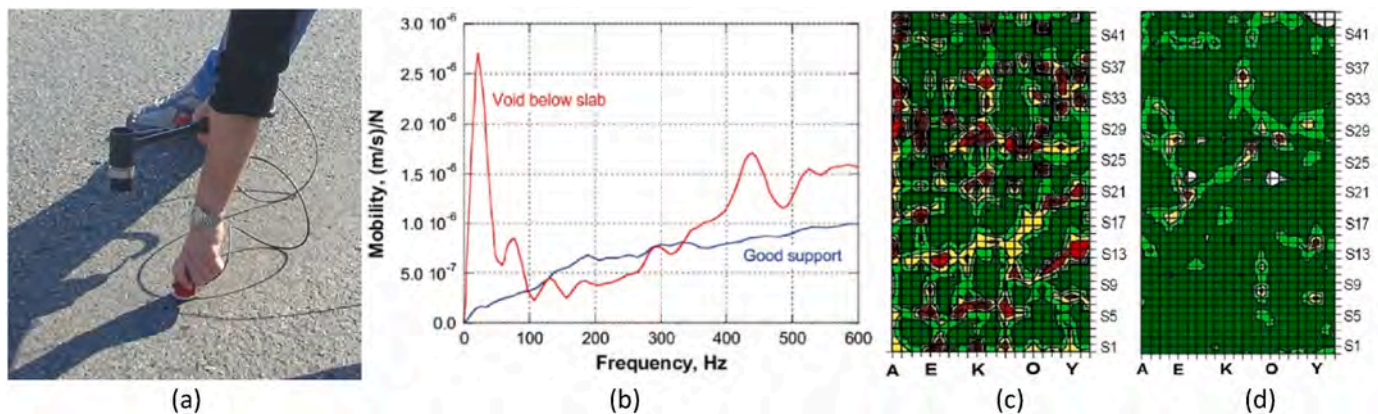
Fig. 32. (a) Impact hammering and geophone placement during I-R measurement, (b) indicative mobility curves (Germann Instruments, 2024), (c) mobility map before and (d) after grout injection on the concrete floor (Zoidis et al., 2013).

reaction of the member (Fig. 32(a)). When the material is very stiff or heavy, then the response (defined by the “mobility” curve), as calculated in the frequency domain through deconvolution of the impact and the recorded response, is expected to be low (Fig. 32(b)). However, when the top layer is delaminated, severely cracked or compromised in any way, a much higher mobility curve is expected (Fig. 32(b)). By applying the impact and reception on a regular pattern of points on the surface, a map can be created based on the average level or slope of the mobility curve indicating the current condition, while comparison before and after repair can highlight the improvement, as seen in Fig. 32(c) and (d). In this case, some points of higher mobility were persistent even after repair, leading to another injection round at a secondary grid. The I-R investigation (map in Fig. 32(d)) exhibited a much lower average level of mobility as well as revealed local changes in the areas of interest, verifying that the floor was adequately repaired (Zoidis et al., 2013).
