Non-destructive inspection technologies for repair assessment in materials and structures

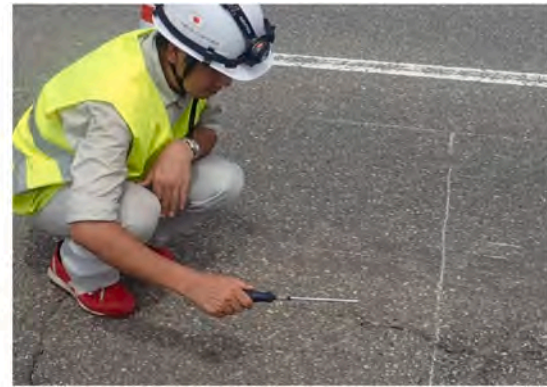
Fig. 11. (a) Analysis model for AE tomography, (b) steel-ball tapping (Okude et al., 2018).

Fig. 11(a) shows the model of AE tomography analysis and the positions of the sensors. The shaded part at the top of the model indicates the asphalt layer with thickness of 50 mm. As elements for AE tomography analysis, the applicable region was divided in 16×8 , which gives a total of 128 elements. In this study, elastic waves were excited by steel-ball tapping. A steel-ball of 5 mm diameter was tapped at several locations on the asphalt surface, ensuring that the distribution of impact points was as uniform as possible at the target area. The steel-ball tapping is illustrated in Fig. 11(b) (Okude et al., 2018).

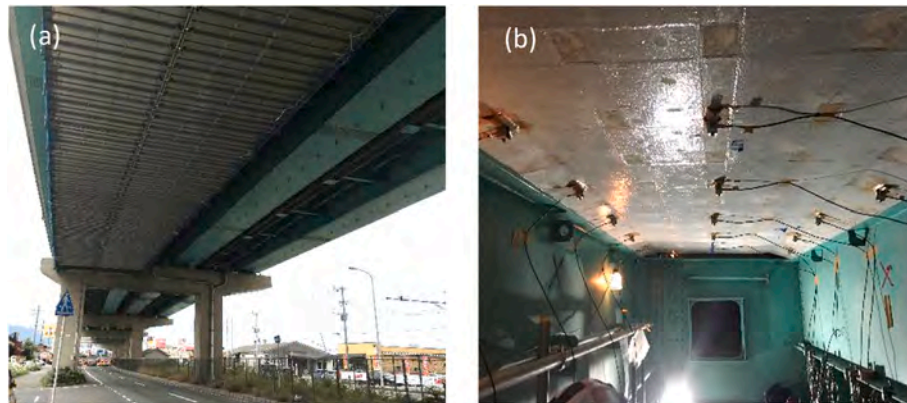
Fig. 13. (a) Tested highway bridge, (b) sensor arrangement for the measurement before repair.

The effect of repair by epoxy injection on an RC slab of a highway bridge was visualized (Takamine et al., 2018). The results before and after repair were compared to visualize the soundness based on the elastic wave source distribution by measuring the elastic waves generated by the traffic. Fig. 13 shows an overview of the measurement. The bridge of interest is a highway bridge in service, and elastic waves generated by vehicle traffic were measured for the RC slab. The target panel had cracks which were visible from the underside and was reinforced with CFRP sheets. Eighteen AE sensors were installed in a grid pattern of 3×6 on the underside of the deck. The sensor spacing was 780 mm in the bridge axis direction and 700 mm in the direction perpendicular to the bridge axis.

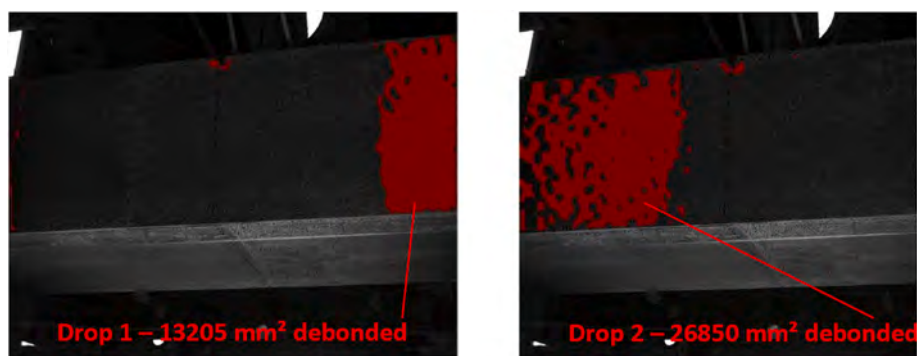
Fig. 22. Quantification of the debonding area of repairing TRC patch from concrete substrate by DIC strain difference before and after two load drops (Aggelis et al., 2016).

In addition, the AE parameters showed distinct differences, especially at the transient load drops. For the reference beams, parameters did not show big changes implying that the fracture mechanism was essentially the same throughout loading (i.e. matrix cracking), while for the externally retrofitted beams, during the transient load drops the RT and RA values were approximately double, indicating that at that moment, debonding of the patches was happening. This was confirmed by DIC showing a sudden release of strain on the debonded patch areas, allowing the determination of the exact area where the repair/retrofitting layer was debonded (Fig. 22, Aggelis et al., 2016).

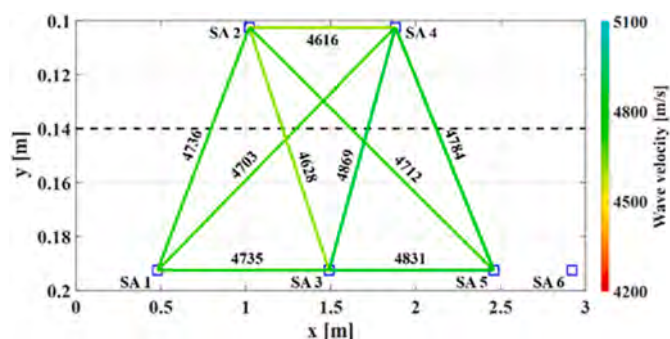
Fig. 23. Wave velocity in each ray path on the 757th day (Cheng et al., 2022).

newly-cast concrete. The sensors formed ray paths across the old and new concrete and their interfaces. Potential changes in wave velocity between the ray paths across the interfaces would indicate potential delamination. Over a two-year period, measurements were taken, and the comparison of wave velocities in different ray paths did not indicate any delamination in the newly applied concrete cover (Fig. 23). The method is demonstrated to be effective for long term monitoring of repair patches.
