Non-destructive inspection technologies for repair assessment in materials and structures

# Non-destructive inspection technologies for repair assessment in materials and structures

T. Shiotani<sup>a</sup>, N. Ogura<sup>a</sup>, N. Okude<sup>a</sup>, K. Watabe<sup>a,b</sup>, C. Van Steen<sup>c</sup>, E. Tsangouri<sup>d,e</sup>,  
G. Lacidogna<sup>f</sup>, S. Czarnecki<sup>g</sup>, H.K. Chai<sup>h</sup>, Y. Yang<sup>i</sup>, E. Verstrynge<sup>c</sup>, D.G. Aggelis<sup>d,\*</sup>

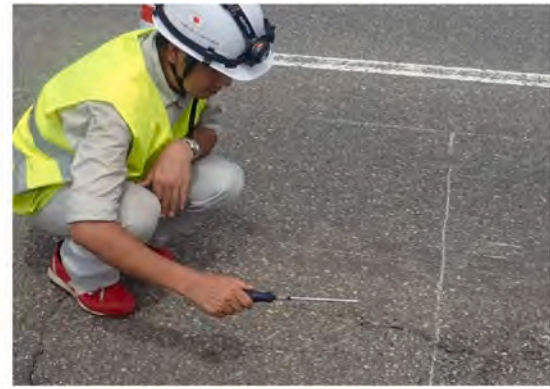
Fig. 11. (a) Analysis model for AE tomography, (b) steel-ball tapping (Okude et al., 2018).

Fig. 11(a) shows the model of AE tomography analysis and the positions of the sensors. The shaded part at the top of the model indicates the asphalt layer with thickness of 50 mm. As elements for AE tomography analysis, the applicable region was divided in  $16 \times 8$ , which gives a total of 128 elements. In this study, elastic waves were excited by steel-ball tapping. A steel-ball of 5 mm diameter was tapped at several locations on the asphalt surface, ensuring that the distribution of impact points was as uniform as possible at the target area. The steel-ball tapping is illustrated in Fig. 11(b) (Okude et al., 2018).

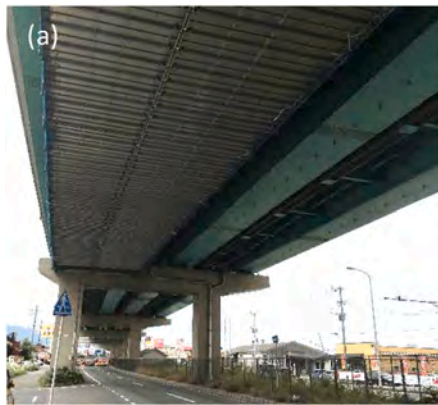
Fig. 13. (a) Tested highway bridge, (b) sensor arrangement for the measurement before repair.

The effect of repair by epoxy injection on an RC slab of a highway bridge was visualized (Takamine et al., 2018). The results before and after repair were compared to visualize the soundness based on the elastic wave source distribution by measuring the elastic waves generated by the traffic. Fig. 13 shows an overview of the measurement. The bridge of interest is a highway bridge in service, and elastic waves generated by vehicle traffic were measured for the RC slab. The target panel had cracks which were visible from the underside and was reinforced with CFRP sheets. Eighteen AE sensors were installed in a grid pattern of  $3 \times 6$  on the underside of the deck. The sensor spacing was 780 mm in the bridge axis direction and 700 mm in the direction perpendicular to the bridge axis.
