PANAYİA KİLİSESİ (REŞADİYE)

envanter no: 329

THE PANAGIA CHURCH (REŞADIYE)

inventory no: 329

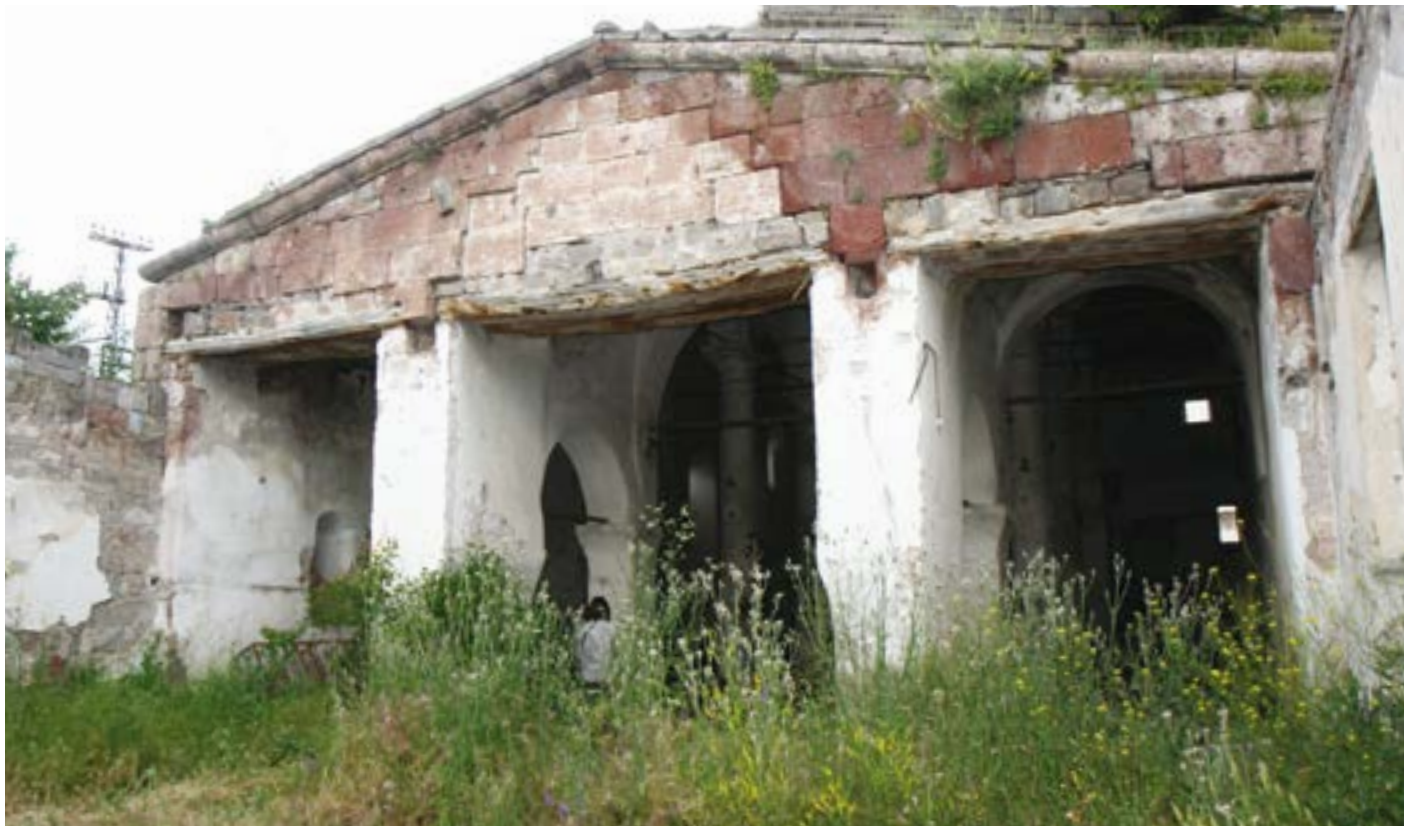
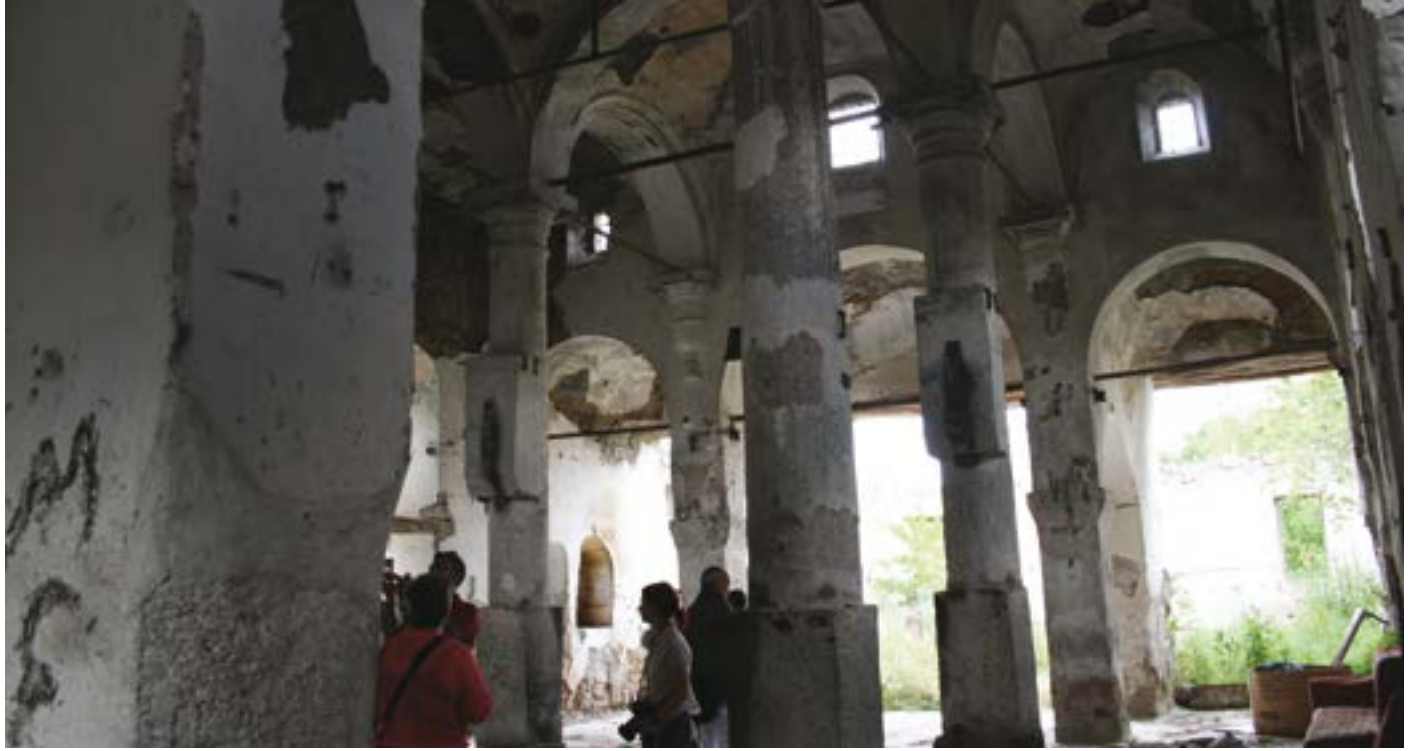
The interior of the three-naved naos measures 9.7 x 14.04 meters and has built with three columns on either sides and two piers defining the apse. 48 cm in diameter, the columns rest on square and rectangular pedestals measuring between 60-75 cm and 60-70 cm.

The church has ashlar masonry double walls filled with rubble. The columns and piers are made of stone and covered with stucco. Columns rest on rectangular stone pedestals. Columns and piers are connected to each other with spreaders and arches. Arches rest on corbels on the side naves. The naos area is covered with barrel vaults and groin vaults, with the profiles of vaults discernible even through the destroyed apse. The roof is covered with interlocking fluted stones. The floor is layered with cement today, making it impossible for the original level to be identified.

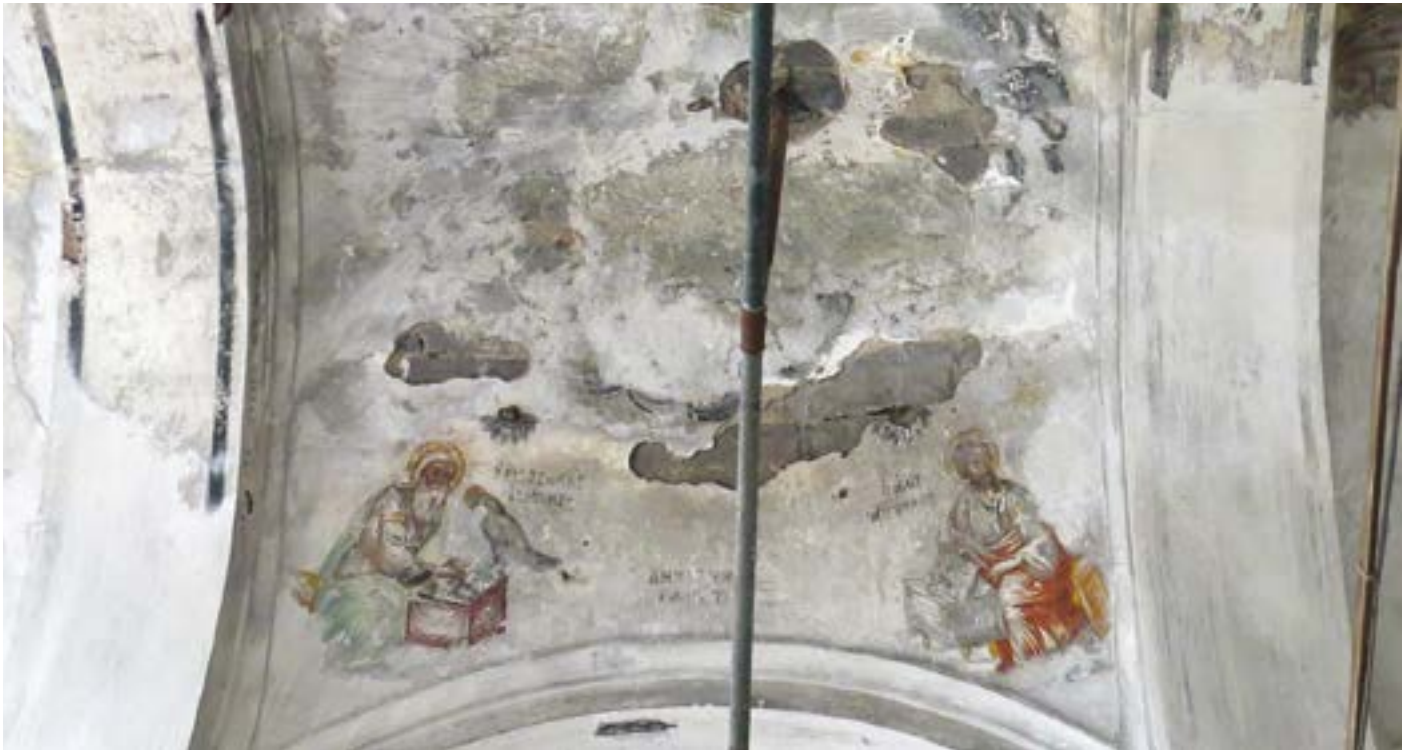
Even though the difference between empty elements and voids can be guessed, original features have disappeared. North and south main walls have niches. The gallery of the west wall contains three arched windows while there are three more on the gable on the east wall which defines the naos.

There are traces of iconographical frescoes on the vaults. Capitals are decorated with stucco and Tuscan-like elements, and the corbels supporting the arches on side naves are ornamented with acanthus leaves.
