Panagia Church (Readiye) / Dinler, M. - In: Kayseri with its Armenian and Greek Cultural Heritage / Mehmet Atlgan; Onat Eren; Nora Mildanolu; Mehmet Polatel. - STAMPA. - Istanbul : Hrant Dink Foundation, 2016. - ISBN 978-605-86570-0-7. - pp. 204-207

## PANAYİA KİLİSESİ (REŞADİYE)

## THE PANAGIA CHURCH (REŞADIYE)

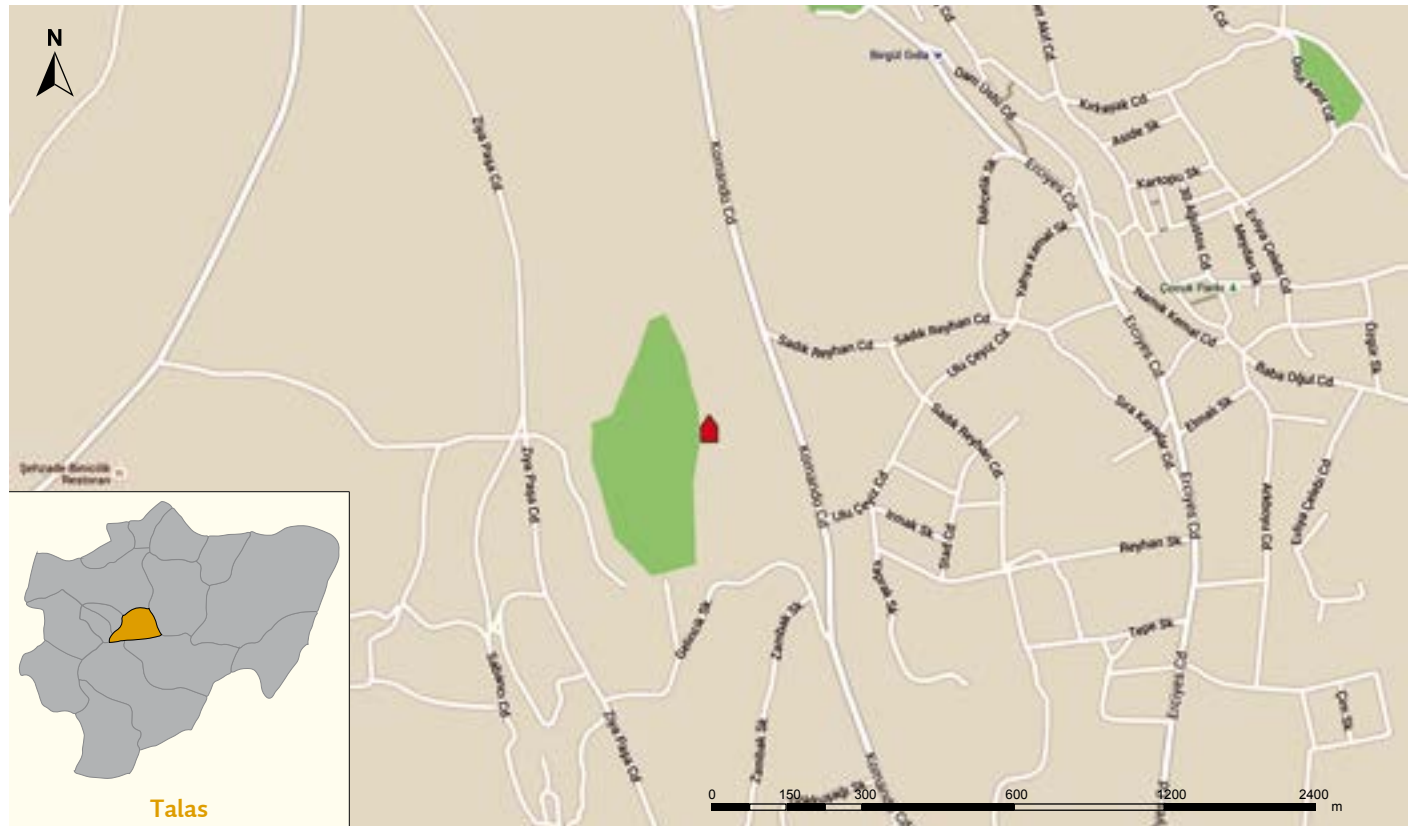
The interior of the three-naved naos measures 9.7 x 14.04 meters and has built with three columns on either sides and two piers defining the apse. 48 cm in diameter, the columns rest on square and rectangular pedestals measuring between 60-75 cm and 60-70 cm.

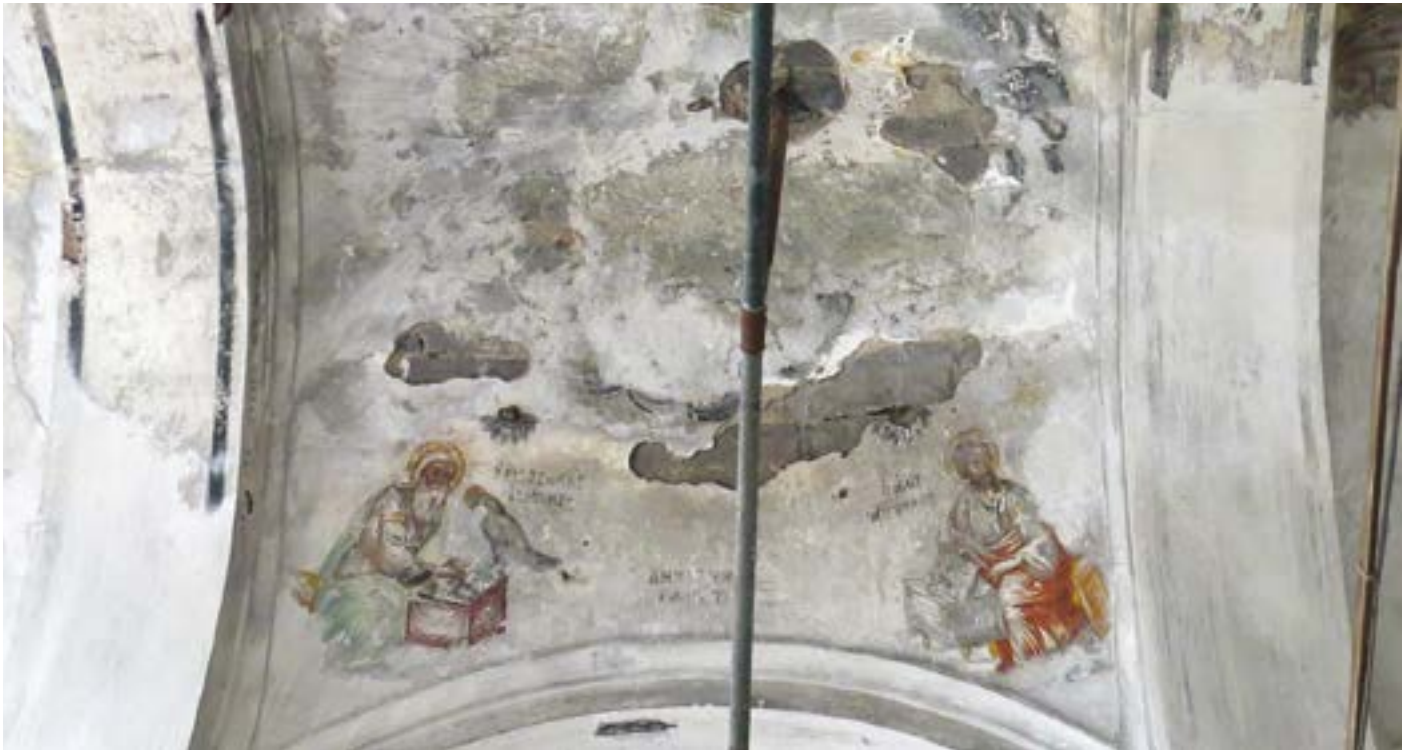
Even though the difference between empty elements and voids can be guessed, original features have disappeared. North and south main walls have niches. The gallery of the west wall contains three arched windows while there are three more on the gable on the east wall which defines the naos.

There are traces of iconographical frescoes on the vaults. Capitals are decorated with stucco and Tuscan-like elements, and the corbels supporting the arches on side naves are ornamented with acanthus leaves.
