Non-destructive inspection technologies for repair assessment in materials and structures

Non-destructive inspection technologies for repair assessment in materials and structures / Shiotani, T.; Ogura, N.; Okude, N.; Watabe, K.; Van Steen, C.; Tsangouri, E.; Lacidogna, G.; Czarnecki, S.; Chai, H. K.; Yang, Y.; Verstrynghe, E.; Aggelis, D. G.. - In: DEVELOPMENTS IN THE BUILT ENVIRONMENT. - ISSN 2666-1659. - STAMPA. - 18:(2024), pp. 1-20. [10.1016/j.dibe.2024.100443]

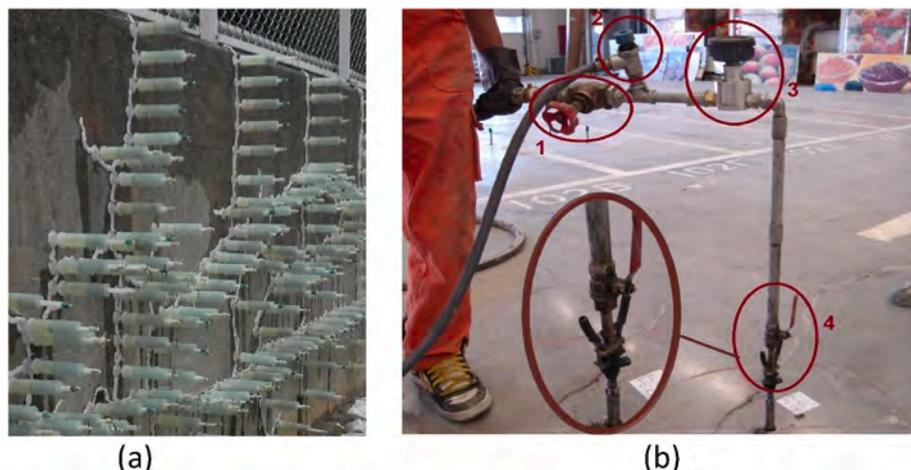
Fig. 1. (a) Epoxy injection in a concrete wall (courtesy Kyoto University) and (b) grouting injection in a concrete floor (Zoidis et al., 2013).

In this case, a filling material is placed (injected by pressure and with the aid of capillary action) into the cracked volume. This can be applied through the opening of surface breaking cracks using syringes that push liquid agent (commonly epoxy) into the empty volume of the crack (Issa, 2009, Fig. 1(a)). Alternatively, a certain predefined grid is prepared by drilling holes and injecting cementitious grout into the structure (Fig. 1(b)).

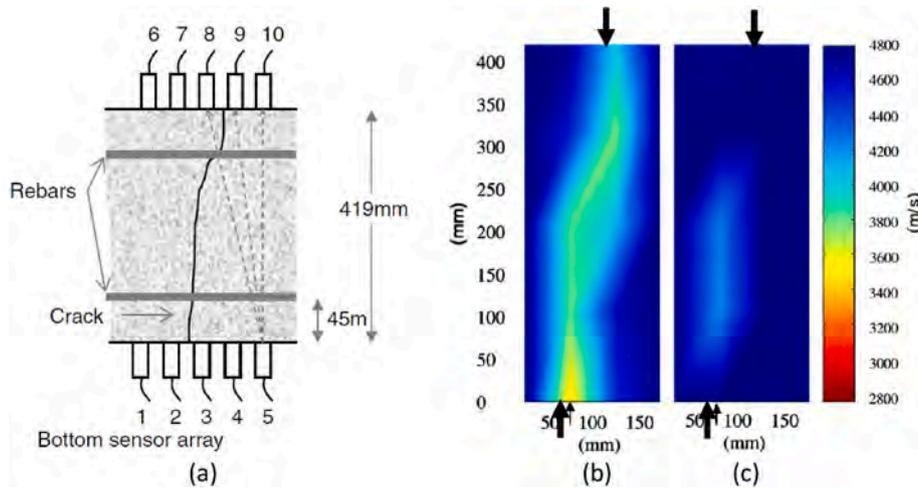
Fig. 2. (a) Side view of the sensor locations and crack position through the bridge deck, (b) ultrasonic tomogram before repair, and (c) after repair with epoxy injection in the crack (Aggelis and Shiotani, 2007).

In case of specific defects like through-thickness cracks in a concrete slab, ultrasonic wave propagation and tracking could successfully evaluate the difference between the damaged and the repaired state of the member after epoxy injection. In Aggelis and Shiotani (2007), groups of five resonant piezoelectric sensors were arranged at the top and the bottom surface, Fig. 2(a). Excitations were made at each sensor position and the propagating wave was recorded at all other sensor positions. Reasonably, wave paths not intersected by the crack exhibited higher velocity than the ones including a crack. By combining the information of the transit time of all the different wave paths in the tomography procedure, the visualization of the velocity structure of the cross-section is conducted (see Fig. 2(b)). In the initial tomogram, the crack is clearly visible, and associated with much lower wave velocity than the sound material away from the crack. After repair, the overall velocity map has substantially improved since the void was filled. In Fig. 2(c), there are only tiny traces of the crack still visible, something considered normal because the epoxy, even though it has higher strength than concrete, possesses a lower elastic modulus (3–5 GPa). Nevertheless, the information supplied by the ultrasonic tomogram was sufficient to realize that the filling was satisfactory and allowed the continuation of the works.

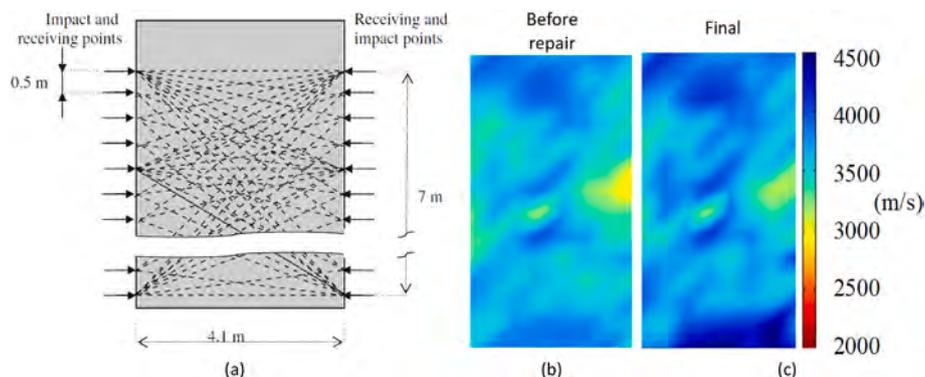
Fig. 3. (a) Schematic representation of concrete cross section with elastic wave paths, (b) wave velocity tomograms before and (c) after repair through grout injection (Shiotani et al., 2009).

condition and the repair effectiveness of grouting (through a certain predefined grid) in pylons of a water intake facility (Shiotani et al., 2009). The final modulus of the cementitious grout was nominally 21.5 GPa, while the one of the original concrete was evaluated at 35 GPa. After grouting was performed and allowing the necessary curing period, through-thickness elastic wave testing was conducted (Fig. 3(a)) and compared to the results of the reference investigation before repair. The excitation was conducted with a pneumatic impact hammer, and low frequency accelerometers (up to 40 kHz) were used to capture the response from opposite sides of the structure. Low frequencies were necessary due to the large size and long propagation distances, while stacking of approximately 800 individual excitations was also applied to enhance the signal-to-noise ratio of the waveforms. Combining the transit time of all different wave paths, tomography results showed the distribution of reference damage (Fig. 3(b)), while after injection and hardening of the grout (Fig. 3(c)), there was an overall velocity increase of approximately 5–10 % (Shiotani et al., 2009), with specific regions showing greater or limited restoration.

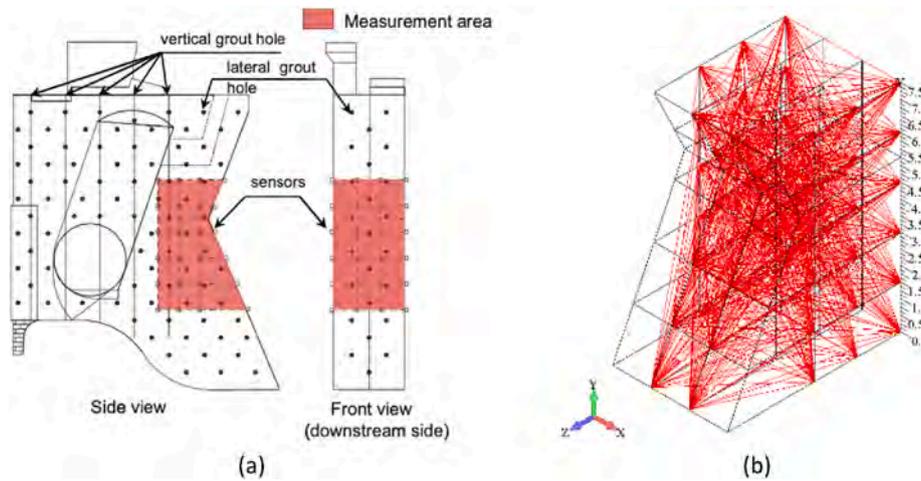
Fig. 4. Application of three-dimensional elastic wave tomography: (a) accelerometer placement, (b) ray path distribution (Momoki et al., 2013).

In an extended work at the same water intake facility which required validation of the repair effectiveness of other concrete pylons, three-dimensional elastic wave tomography was developed and applied (Momoki et al., 2013). For measuring the elastic waves' travel time, 48 accelerometers with a maximum frequency of 40 kHz, as in the above case, were instrumented on three sides of each pylon as shown in Fig. 4 (a). The arrangement created altogether 1512 potential "ray paths" for elastic wave through-the-thickness transmissions, as indicated in Fig. 4 (b). The longest straight-line distance between two accelerometers was 9.7 m. Elastic waves were excited by two different mechanical means: manual steel ball hammer impact and electro-pneumatic hammer impact to cater for comparison purpose on the effectiveness of signal generation and acquisition. The travel time tomography results are exemplified in Fig. 5(a) from measuring one of the pylons. The three-dimensional tomographic reconstruction has allowed for the visualization of any cross sections (i.e. Fig. 5(b)) of interest internally without the need to repeat measurements. This feature further adds to the technique's versatility for use in evaluating the repair efficiency of materials and structures of practical scales.

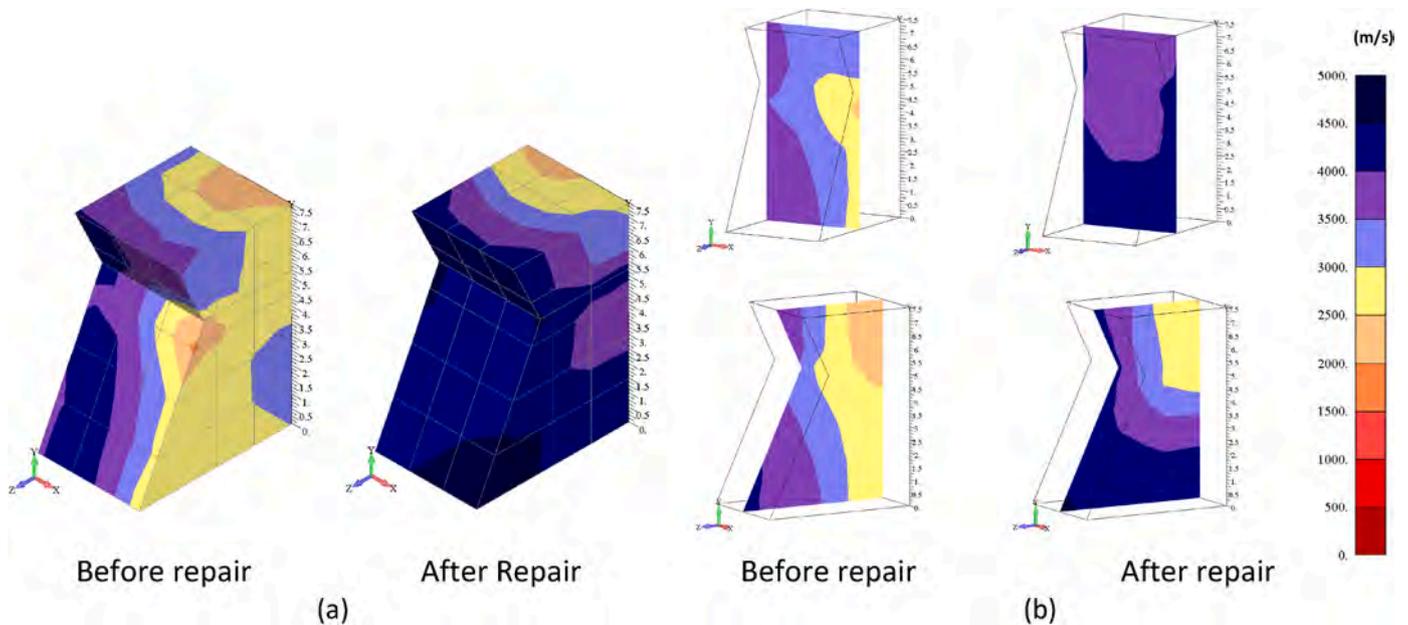
Fig. 5. Elastic wave tomographic reconstruction results of concrete pylon: (a) three-dimensional coverage, (b) central cross section visualizations (Momoki et al., 2013).

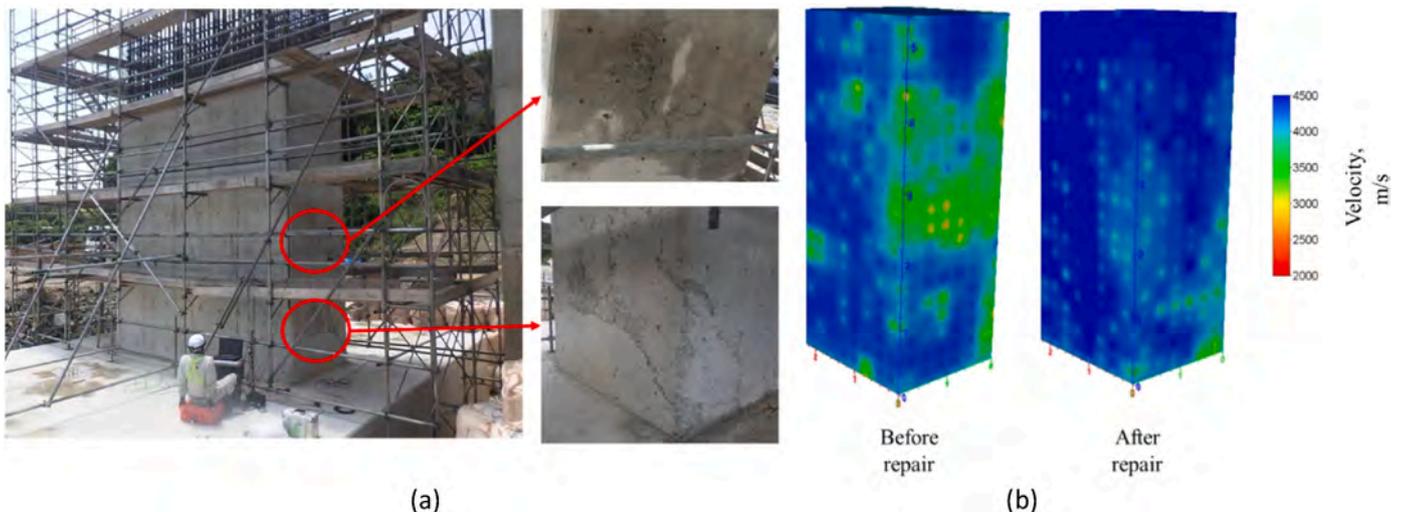
Fig. 6. (a) Tested bridge pier with honeycombs on the surface, and (b) results of elastic wave velocity tomography before and after repair.

reinforcement placement, concrete casting and curing. Shortcomings may occur in one or several stages of this process (for instance, congested reinforcement placement, insufficient compaction, etc.), which results in defects, such as voids or honeycombing. Any decision on possible action or repair should be based on the defect’s condition and the general damage level. After the formwork removal on this bridge construction project, extensive honeycombing was found on part of a concrete surface. The authors adopted the elastic wave velocity tomography method to evaluate the damage level of a newly built bridge pier with an extensive honeycomb area. Tomography results can be visualized in 3D contour plots of velocity distribution, in which regions with lower velocity correspond to regions with a defect. In this case, the initial measurement was carried out and the result showed areas with lower wave velocity in the locations corresponding to the honeycombs. Later on, the honeycombs were removed, and repair was applied by means of a new layer of concrete. After the repair, elastic wave velocity tomography was carried out again. In the resulting velocity distribution, the areas with lower velocity corresponding to the honeycombs were eliminated. Thus, the effect of repair works was confirmed. The tested

structure and results of elastic wave tomography are presented in Fig. 6.

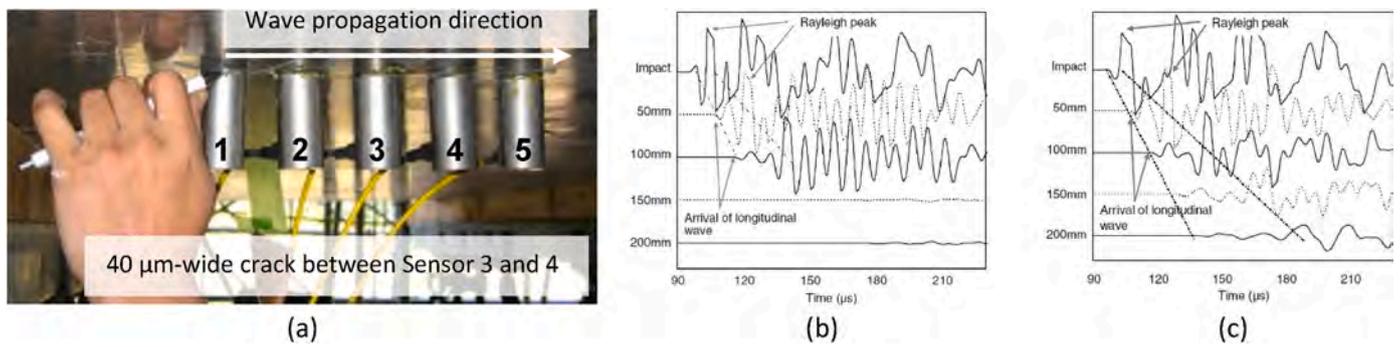
Fig. 7. (a) Sensor arrangement for surface wave measurement, (b) waveforms before repair, (c) waveforms after repair with epoxy injection (Aggelis and Shiotani, 2007).

In case access to both sides is not feasible, ultrasonic inspection can be conducted by one-sided measurements and based on the surface or Rayleigh waves. These surface waves propagate only through the top surface layer at a depth roughly equal to their wavelength (Jacobs and Owino, 2000, Carino, 2003). Therefore, the waves are sensitive to the presence of a crack and its possible repair/filling up to the maximum depth of their propagation. The example of Fig. 7(a) shows the five-sensor arrangement (with separation 50 mm distance) mounted on a concrete slab with the pencil lead break excitation. This excitation is casually applied as it results in the introduction of a broad band of frequencies and is described by ASTM E976. Fig. 7(b) shows the waveforms received after wave excitation adjacent to sensor 1. It is obvious that the discontinuity of the crack (between Sensor 3 and 4) does not allow the wave energy to pass after sensor 3, with the waveforms of sensor 4 (150 mm) and sensor 5 (200 mm) showing practically no content. However, the energy at the last two sensors is substantially increased after the epoxy injection (Fig. 7(c)). The onset became clearly distinguishable while the strong Rayleigh peak appeared again allowing the measurement of longitudinal and Rayleigh wave velocities (Aggelis and Shiotani, 2007).

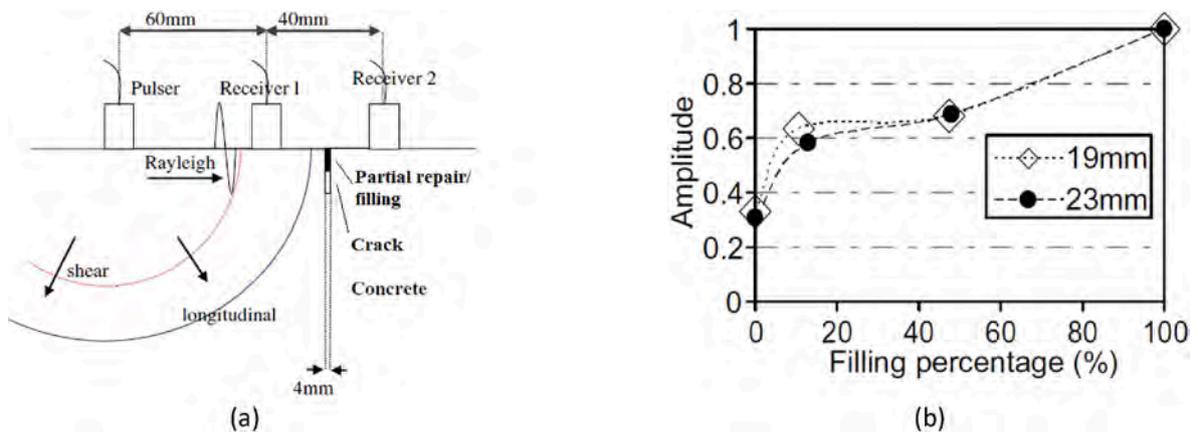
Fig. 8. (a) Schematic representation of testing geometry for repair assessment through Rayleigh waves, (b) Wave amplitude normalized to maximum vs. the filling percentage of cracks (Aggelis et al., 2009a).

In an effort to quantify the filling degree, experiments and simulations were conducted on concrete beams with manufactured slots (one with depth of 19 mm and another with depth of 23 mm) and partially or fully repaired by epoxy injection (Fig. 8(a)). The amplitude of the Rayleigh wave was monotonically correlated to the filling degree. Specifically, for an empty slot (or 0% filling, Fig. 8(b)), the Rayleigh amplitude starts at approximately 35% of the maximum (corresponding to full filling). The initial layer filling of a few mm, corresponding to 15% of the entire slot depth (see Fig. 8(b)), restores the amplitude already to 60% of maximum, while at 50% of crack filling, the wave amplitude was restored to almost 70% of the maximum. The results concern a main excitation of 115 kHz, resulting in a nominal Rayleigh wavelength of approximately 25 mm, which is longer than the slot's

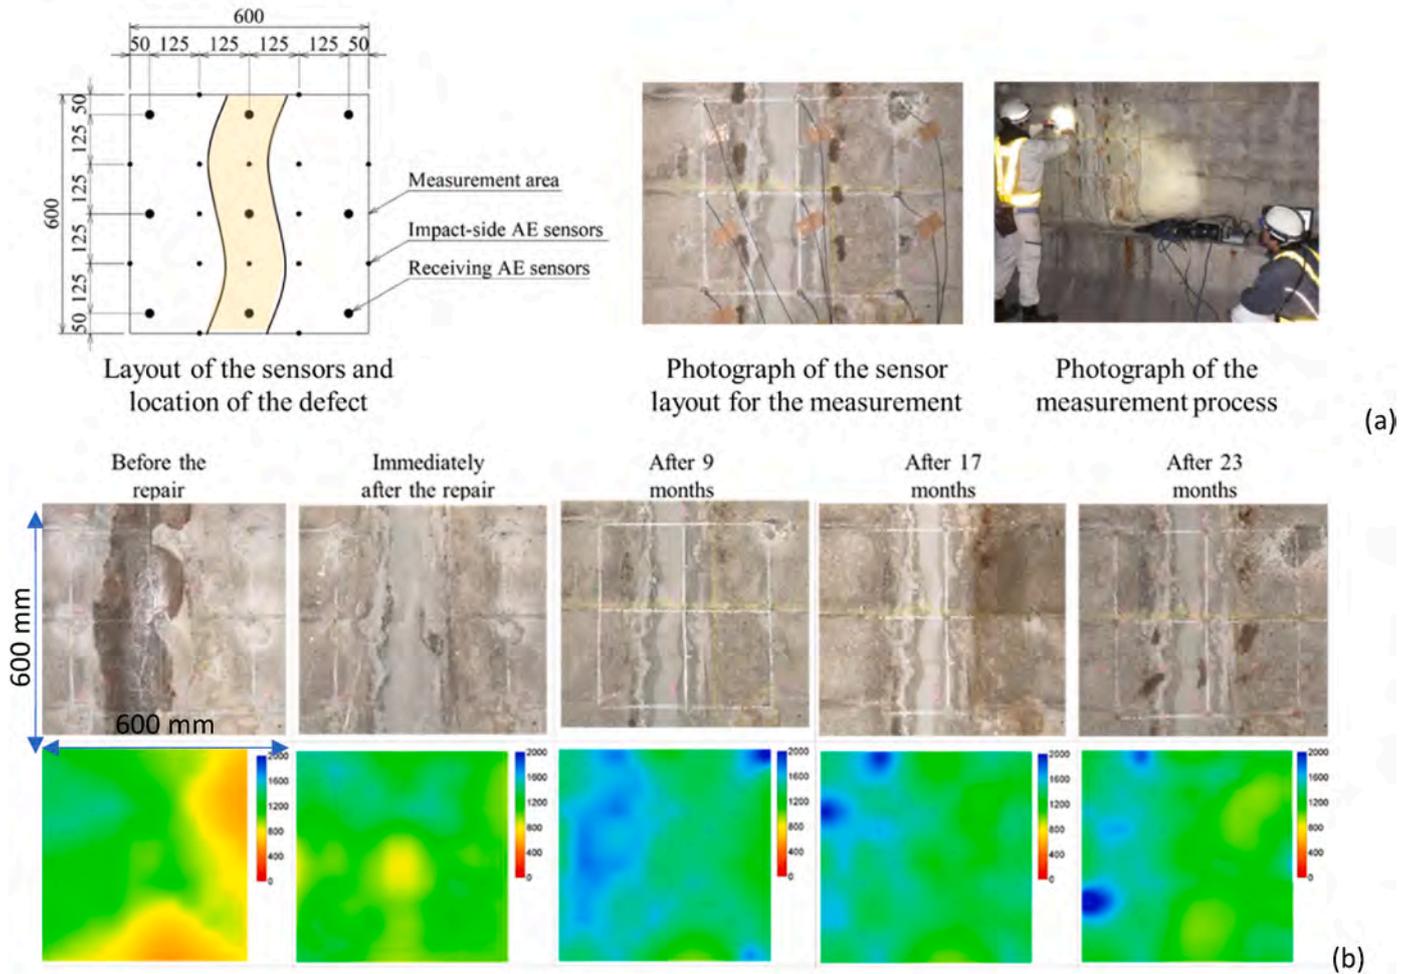
Fig. 9. Surface wave tomography: (a) schematic representation and photograph of the inspected area, (b) monitoring results (photographs of the surface at the corresponding times and tomograms (the colormap is in m/s, Ogura et al., 2023).

Based on surface waves, "surface wave tomography" is a type of elastic wave tomography focusing on the "Rayleigh" wave that propagates along the surface, like in the above-mentioned case. The method consists of attaching an group of AE sensors to the surface of a structure in a pattern and introducing elastic waves by means of impacts of steel balls of different diameters. This allows the measurement of surface wave velocity between impact points and AE sensors. This data is then processed by the tomography algorithm, which reconstructs a tested structure's elastic wave velocity distribution. Elastic wave velocity distribution is visualized as a contour plot, where areas with low elastic wave velocity correspond to areas with defects. In the specific application, a water leak in an underground structure was monitored before, immediately after the repair and 9, 17 and 23 months later. Fig. 9(a) shows the layout of the sensors used in this inspection, as well as photographs taken during measurements. Nine receiving sensors were placed in three lines and three rows (500 × 500 mm), and impact-side sensors were placed at 16 arbitrary points. The outer receiving sensors were arranged symmetrically with respect to the defect, and the inner ones were positioned on the center line of the measurement area. This sensor arrangement made a total of 144 scan lines. The sensors used in this study were 60 kHz resonant AE sensors. The inspection showed that immediately after repair, the velocity increased, indicating the crack filling by the repair agent (Fig. 9(b)). After 9 months, there was a slight increase in velocity, which can be explained by additional hydration of the repair material due to existing moisture. After 17 and 23 months, there was a minor decrease in velocity, which can be explained by minor water leaks, observed during the visual inspection. Minor water leaks can indicate a recurrence of cracking, which can decrease the velocity. Therefore, Rayleigh elastic waves indicate the initial condition and the effectiveness of repair, while allowing monitoring at later ages.

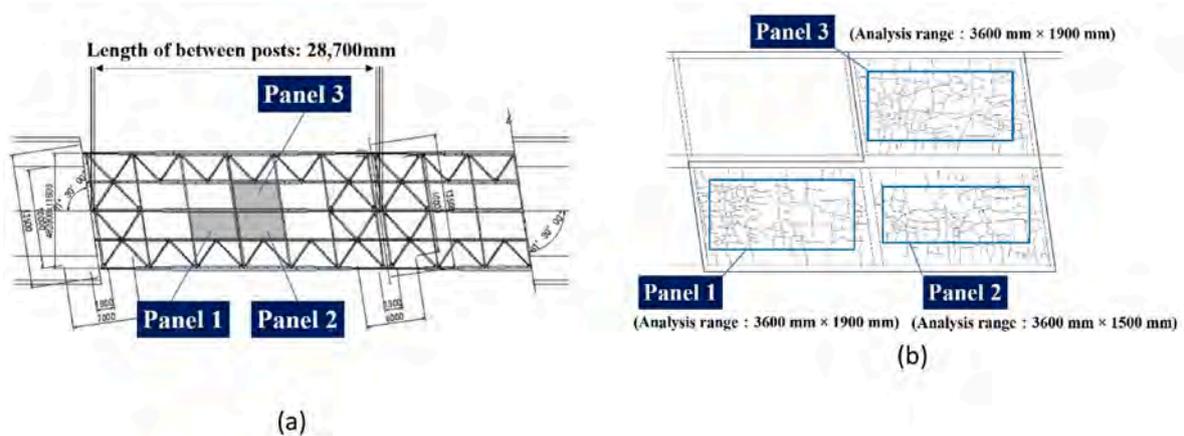
Fig. 10. (a) An overview of the bridge and (b) a sketch of the cracking pattern (Okude et al., 2018).

in service. Fig. 10 (b) shows a sketch of cracks obtained through visual inspection from the bottom side of the slab. These cracks are thought to be caused primarily by the alkali-silica reaction in concrete.

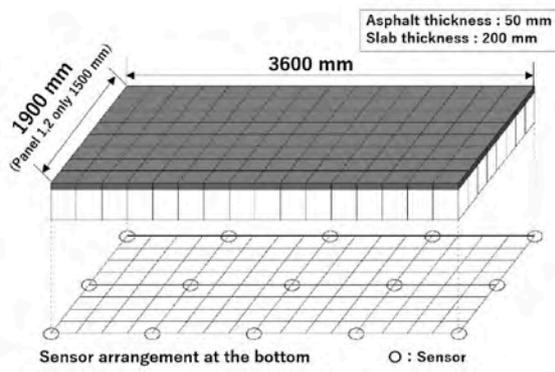
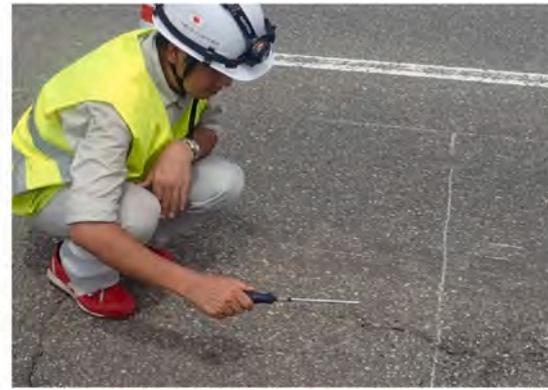
Fig. 11. (a) Analysis model for AE tomography, (b) steel-ball tapping (Okude et al., 2018).

Fig. 11(a) shows the model of AE tomography analysis and the positions of the sensors. The shaded part at the top of the model indicates the asphalt layer with thickness of 50 mm. As elements for AE tomography analysis, the applicable region was divided in 16×8 , which gives a total of 128 elements. In this study, elastic waves were excited by steel-ball tapping. A steel-ball of 5 mm diameter was tapped at several locations on the asphalt surface, ensuring that the distribution of impact points was as uniform as possible at the target area. The steel-ball tapping is illustrated in Fig. 11(b) (Okude et al., 2018).

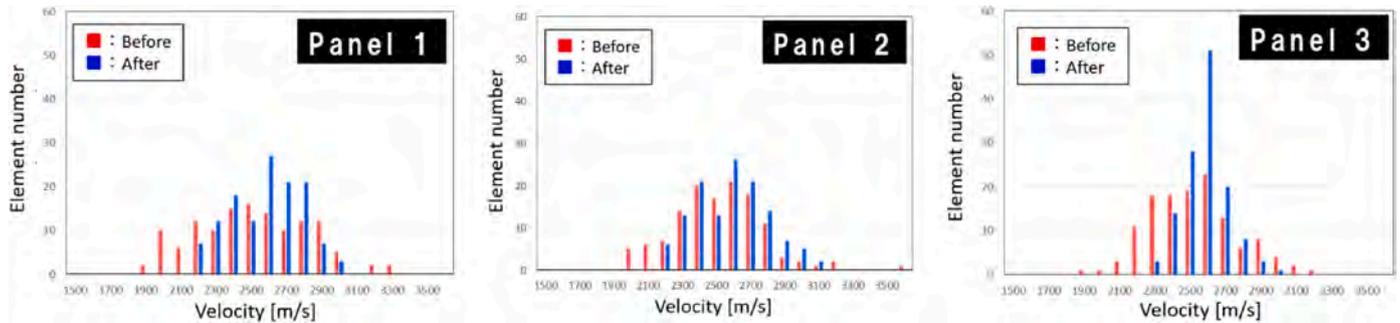
Fig. 12. Histograms of velocities obtained in all three elements before and after repair.

AE tomography results show that in all slab panels, the velocity after repair increased compared to before repair. Fig. 12 shows the histograms of velocities obtained in all the panels. For all slab panels, it is evident that the velocities clearly shift to higher values after repair. Due to the effectiveness of injected material in filling cracks and defects, deviations and distortions in the propagation paths of elastic waves are (partially) eliminated and the distribution of apparent velocities are increased. Low velocities, below 2500 m/s are still observed even after repair, which is reasonable because of the existence of independent voids due to air-entraining agent and limited injection in fine cracks. In addition, the propagation was partially done through the asphalt layer which exhibits a wave velocity of about 2800 m/s. This seems to contribute to the relatively low absolute values, but it is highlighted that the importance lies in the relative improvement before and after repair, while the very low values close or below 2000 m/s were totally eliminated.

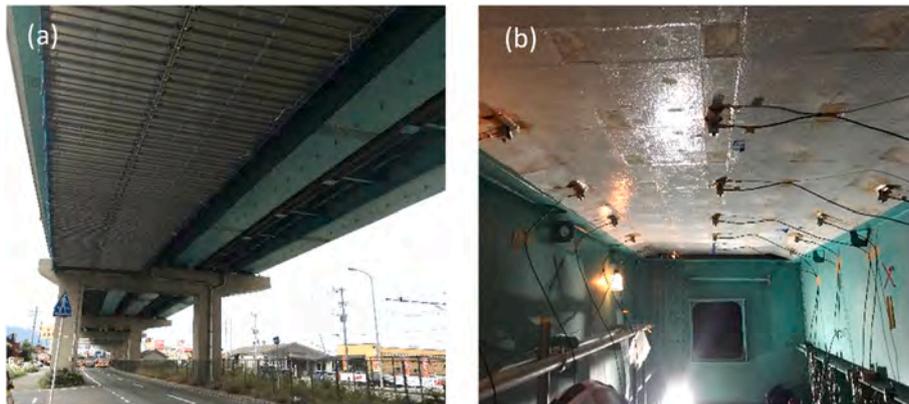
Fig. 13. (a) Tested highway bridge, (b) sensor arrangement for the measurement before repair.

The effect of repair by epoxy injection on an RC slab of a highway bridge was visualized (Takamine et al., 2018). The results before and after repair were compared to visualize the soundness based on the elastic wave source distribution by measuring the elastic waves generated by the traffic. Fig. 13 shows an overview of the measurement. The bridge of interest is a highway bridge in service, and elastic waves generated by vehicle traffic were measured for the RC slab. The target panel had cracks which were visible from the underside and was reinforced with CFRP sheets. Eighteen AE sensors were installed in a grid pattern of 3×6 on the underside of the deck. The sensor spacing was 780 mm in the bridge axis direction and 700 mm in the direction perpendicular to the bridge axis.

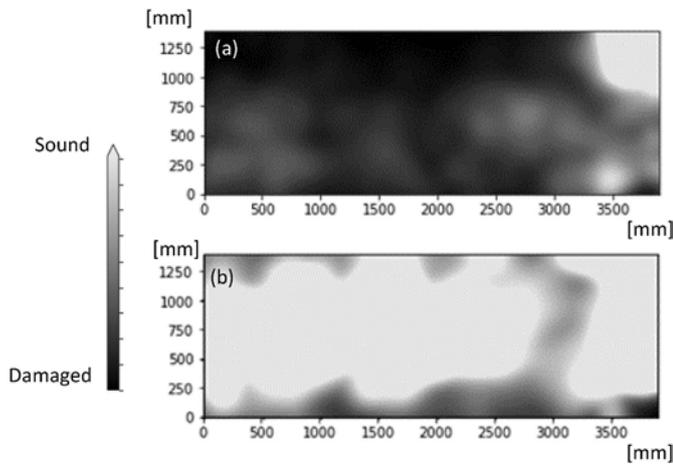
Fig. 14. Results of elastic wave analysis (a) before repair and (b) after repair.

The results of the soundness evaluation before and after repair of the RC slab are shown in Fig. 14. The sound area is displayed white, and the unsound or damaged area is shown dark. The relatively damaged area has lower density of the located elastic wave sources, indicating that there are cracks or voids that hinder the propagation of elastic waves. The recovery of the soundness by repair is obvious comparing the results before and after repair (Fig. 14 a and b). In the area to the right of the slab, although the soundness (capacity to transmit AE events) has slightly improved, there are segments where the soundness remains lower. This indicates that there can be segments where resin filling is not complete and in general the method shows the ability to detect restoration after repair and to visualize repair effects in a planar (2D) manner. It is mentioned that the numbers of passing vehicles during both measurements were counted and the results of elastic wave source density are normalized by the vehicle number. Therefore, both results are compared validly even if the tested periods are different.

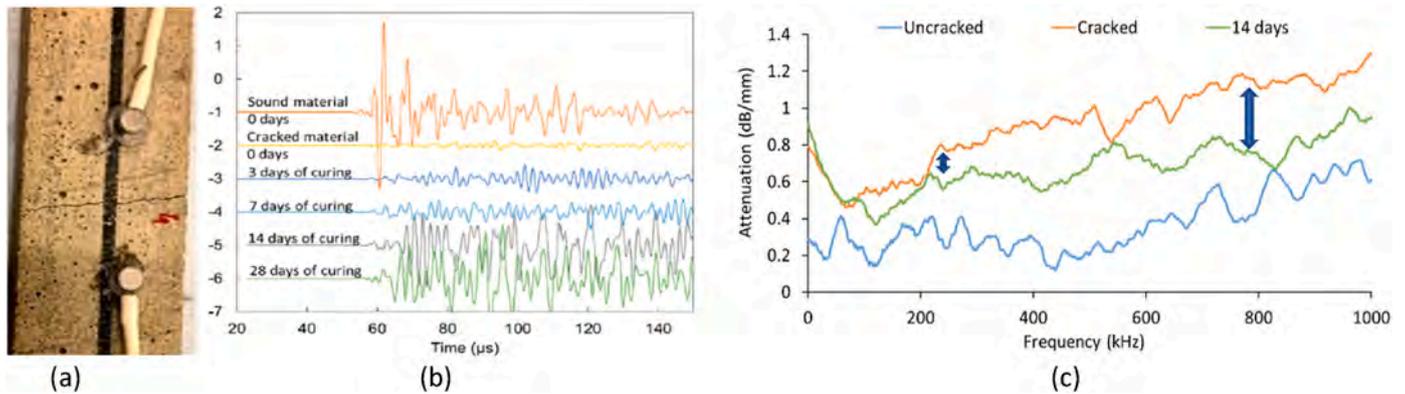
Fig. 15. (a) Pico sensors placed at both sides of the crack in a mortar specimen, (b) waveforms after the crack for different conditions of the cracking and healing ages, (c) surface wave attenuation vs. frequency curves for intact, cracked and partially healed mortar with nanosilica (Lefever et al., 2020).

specimen surface, mainly in the forms of wave velocity and amplitude. Two relatively broadband sensors with a peak frequency response of 450 kHz were attached on the specimen surface at both sides of the crack, see Fig. 15(a) and the excitation was conducted by pencil lead breaks. It was clear that a sharp decrease in velocity and amplitude was noticed after cracking (Fig. 15(b), see waveform ‘Cracked material 0 days’). In contrast, later, with the healing progress, the wave amplitude was restored towards the original level.

from deeper layers. Fig. 15(c) shows the attenuation curve for an indicative mortar mix (with cement type CEM I and nanosilica particles before cracking, after cracking and 14 days after wet-dry cycles (Lefever et al., 2020)). The initial (uncracked) curve is at relatively low values and shows an increasing trend since the higher frequencies are normally more effectively damped and scattered by the inherent microstructure. As expected, the through-the-thickness crack sharply increases the level of the apparent attenuation by about 5 times (i.e. from the level of about 0.2 dB/mm to almost 1 dB/mm, ‘cracked’ curve). The wet-dry cycles until 14 days have a certain decreasing effect on the attenuation. Since healing products are precipitated in the crack, wave transmission is partially restored and the attenuation curve at ‘14 days’ is lower. Furthermore, it is indicative that higher frequencies show a stronger decrease after healing, than lower ones. Indicatively, attenuation drops by approximately 0.3–0.4 dB/mm at the zones around 800 kHz, while it drops by about 0.1 dB/mm or less around 200 kHz. This confirms that

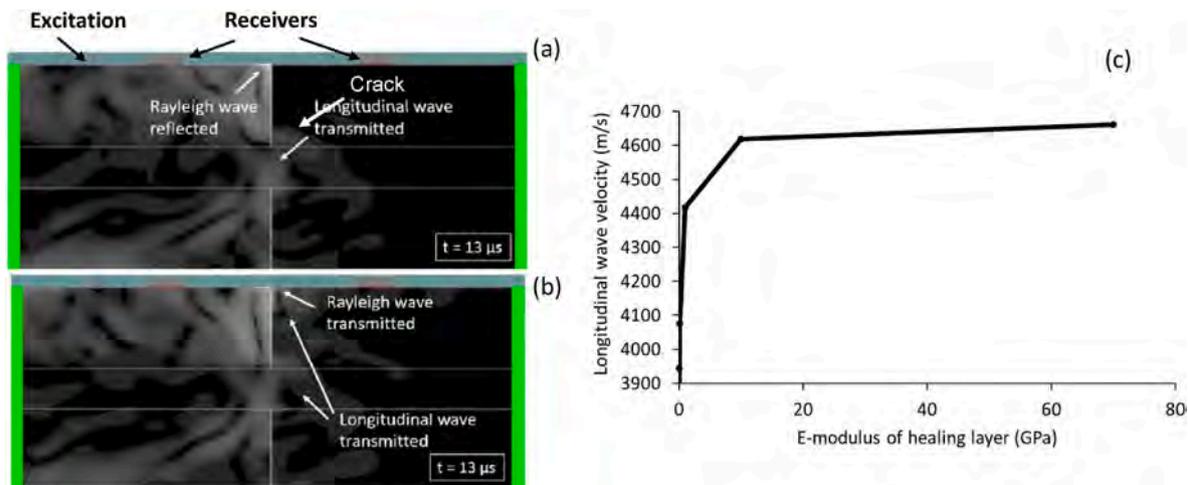
Fig. 16. Simulated wave displacement field in mortar (a) in the presence of crack (b) with healing agent in the crack, (c) simulation of wave velocity dependence on E-modulus of healing material (Lefever et al., 2022a).

The restoration degree of the pulse velocity or attenuation gives a measure to quantify the self-healing. However, this applies to the wave parameters and is not directly translated into mechanical properties restoration. In an effort to better relate the restoration of wave parameters (amplitude, wave velocity) to the stiffness of the healing products, a numerical study was recently reported (Fig. 16(a) (Lefever et al., 2022a)). There, the equivalent stiffness of the healing material was varied to check its effect on the macroscopically measured pulse velocity and attenuation. At zero stiffness, the Rayleigh wave is not transmitted through the crack and is completely reflected as shown in Fig. 16(a). In the case of a material with considerable stiffness inside the crack, the Rayleigh wave is partially transmitted (Fig. 16(b)). It was found that the early healing (i.e. increase of the Young’s modulus of the healing product from 0 to 1 GPa) is already responsible for approximately 60% of the restoration of the wave velocity and amplitude while further hardening of the healing layer, has a smaller effect, see Fig. 16(c). Therefore, surface ultrasound is sensitive to healing and especially the initial crucial stage of healing product formation, which makes the difference between the discontinuity (empty crack) and an elastic medium that can support elastic waves, showing a minimum of mechanical properties. Considering that the experimental restoration of the wave velocity and amplitude was also at approximately 60% (Lefever et al., 2022a), it was concluded that the healing products were of the order of 1 GPa after 28 days of healing.

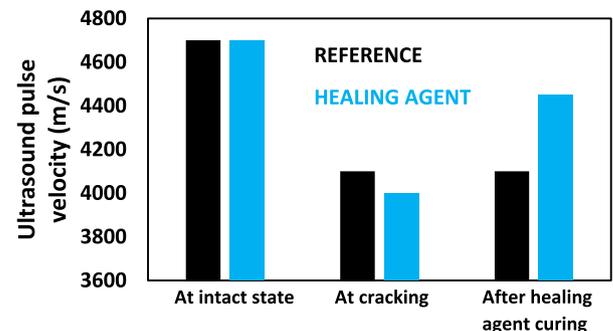
Fig. 18. Ultrasound pulse velocity for reference mortar and mortar with encapsulated healing agent (Vangansbeke et al., 2023).

Another self-healing approach that has gained the attention of the scientific committee over the last decade is the autonomous self-healing, which involves the use of healing agent carriers that are encapsulated in concrete during casting and would break under mechanical stresses as a crack propagates through the capsule to cause release of sealant that fills the crack. Elastic wave inspection plays a key role in the assessment of concrete repair after the healing activation. Specifically, Van Tittelboom et al. (2012) proposed the embedment of glass capsules in concrete that would carry a polymeric agent that, upon breakage, would fill up the crack. The UPV appeared to be a direct and reliable tool for the repair efficacy assessment (Muhammad et al., 2016). As pointed out in Fig. 18, the UPV, as measured in transmission mode through concrete beams cracked under three-point bending with crack openings up to 0.3 mm, is significantly recovered after the healing agent release and curing of the agent up to 24 h in ambient conditions (Vangansbeke et al., 2023).

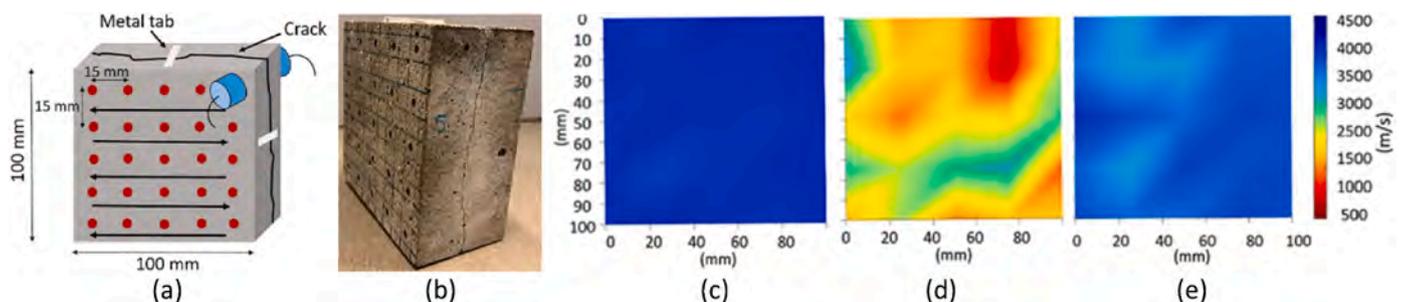
Fig. 17. (a) Schematic representation of the ultrasonic face-to-face measurements for self-healing evaluation, (b) photograph of the specimen with the initial crack, ultrasonic velocity visualization of a cross-section at different stages (c) sound, (d) cracked, (e) after 28 days of healing (Lefever et al., 2022b).

propagation. In case the through-thickness application is possible, ultrasonic mapping can be conducted through longitudinal waves with pulser and receiver in a face-to-face configuration, as shown in Fig. 17 (a). In this example (Lefever et al., 2022b), cracks were created by the Brazilian test (Fig. 17(b)), and the specimens were similarly cured in wet-dry cycles as mentioned above. Some specimens included SAPs aiming at promoting healing. Based on the pulser-receiver transit time, the UPV for all direct horizontal paths is calculated and presented for a typical case at different ages: sound condition (Fig. 17(c)), cracked condition (Fig. 17(d)), and after 28 days healing (Fig. 17(e)).

Cracking has a direct effect in reducing the overall velocity from the level of 4000 m/s to 2000 m/s. Later, propagation was restored close to 70% of the original level (Fig. 17(e)), with average velocity reaching approximately 3400 m/s. Ultrasonic maps of more ages can be seen in the original publication (Lefever et al., 2022b), indicating not only a general level of restoration but also the distribution or level of uniformity of healing, which is challenging to evaluate with other assessment techniques. Attenuation results were on the same line, while microscopic measurements of the crack width revealed similar trends: the crack width decreased, but was not completely eliminated. The above shows that wave propagation is advantageous for monitoring cracking as well as repair through healing, while non-contact sensors are recently employed to avoid coupling variability (Lefever et al., 2024).

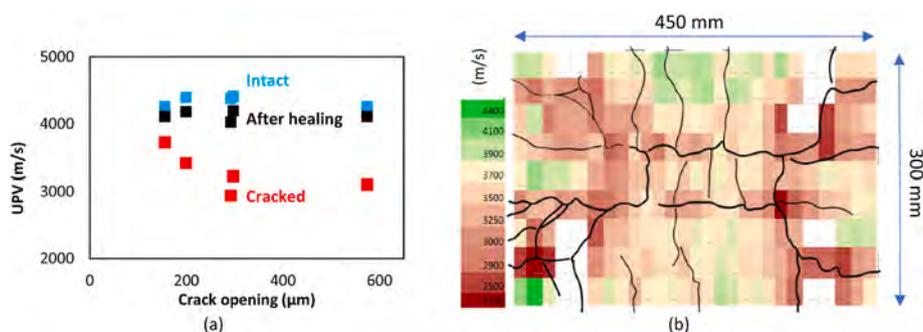
Fig. 19. (a) UPV measured through transmission in several concrete beams loaded in four-point bending and healed by agent distributed through a linear tubes network, (b) Ultrasound mapping of a concrete slab healed by agent distributed through vascular networks of 3D printed polymeric tubes (Tsangouri et al., 2022). The thickness of the slab is 55 mm and it is reinforced by four $\Phi 8$ ribbed steel rebars.

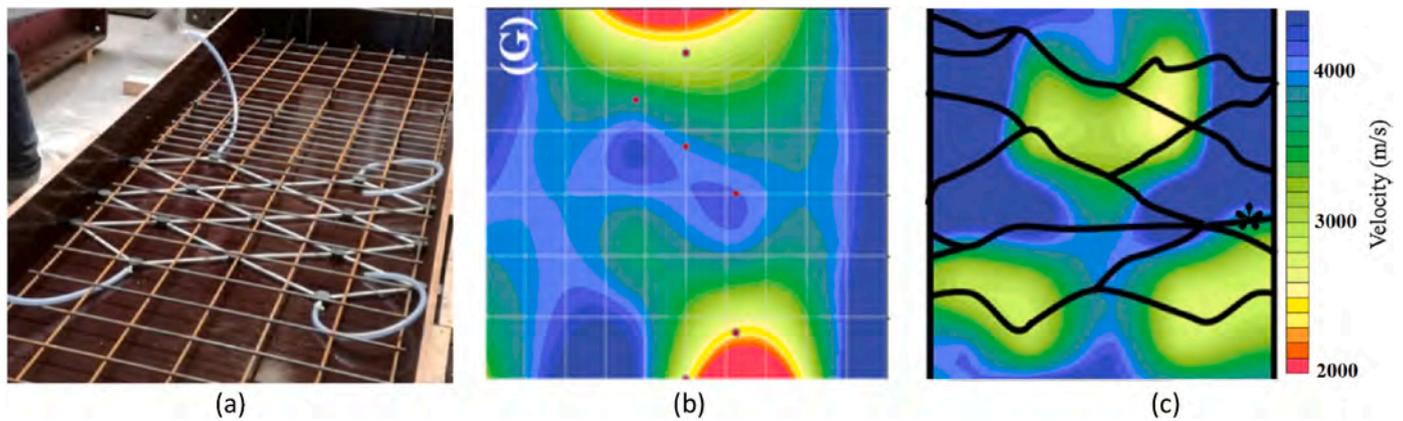
Fig. 20. (a) Vascular network of capsules and steel mesh before casting of the concrete slab, (b) velocity tomogram after loading, (c) velocity tomogram after healing (Tsangouri et al., 2019). The solid dark lines indicate the surface pattern of cracks, that partially reflect the position of the healing system.

On a larger scale, assessment of self-healing was conducted for a concrete slab. Healing was supplied by a smart capsules network (Fig. 20 (a)). After creating cracks using four-point bending loading, the specimen was allowed to heal by supplying healing agent through the network. AE tomography was applied before and after healing and the results are shown in Fig. 20 (b) and 20(c) respectively. At the end of loading, certain areas close to the middle of the slab exhibited a low velocity of even 2000 m/s which is indicated in red. After eventual healing, the tomogram revealed elevation of the velocity in average, while the specific low-velocity zones were eliminated. Cores were also extracted at different areas with high velocity restoration and confirmed the tomography result by the visual observation of the healing agent, as well as UPV measurements at different heights. A limit in the crack opening susceptible to healing with this system was suggested, since cracks with openings larger than 0.5 mm did not show any recovery, while cracks with openings smaller than 0.5 mm in the capsule network, exhibited eventual rise of velocity above 3500 m/s (Tsangouri et al., 2019).

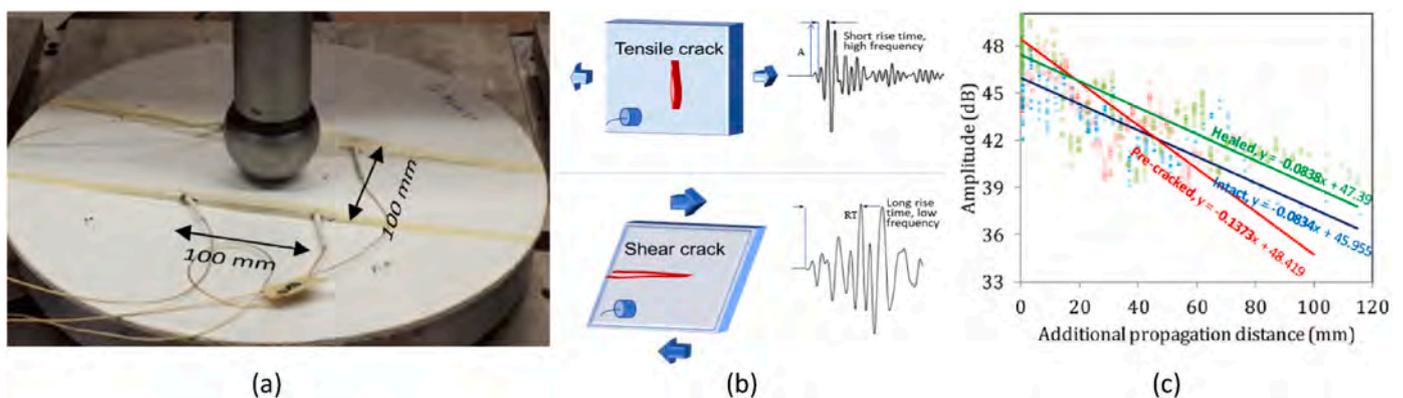
Fig. 21. (a) Circular TRC plate under point loading with four AE “pico” sensors, (b) different fracture modes with corresponding AE waveforms (cracking and debonding) as measured by piezoelectric sensors attached on the surface, (c) amplitude vs. distance of AE signals for different material conditions (El Kadi et al., 2017).

Continuing in cases related to self-healing, Textile Reinforced Cement (TRC) plates with and without healing polymer powder were first thermally cracked and later mechanically loaded in bending (Fig. 21(a)). Exposure to high temperature led to extensive cracking, one of the basic damage mechanisms for this material, while the others are debonding between successive plies and fiber pull-out. When cracking is already saturated (in the thermally cracked specimens), the debonding phase is accelerated, resulting in a much different AE behavior. This is due to the different micro-displacement of the crack sides. In case of debonding, shear stresses emit most of the energy in the slower shear wave mode than the longitudinal waves that are mostly emitted by the tensile cracking. Therefore, for debonding associated signals most of the energy arrives later in the waveform, increasing the rise time (RT, Fig. 21(b)), as well as the overall signal duration, while it inversely decreases the frequency content. However, in the specimens with healing polymer (El Kadi et al., 2017), an almost-complete restoration of the AE properties towards the reference specimens was observed. Indicatively, the intact specimens exhibited RA-value (calculated as rise time, RT, over Amplitude, A, see Fig. 21(b)) of less than 600 $\mu\text{s}/\text{V}$, while that of the thermally cracked specimen achieved almost 1500 $\mu\text{s}/\text{V}$. The healed specimen exhibited less than 800 $\mu\text{s}/\text{V}$ in RA-value, much closer to the original value. Similar was the restoration of the frequency content, indicating that cracking was again the dominant mechanism and that the behavior of the healed specimens was closer to the intact ones rather than the thermally damaged ones. The reason was that although the high temperatures produced distributed cracking in the matrix, at the same time, melted the polymer powder directly filling or repairing these cracks. Wave transmission was also indicative since thermal cracking increased the attenuation coefficient from 0.084 dB/mm to 0.137 dB/mm, while the healed material was restored to the levels of intact (Fig. 21(c)).

As aforementioned and shown in Fig. 21(b), the shape of the AE waveforms is typical of the fracture mode, with shear events, characterized by longer rise times, and lower frequencies than the waveforms related to tensile mode fracture. Through the analysis, it was possible to identify a first phase of the test in which a fracture of mode I for traction prevails (AF values up to 300 kHz), followed by a shift to mode II for shear load during the delamination process (events with frequency of approximately 100 kHz). This study is more related to the evaluation of compatibility (similarity in mechanical characteristics) and durability over time when subjected to fatigue cycles and is not directly connected to the successful application of the repair. However, it is included in this report to show how relevant the interface bond compatibility is for a broader interpretation of repair on masonry and for assessing of the

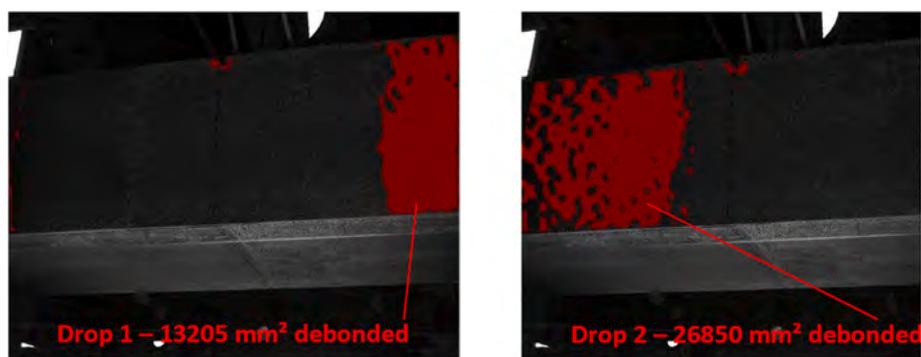
Fig. 22. Quantification of the debonding area of repairing TRC patch from concrete substrate by DIC strain difference before and after two load drops (Aggelis et al., 2016).

In addition, the AE parameters showed distinct differences, especially at the transient load drops. For the reference beams, parameters did not show big changes implying that the fracture mechanism was essentially the same throughout loading (i.e. matrix cracking), while for the externally retrofitted beams, during the transient load drops the RT and RA values were approximately double, indicating that at that moment, debonding of the patches was happening. This was confirmed by DIC showing a sudden release of strain on the debonded patch areas, allowing the determination of the exact area where the repair/retrofitting layer was debonded (Fig. 22, Aggelis et al., 2016).

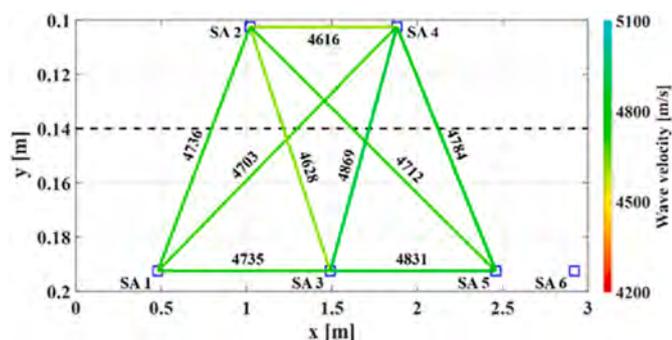
Fig. 23. Wave velocity in each ray path on the 757th day (Cheng et al., 2022).

newly-cast concrete. The sensors formed ray paths across the old and new concrete and their interfaces. Potential changes in wave velocity between the ray paths across the interfaces would indicate potential delamination. Over a two-year period, measurements were taken, and the comparison of wave velocities in different ray paths did not indicate any delamination in the newly applied concrete cover (Fig. 23). The method is demonstrated to be effective for long term monitoring of repair patches.

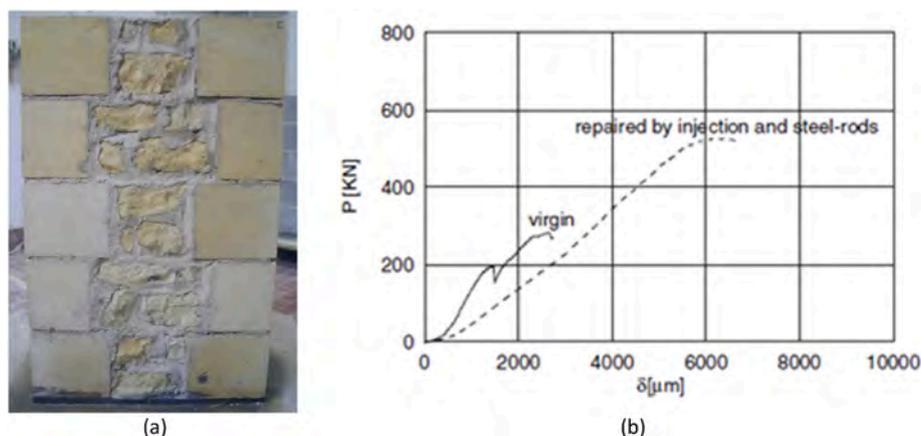
Fig. 24. (a) Typical geometry of the tested walls, (b) Load-displacement curves of masonry wall component (PN4) in Noto stone (reference and reinforced by mortar injections and steel rods) (Anzani et al., 2008).

(Anzani et al., 2008). The test specimens (see Fig. 24(a)) were instrumented with 6 AE sensors, which allowed to localize the points of initiation of the cracks and interpret their trend during loading. After repair, masonry test specimens reinforced by steel rods, mortar injection, or a combination of both (Fig. 24(b)) were monitored with AE throughout the loading test. Samples were loaded under stress control, imposing constant speed of displacement. Cumulative AE counts increase slowly in the first load phase, after which they increase proportionally to the load, reaching a peak close to the test failure load (Fig. 25(a)). The function representing the count rate (AE counts number per minute) reaches its maximum value in the ascending branch of the load-displacement curves and is then reduced to zero in the proximity of the final load. It is, therefore, possible to identify two phases during testing: a first phase during which the largest cracks are formed and the material reaches a critical damage condition (Phase 1), and a second phase during which the material tends to exhaust its load capacity (Phase 2). For the repaired specimen with mortar injection and steel rods, the cumulative AE activity was notably lower (less than one third of the reference) (Fig. 25(b)).

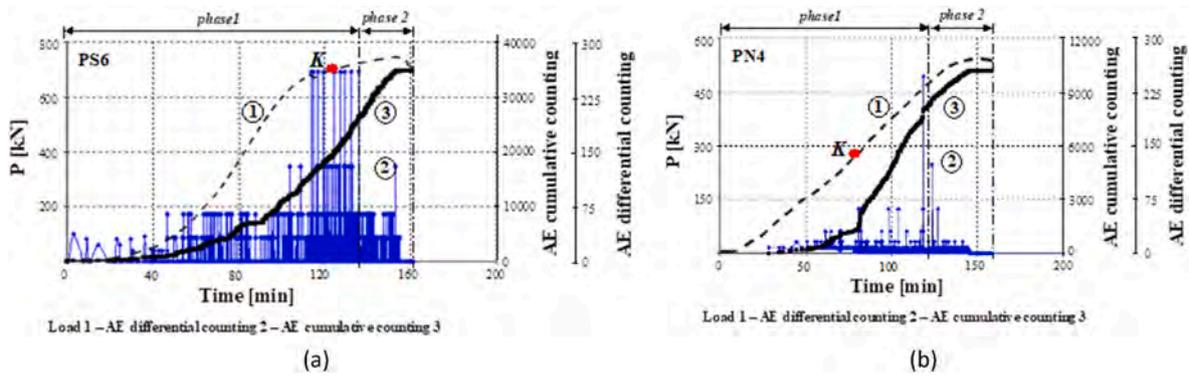
Fig. 25. Load/AE activity-time curves for walls PS6 (reference) and PN4 (repaired) (Anzani et al., 2008).

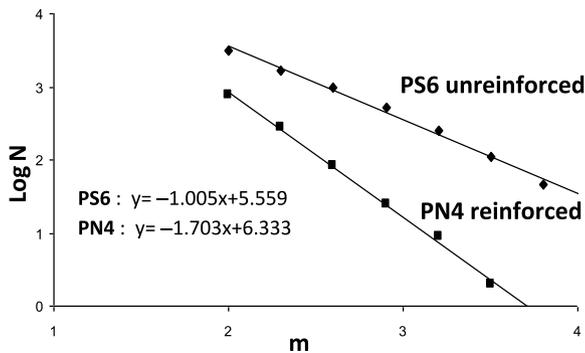
Fig. 26. Determination of “b-value” at the end of the loading test on the two specimens (Anzani et al., 2008).

In the AE field, the “b-value” is calculated by analogy with seismic phenomena. It stands for the proportion of low-intensity events over the high energy events and is calculated as the slope of the inverse cumulative amplitude distribution (Fig. 26). Low absolute b-values indicate the progress of the fracture towards larger scale events that occur at the limit of the load-bearing capacity of the component (Carpinteri et al., 2009, 2011). This parameter changes systematically at different stages in the course of the damage process and, therefore, can be used to estimate damage evolution modalities. By applying these concepts to different specimens, unreinforced (PS6) and reinforced with mortar injection and steel rods (PN4), it can be seen that the former exhausted its bearing capacity during the load test, with the formation of cracks of a size comparable to that of the specimen, forming along the interface between the filler and the outer wall (b-value $\cong 1$), and the latter, characterized by a widespread cracking pattern, still has a reserve of strength before reaching the final collapse (b-value $\cong 1.7$). The determination of the “b-values” for the two specimens is shown in Fig. 26, which is based on calculating the gradient of linear regressions obtained from Log N versus m plots. In seismicity N is the cumulative number of earthquakes with magnitude $\geq m$ in a given area and a specific time-space. While in AE analysis N is the cumulative number of AE signals whose magnitude is calculated as $m \propto \text{Log } 10 A_{\text{max}}$, A_{max} being the maximum amplitude of the signals (Anzani et al., 2008).
