Non-destructive inspection technologies for repair assessment in materials and structures

Non-destructive inspection technologies for repair assessment in materials and structures / Shiotani, T.; Ogura, N.; Okude, N.; Watabe, K.; Van Steen, C.; Tsangouri, E.; Lacidogna, G.; Czarnecki, S.; Chai, H. K.; Yang, Y.; Verstrynghe, E.; Aggelis, D. G.. - In: DEVELOPMENTS IN THE BUILT ENVIRONMENT. - ISSN 2666-1659. - STAMPA. - 18:(2024), pp. 1-20. [10.1016/j.dibe.2024.100443]

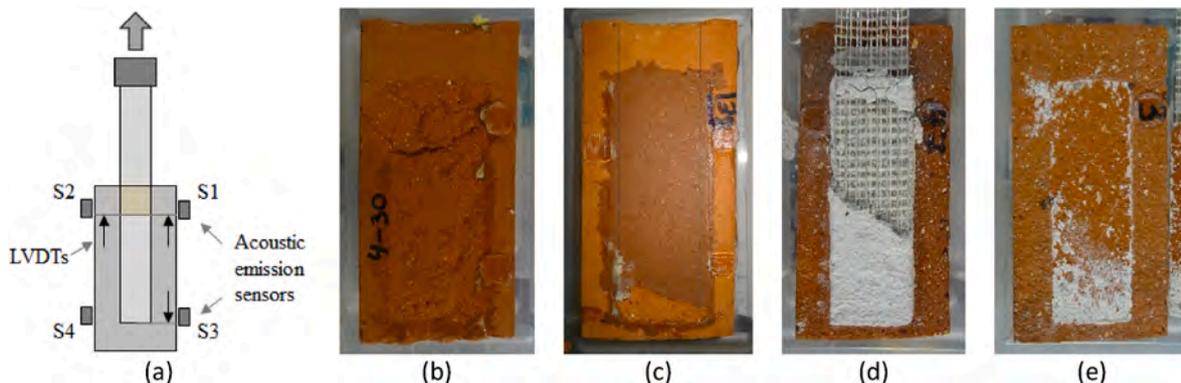
Fig. 27. (a) Setup of shear bond test with AE monitoring, pictures of observed failure modes: (b) FRP cohesive failure, (c) FRP adhesive failure, (d) SRG fiber slipping, and (e) SRG mortar-brick detachment (Ghiassi et al., 2014).

and strengthening interventions, it is also important to be able to detect possible failure of the strengthening techniques (Saidi et al., 2022). Therefore, the AE technique was used to investigate damage in composite masonry strengthening systems with a polymer- or mortar-based matrix (Ghiassi et al., 2014; Verstryngue et al., 2016). More specifically, clay bricks were strengthened with Glass Fibre Reinforced Polymer (GFRP) and with Steel Reinforced Grout (SRG) and were tested during single-lap shear bond tests (Fig. 27). It was observed, based on localized AE events, that delamination started at the loaded end and moved downward during testing, according to the expected movement of the debonded area. A clear distinction based on the AE energy was found between specimens showing different failure modes, i.e. GFRP cohesive or adhesive failure (Fig. 28(a)) and SRG brick/mortar detachment or fibres slipping (Fig. 28(b)). It can be concluded from these tests that the AE technique can characterize the failure mode of GFRP- and SRG-strengthening debonding.

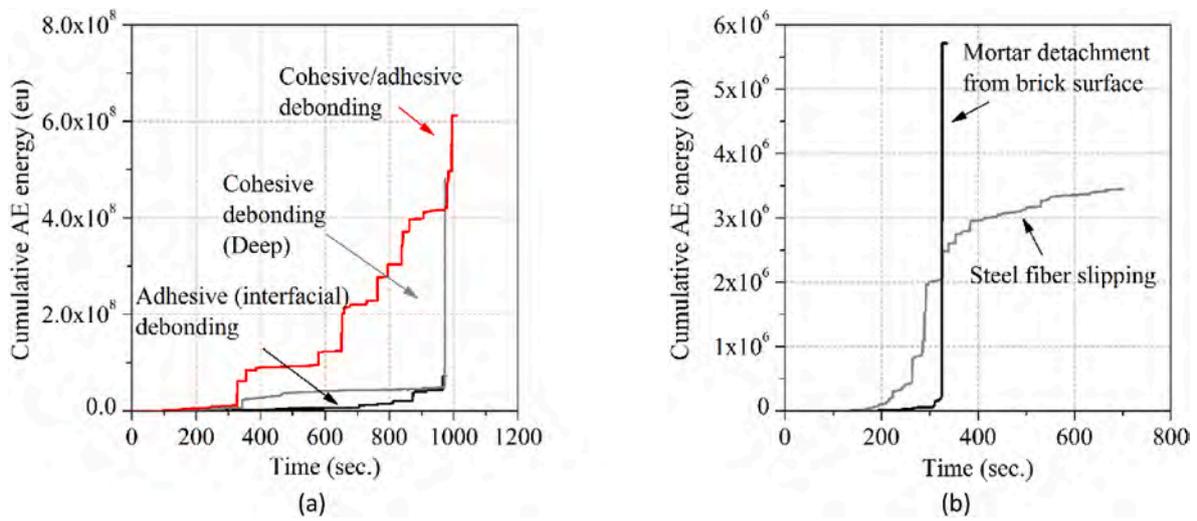
Fig. 28. (a) Representative results of cumulative AE energy measured during shear bond tests on brick specimens with FRP-strengthening and (b) SRG-strengthening (Verstrynge et al., 2016).

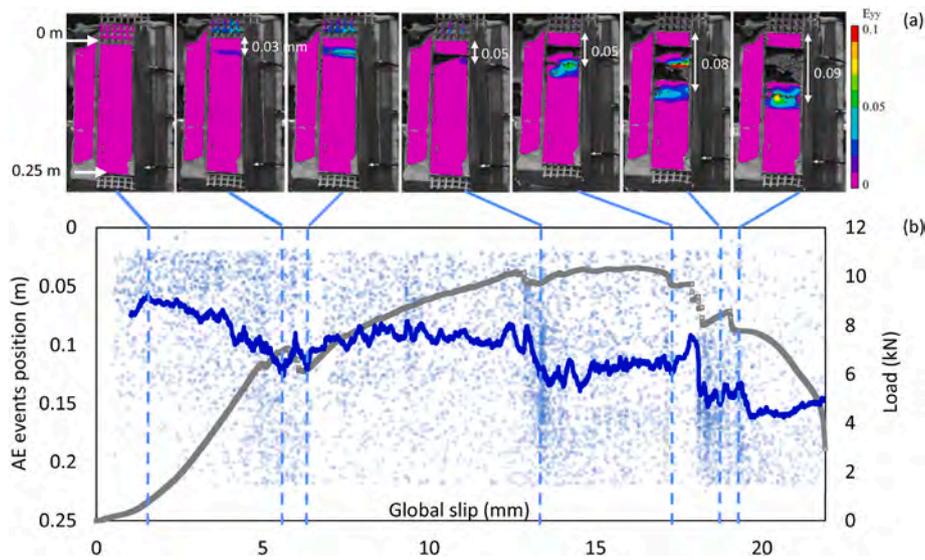
Fig. 29. Carbon TRC retrofit patch on masonry brick under single-lap shear test: (a) DIC Eyy strain maps, and (b) AE events localized in a vertical line along the TRC layer, as projected on the load-slip curve (Linn et al., 2022).

In a similar study, the progressive failure under shear bond testing of carbon TRC retrofitting layer mounted on brick masonry is tracked with AE source localization method in correlation to DIC as illustrated in Fig. 29 (Linn et al., 2022). The vertical Eyy strains were mapped at different loading stages as multiple cracks progressively form along the TRC retrofitting patch, while, below, the AE events distribution along the vertical axis are plotted as well at the same loading stages. For both the visual DIC analysis and the AE events localization tracking method, the cracks (associated with AE events) initiated at the top side of the patch and propagated towards the bottom of the TRC patch. It was evident that AE can accurately monitor the damage evolution and precisely pinpoint the damage front at any moment during a single-lap shear test.

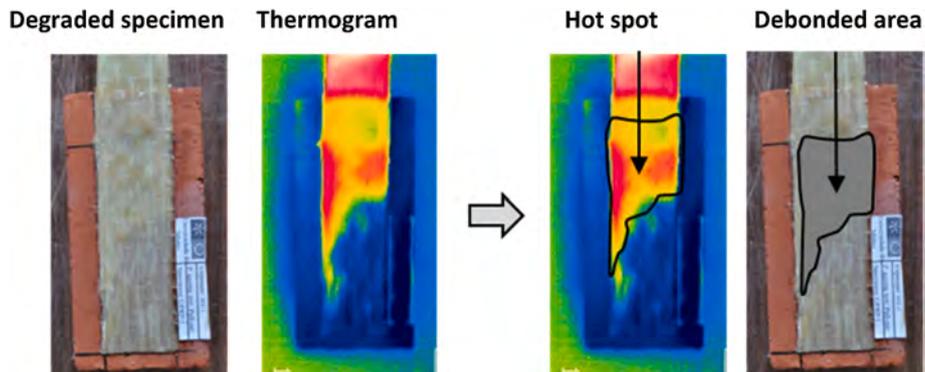
Fig. 30. Debonding detection with infrared thermography (Ghiassi et al., 2013; Verstrynge et al., 2016).

the specimens. The existence of discontinuities, such as interfacial defects or delaminations, affects the thermal properties. The temperature decay in degraded areas is altered, which can be identified as hot spots in the thermal images, as exemplified in Fig. 30. This test provides a picture of the potential detachments. However, high thermal conductivity (carbon or steel fibres) or high matrix thicknesses could limit the detectability of the test.

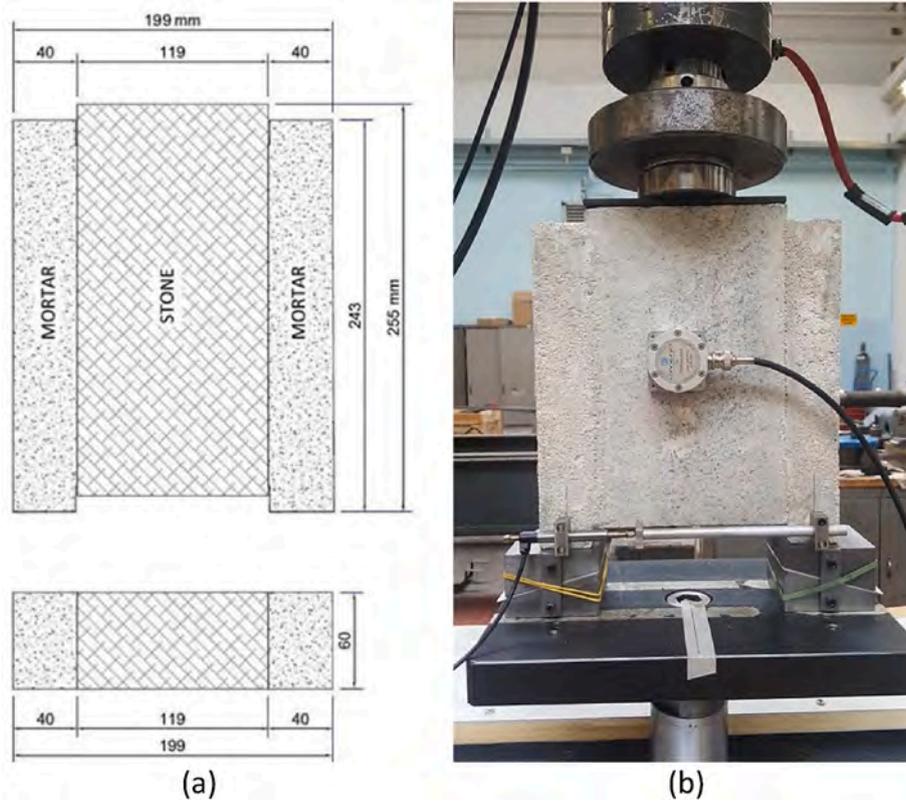
Fig. 31. (a) Side and top view of composite specimen, (b) test setup (Grazzini et al., 2020).

In order to examine the bonding conditions and the general mechanical behavior in coupled materials consisting of stone and repair plaster, “triplet” specimens were subjected to compression with the concurrent acquisition of AE (Fig. 31(a and b)). This way, the fracture mode at the interface between the two materials can be examined (Grazzini et al., 2020). The test is helpful in assessing the compatibility of new repair mortars against the historic masonry support, to whose interface often stresses arise due to the excessive rigidity of the repair mortars when they are stressed by thermal or mechanical cycles.

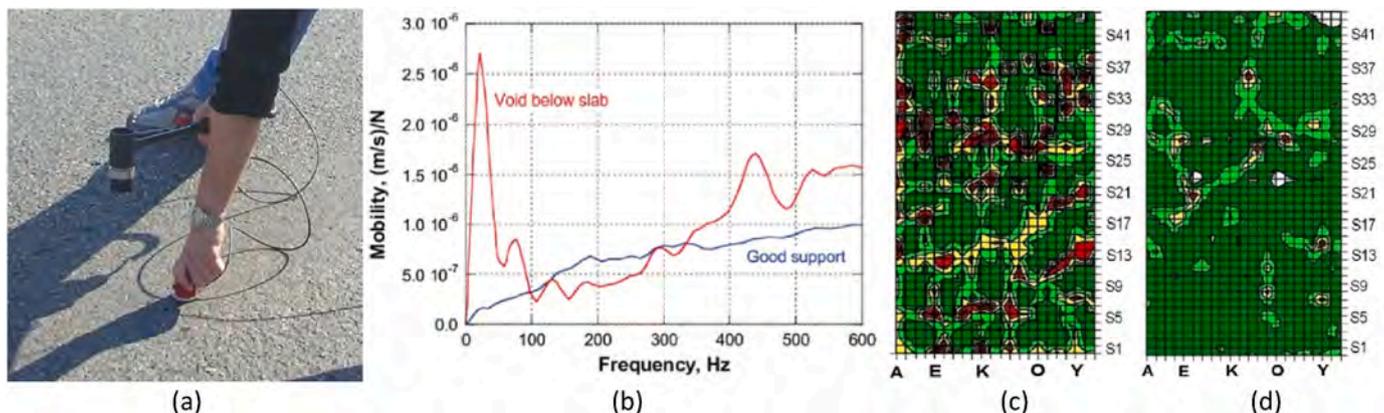
Fig. 32. (a) Impact hammering and geophone placement during I-R measurement, (b) indicative mobility curves (Germann Instruments, 2024), (c) mobility map before and (d) after grout injection on the concrete floor (Zoidis et al., 2013).

Moving to a technique in the interphase between waves and vibrations, the following case includes the repair assessment of an industrial concrete floor. The floor was severely cracked, falling into the typology usually termed as “curling” (Kovler and Chernov, 2009), causing even problems in the driving of the vehicles. Repair through injection of grout through a primary grid was selected. Before and after repair, the impulse response (I-R) technique was applied. In this case, a relatively high-intensity impact is inflicted on the test object (floor) using a load-cell instrumented hammer, that records the impact function. A geophone is attached next to the impact point in order to record the

reaction of the member (Fig. 32(a)). When the material is very stiff or heavy, then the response (defined by the “mobility” curve), as calculated in the frequency domain through deconvolution of the impact and the recorded response, is expected to be low (Fig. 32(b)). However, when the top layer is delaminated, severely cracked or compromised in any way, a much higher mobility curve is expected (Fig. 32(b)). By applying the impact and reception on a regular pattern of points on the surface, a map can be created based on the average level or slope of the mobility curve indicating the current condition, while comparison before and after repair can highlight the improvement, as seen in Fig. 32(c) and (d). In this case, some points of higher mobility were persistent even after repair, leading to another injection round at a secondary grid. The I-R investigation (map in Fig. 32(d)) exhibited a much lower average level of mobility as well as revealed local changes in the areas of interest, verifying that the floor was adequately repaired (Zoidis et al., 2013).
