Non-destructive inspection technologies for repair assessment in materials and structures

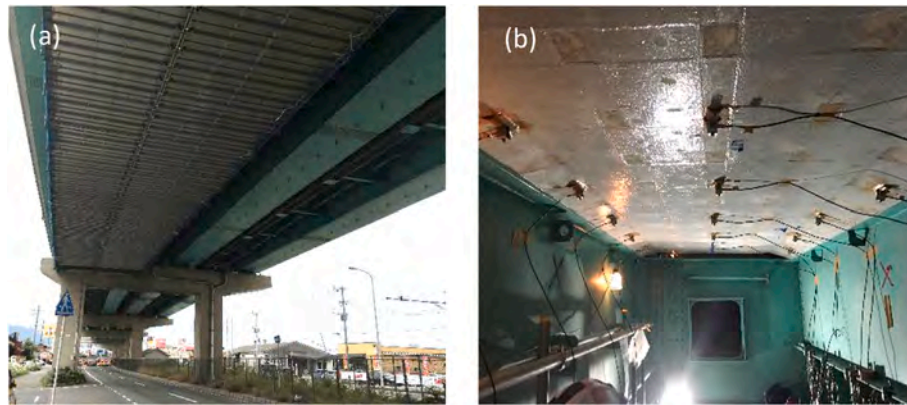
Fig. 13. (a) Tested highway bridge, (b) sensor arrangement for the measurement before repair.

The effect of repair by epoxy injection on an RC slab of a highway bridge was visualized (Takamine et al., 2018). The results before and after repair were compared to visualize the soundness based on the elastic wave source distribution by measuring the elastic waves generated by the traffic. Fig. 13 shows an overview of the measurement. The bridge of interest is a highway bridge in service, and elastic waves generated by vehicle traffic were measured for the RC slab. The target panel had cracks which were visible from the underside and was reinforced with CFRP sheets. Eighteen AE sensors were installed in a grid pattern of 3×6 on the underside of the deck. The sensor spacing was 780 mm in the bridge axis direction and 700 mm in the direction perpendicular to the bridge axis.

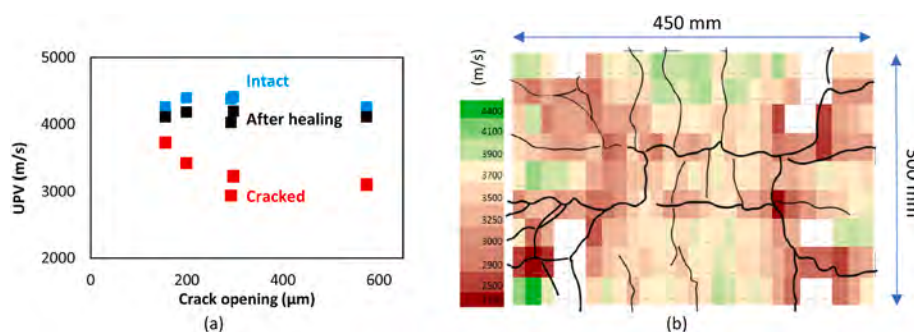
Fig. 19. (a) UPV measured through transmission in several concrete beams loaded in four-point bending and healed by agent distributed through a linear tubes network, (b) Ultrasound mapping of a concrete slab healed by agent distributed through vascular networks of 3D printed polymeric tubes (Tsangouri et al., 2022). The thickness of the slab is 55 mm and it is reinforced by four $\Phi 8$ ribbed steel rebars.
