Synergistic impact of corrosion pitting on the rotating bending fatigue of additively manufactured 316L stainless steel: Integrated experimental and modeling analyses

Alireza Behvar^{a,1}, Yahya Aghayar^{b,1}, Maryam Avateffazeli^a, Andrea Tridello^c,
Alessandro Benelli^c, Davide S. Paolino^c, Mohsen Mohammadi^b, Meysam Haghshenas^{a,*}

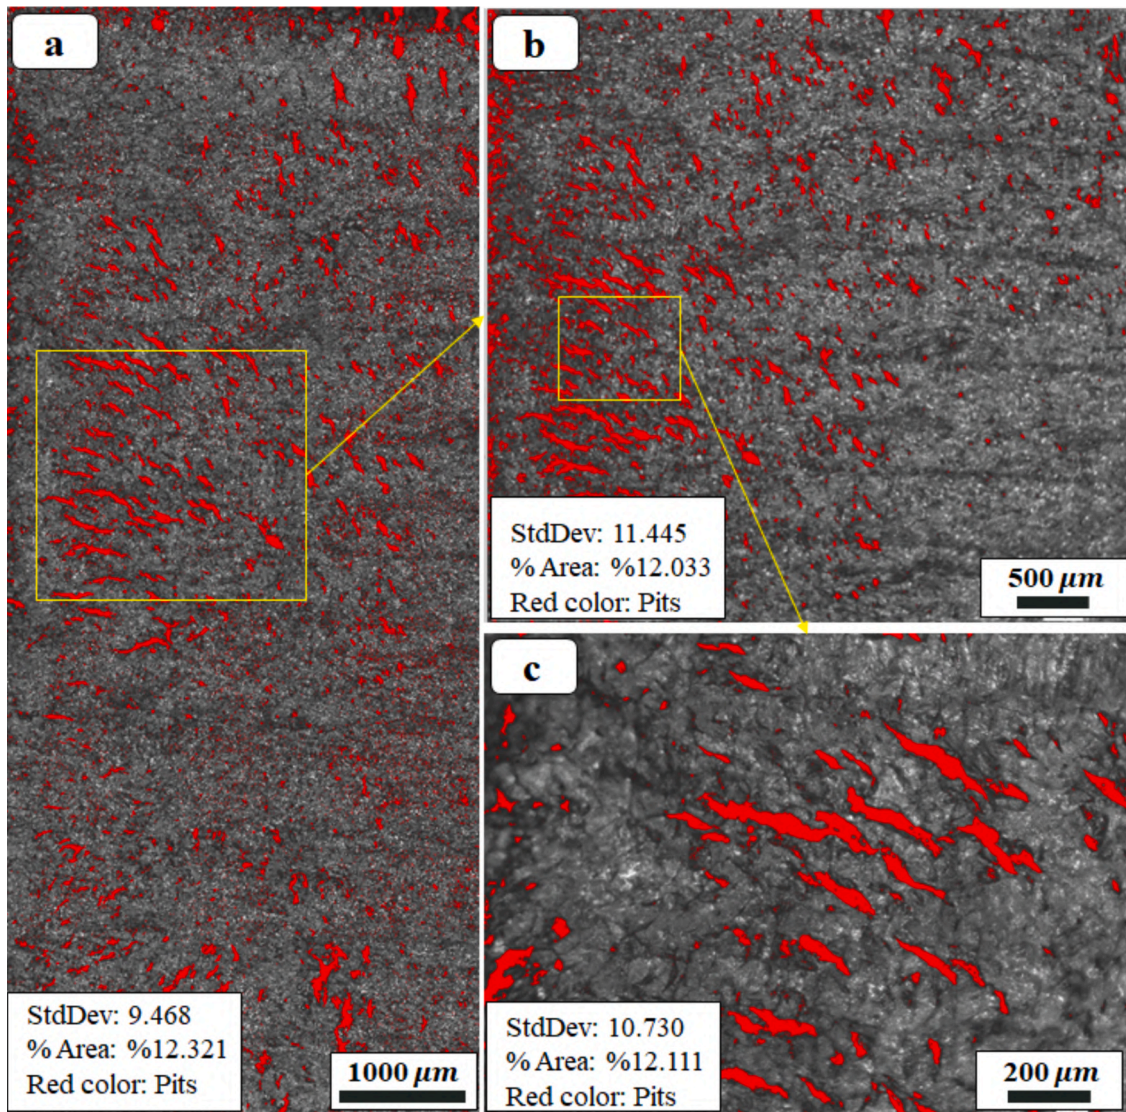
Fig. 8. a) the corroded surface in 50X magnification with 12% of the corroded area, b & c) the selected area in 100X and 200X magnification respectively.

The surface area affected by pitting was quantified in Fig. 8 utilizing an image processing methodology; the calculated area for various magnifications indicates that the pitting on the surface is approximately $12\% \pm 0.5$. This implies that while the corrosion is localized, the locations of corrosion were dispersed at random across the surface, and the pitting area at a large scale (encompassing the entire surface, as shown in Fig. 8(a) mirrored the tiny, magnified region of the specimen under increased magnification. Therefore, we rely on the findings from the witness specimen to infer the extent of surface pitting in the remaining corroded fatigue specimens. It is reasonable to deduce that all specimens experienced a surface pitting of approximately $12\% \pm 0.5$. Additionally, it is critical to note that these results are at the microscale; the maximum magnification of the measurements is X200 in Fig. 8(c) indicating that the image processing was incapable of detecting the crevices at the smaller scale. The surface area (12 %) of corroded sites that have been calculated may serve as an indicator of the surface quality degradation caused by corrosion, a topic that will be further explored in the fatigue results section.

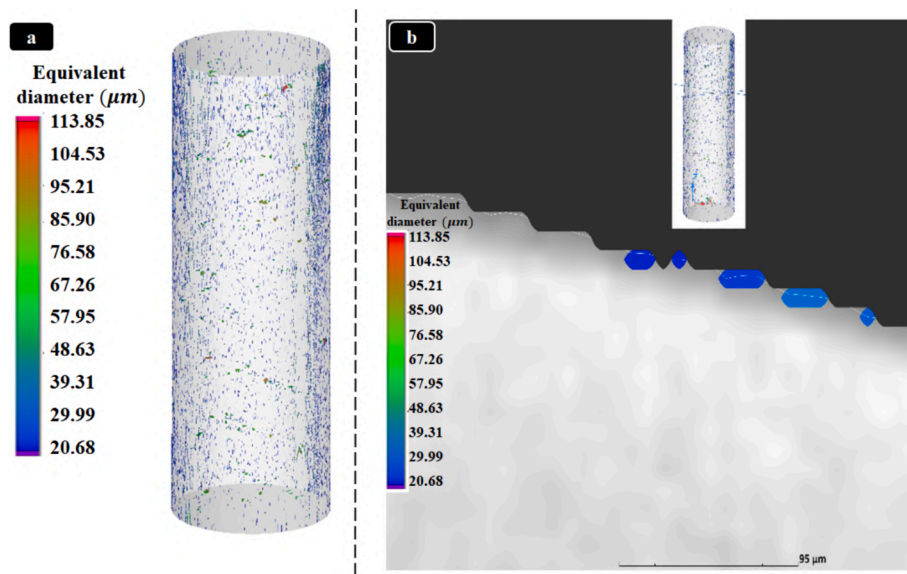
Fig. 9. a) Defect analysis with no edge distance filtering and b) surface artifacts of the surface of the specimen.

In this Section, a detailed defect analysis is carried out. Figs. 9 and 10 compare the distribution of defects within the cylinder volume (the transparent grey area), Fig. 9 for the Non-corroded specimen, and Fig. 10 for the Pre-corroded specimen. By analyzing the control volume, surface corroded fissures are visible, and the surface of the pre-corroded specimen exhibits asperities (Fig. 10), whereas the surface of the non-

corroded specimen is nearly smooth (Fig. 9). Although the primary and common objective of the CT scan is to analyze volumetric defects induced by LPBF in the microstructure, Fig. 10 reveals surface waviness (roughness) caused by corrosion in the pre-corroded specimens (relative to the smooth surface finish of the non-corroded specimens, Fig. 9). The CT scan results indicate that the 10-day exposure to the corrosive environment largely affected the surface, leaving interior defects largely unaffected.

In Fig. 9(a), an increased number of surface defects are visible, while in Fig. 9(b), an enlargement of the surface reveals that these defects are merely artifacts, not actual defects. These artifacts result from the beam hardening phenomenon. Beam hardening is a characteristic of tomography analysis when dealing with heavy and dense alloys such as steel, where the internal volume of the material appears brighter and the surface darker. Since the defect analysis algorithm relies on contrast differences between voids and material, these darker surface shadows can lead to false defect detections.

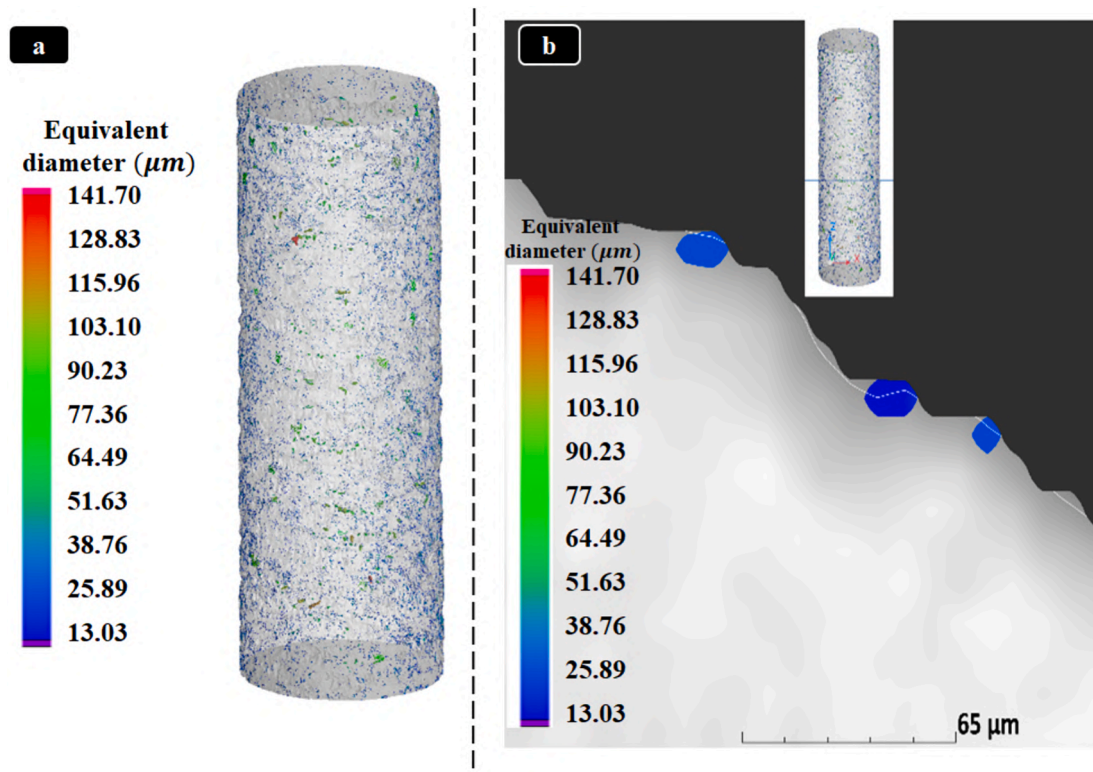
Fig. 10. a) Defect analysis with no edge distance filtering and b) surface artifacts of the surface of the specimen.

In Fig. 10(a), the defect analysis results for the pre-corroded specimen are shown, and in Fig. 10(b), an enlargement of the surface highlights some characteristic artifacts. Therefore, it should be noted that removing the edge distance limitation in the analysis does not change the overall defect detection but introduces numerous small surface artifacts. These artifacts arise from the limitations of tomography analysis with heavy and dense materials like steel. However, despite excluding the surface from the defect analysis, the increase in surface roughness is still clearly visible (Fig. 11).

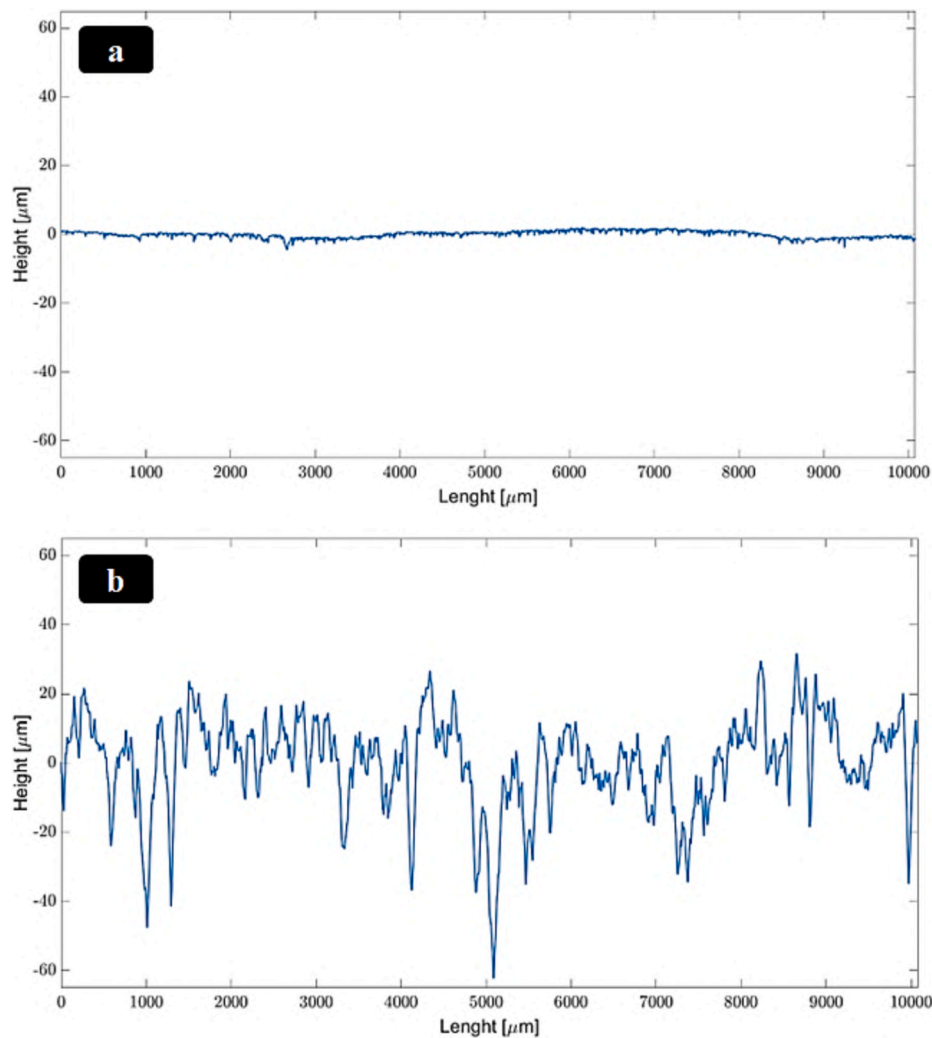
Fig. 13. Surface profile of a) non-corroded sample and b) pre-corroded sample.

To better evaluate the change in the roughness of the pre-corroded sample and the effect of corrosion on surface quality, a profilometry analysis was conducted using the Taylor Hobson Intra Touch 3D Profilometer. Fig. 13 shows the profiles obtained from the profilometry analysis. Specifically, Fig. 13(a) presents the profile of the non-corroded sample, while Fig. 13(b) displays the profile of the pre-corroded sample. Both profiles measured are 10 mm in length. By analyzing these surface profiles, the roughness parameters listed in Table 2 were extracted.

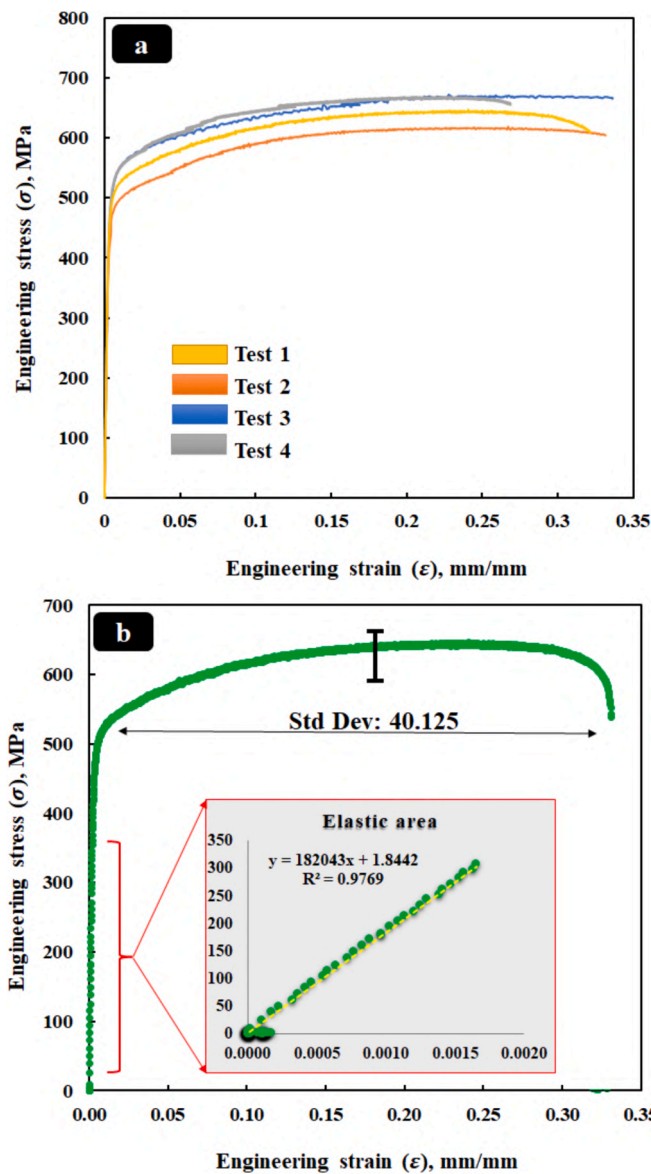
Fig. 14. a) Flow curves of four tensile tests, b) the average flow curve.

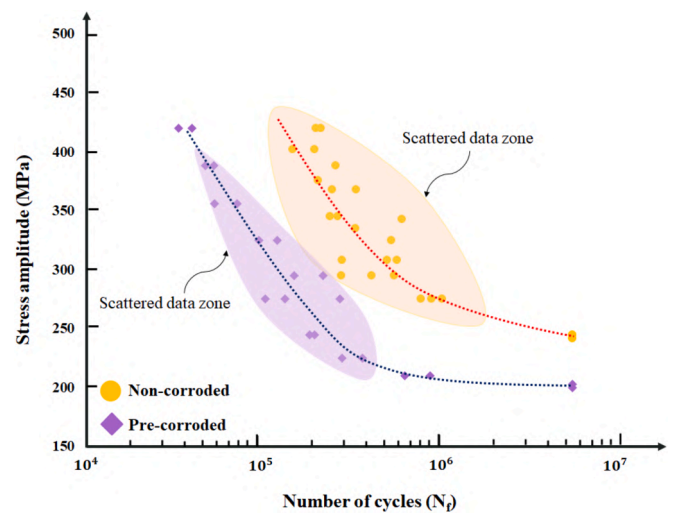
Fig. 15. S-N data for the non-corroded (virgin) and pre-corroded specimens with the scattered data zone.

Fig. 15 depicts the S-N data of the pre-corroded specimens (ex-situ corrosion RBF life) and the virgin (non-corroded specimens). As seen, corrosion tangibly affects fatigue performance (lowers fatigue strength). The fatigue limit for pre-corroded specimens is estimated to be 203 MPa, compared to approximately 242 MPa for non-corroded specimens. The disparity between the two S-N curves indicates a difference of over 40 % in fatigue life between the two specimen groups. The dispersed data in the HCF regime (10^4 to 10^6 cycles) is consistent with the notion that crack initiation from surface defects serves as the primary fatigue mechanism controller. By reducing the stress level to the range of 388 to 356 MPa, the lifetime of pre-corroded specimens decreased by about 70 % compared to non-corroded specimens. For example, the lifetime of a non-corroded specimen at 388 MPa was 241,300 cycles, whereas for a

pre-corroded specimen subjected to the same stress level, it was 45,400 cycles. This substantial reduction underscores the pronounced effect of corrosion on fatigue life under lower-stress conditions. Within the stress range of 325 to 275 MPa, the average decrease in lifetime percentage from non-corroded to pre-corroded specimens was 75 %, with some instances exceeding 80 %. For instance, at a stress level of 275 MPa, the non-corroded specimen exhibited an average of 826,360 cycles, while the pre-corroded specimen endured only 158,730 cycles. Within the last stress range of 275–203 MPa, data scattering decreased, the average lifetime from non-corroded to pre-corroded decreased by 53 %, and the fatigue limit difference between these two types of specimens was 17.1 %.

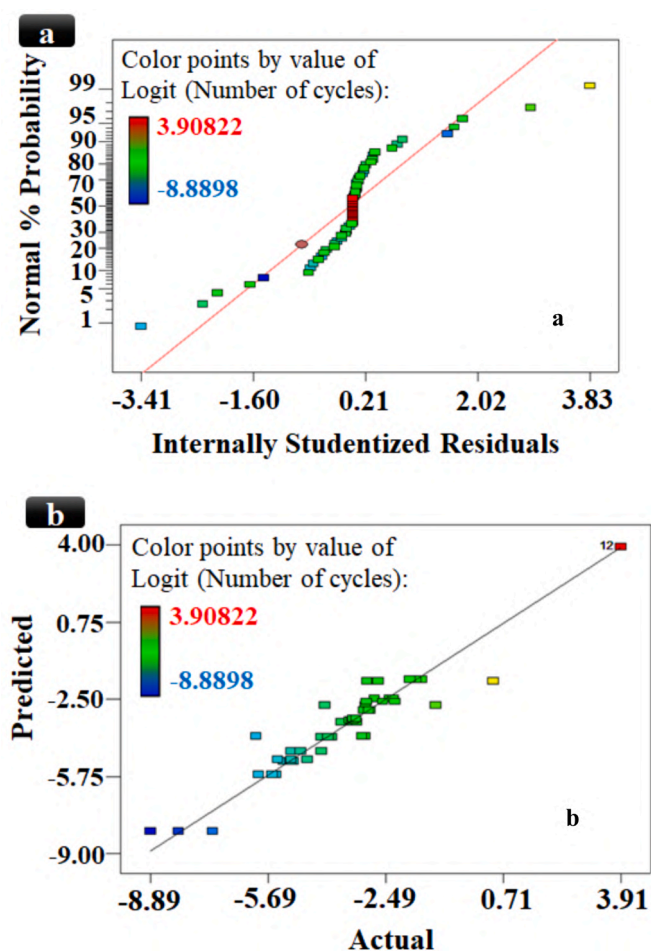
Fig. 16. The statistically analyzed data from the ANOVA method are used to estimate the precision of the model and experimental data; a) The normal plot of residuals; b) The comparison of predicted data from the ANOVA model with actual experimental data.

value of 97.13 %. The accuracy of the model is also demonstrated by the predicted versus actual graph in Fig. 16(b), which demonstrates that the predicted data is 93 % accurate when compared to the actual data. As a result, the coded model format for the relationship between stress levels and categorical corrosion factors has been presented in Table 3. This model encompasses the S-N data from both pre-corroded and non-corroded experiments.

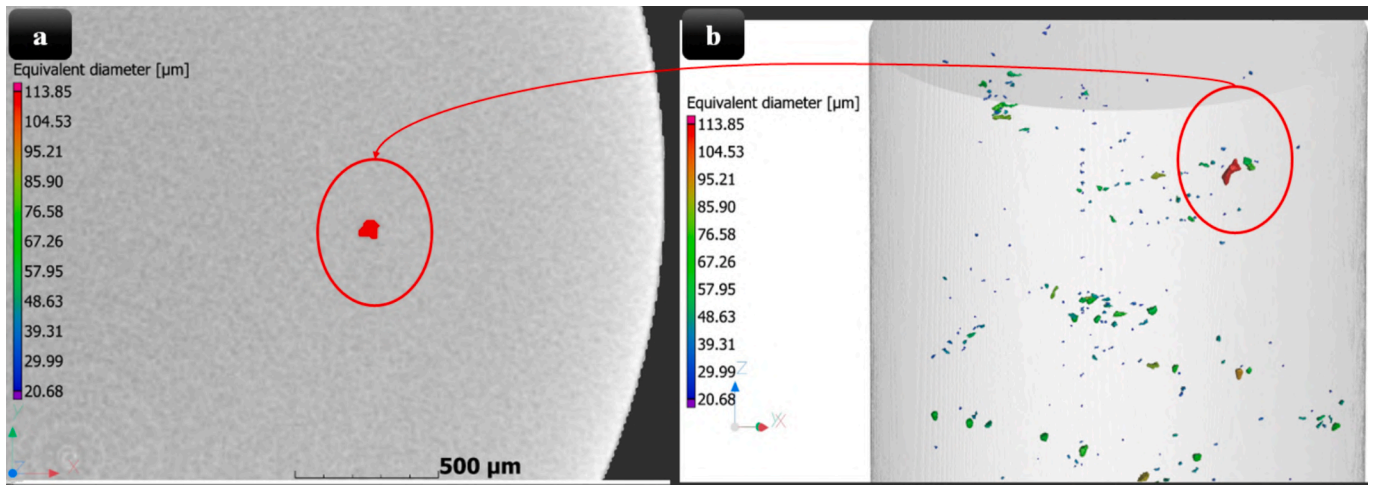
Fig. 19. The CT scan results indicate that the surface layer* contains the greatest size of porosity. *Note. The surface layer considered in this investigation was 1000 μm in thickness before machining. As a result of machining removing this surface layer, defects emerged on the free surface.

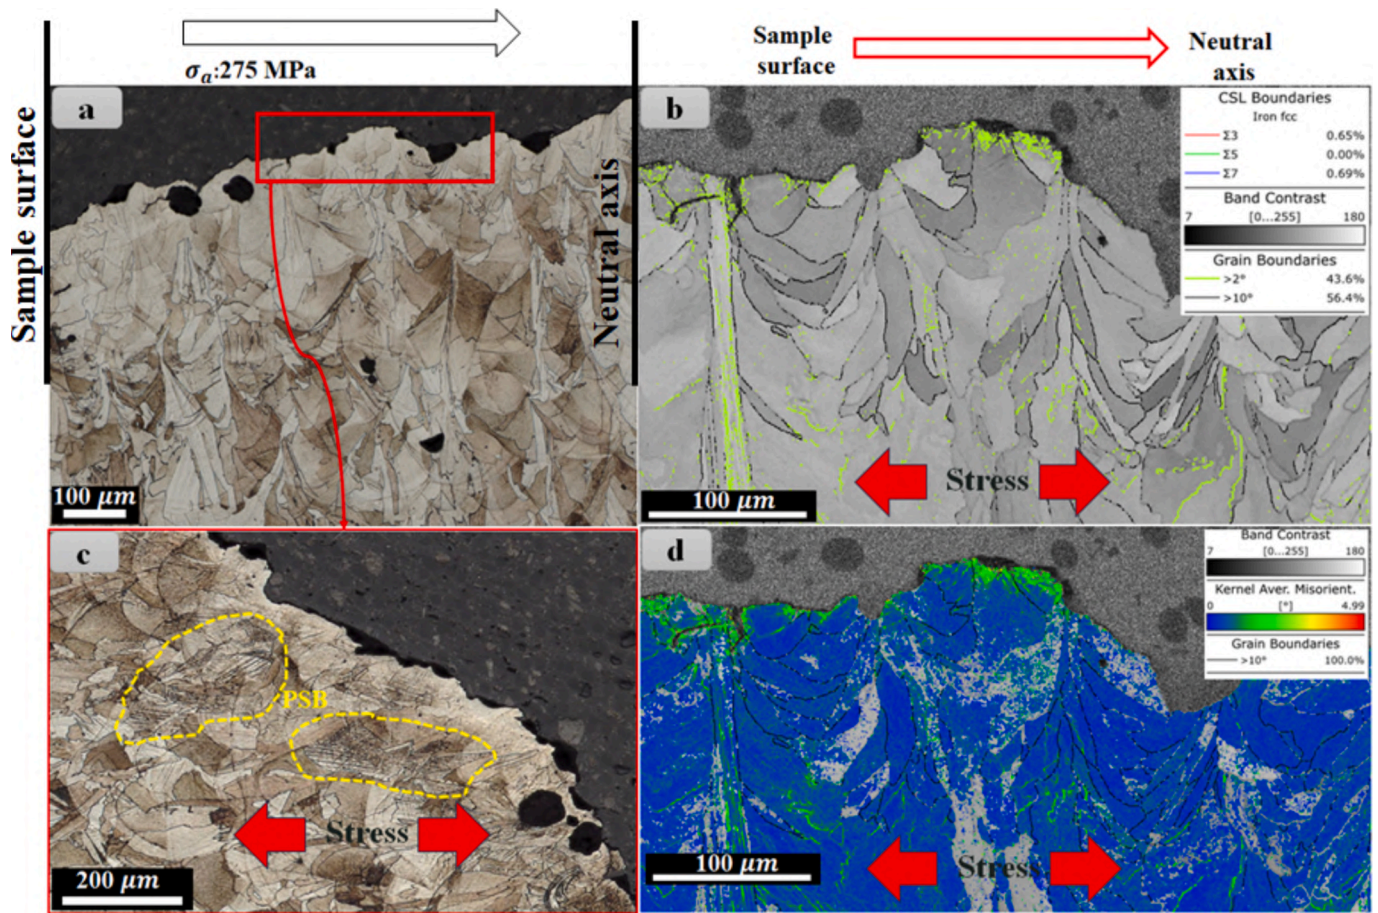
Fig. 24. a) OM image of fractured surface cross-section of the non-corroded specimen under 275 MPa stress amplitude, in the higher magnification the dark black lines are showing slip bands close to fractured surface, b) SEM-based EBSD images with internal average misorientation angles (IAMA) expression, c) is showing the higher magnification of fractured surface layer with slip bands, d) the kernel average misorientation (KAM) expression on EBSD image.

The effect of stress level on the behavior of the fracture surface and microstructure did not exhibit significant differences between specimens subjected to corrosion and non-corroded ones, both have similar behavior. To study the effect of stress level on the microstructure of fractured layers, Figs. 23 and 24 present the EBSD and OM results corresponding to two stress values, 275 and 420 MPa, from fatigue tests conducted on non-corroded specimens. OM images of fracture surface perpendicular sections reveal melt pool layers and grains (see Fig. 23(a) and (c)). Dark black, angularly oriented, narrow lines at high magnification indicate the presence of slip lines in the microstructure, which are denser about the fracture surface. Analysis of the kernel average misorientation (KAM) and internal average misorientation angles (IAMA) expression images in Fig. 23(b) and (d) from the near-fractured surface layer reveals that the EBSD image exhibits a significant grain boundary percentage. The yellow lines in Fig. 23(b), which cover about 83.9% of the grain boundaries, potentially represent slip lines (resulting

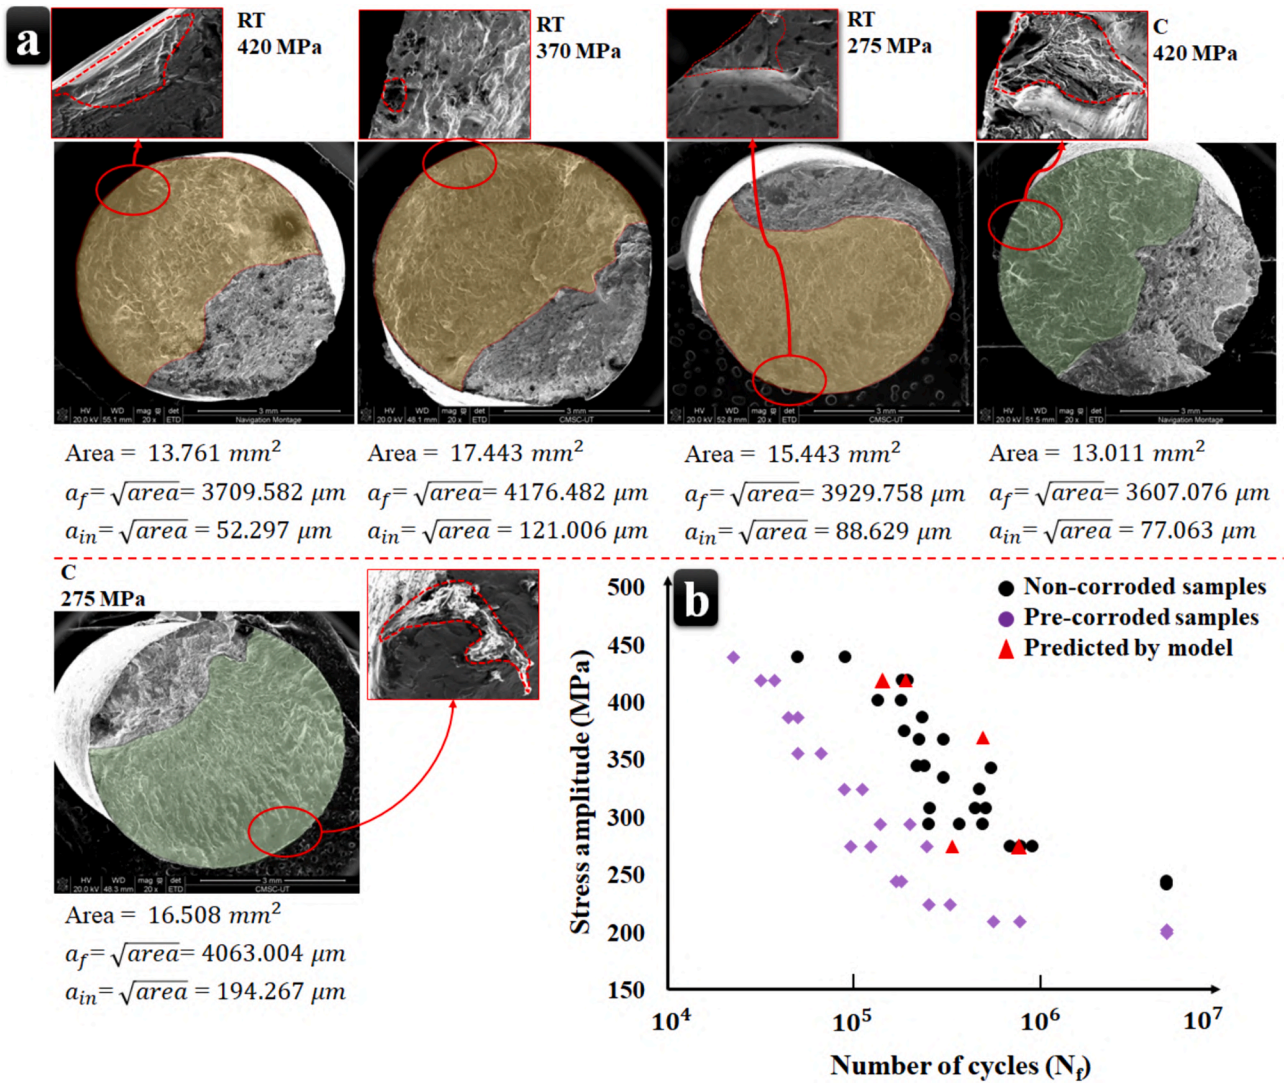
Fig. 25. a) the initial & final crack size measurement based on SEM images, (b) experimental and predicted data from Eq. (7).

The final crack length was determined using SEM data and Murakami's equation has been substituted in Eq. (5). The following equation is the resulting fatigue life prediction equation which has been utilized for generating the Fig. 25 diagram.

The final crack length could be estimated using SEM images by calculating the crack propagation area just before the final brittle fracture. The five SEM images and their corresponding final crack length estimations are displayed in Fig. 25(a). It seems that the fatigue life predicted by the model derived in Eq. (7) using the Paris law and Murakami's expression is nearly within the range of experimental data (Fig. 25(b), red triangles). The predicted data derived from the crack propagation modeling using Eq. (7) are presented in Fig. 25(b). The predicted data lies within the experimental regions (less than 10 % deviation) in this diagram. It is crucial to note that the modeling in this study does not account for the corrosion phenomena, as the corrosion
