Conservation of Earthen Bricks in Architecture: An Experimental Campaign to Test Different Treatments on Vernacular Built Heritage

Silvia Rescic¹, Manuela Mattone^{1,2}, Fabio Fratini¹ and Loredana Luvidi^{3,*}

Keywords: earthen architecture; earthen bricks; conservation issues; protective products; test methods

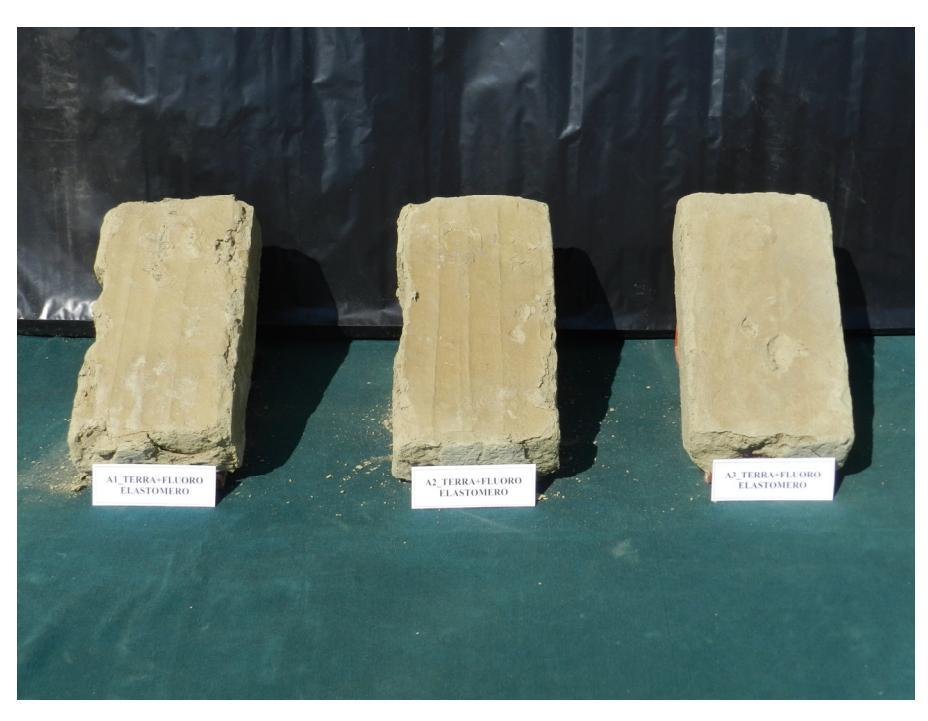
Figure 5. Earthen bricks: Specimens made with local earth (from Alessandria, Italy) and treated with a fluoroelastomer (Tecnoflon N215).

The dimensions of the earthen bricks used for the experimentation were $26 \times 13 \times 6$ cm. Not fissured bricks with relatively regular surfaces were chosen. They were previously cleaned with a chisel stonemason and a brush, removing all traces of plaster, mortar, and any vegetal residues (Figures 5 and 6).

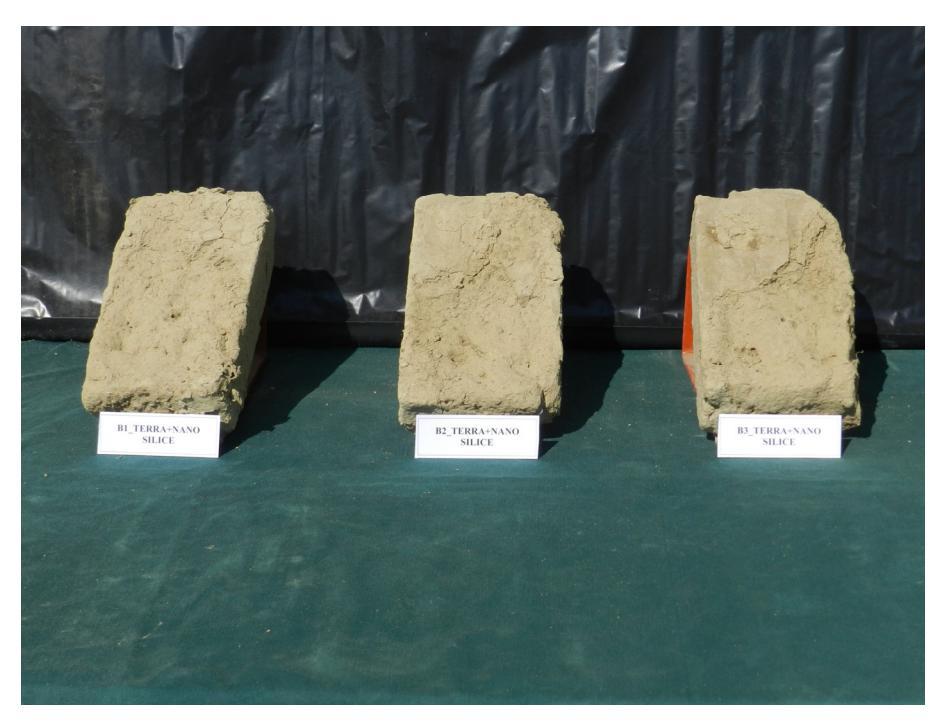
Figure 6. Earthen bricks: Specimens made with local earth (from Alessandria, Italy) and treated with nano-silica (Nano Estel).

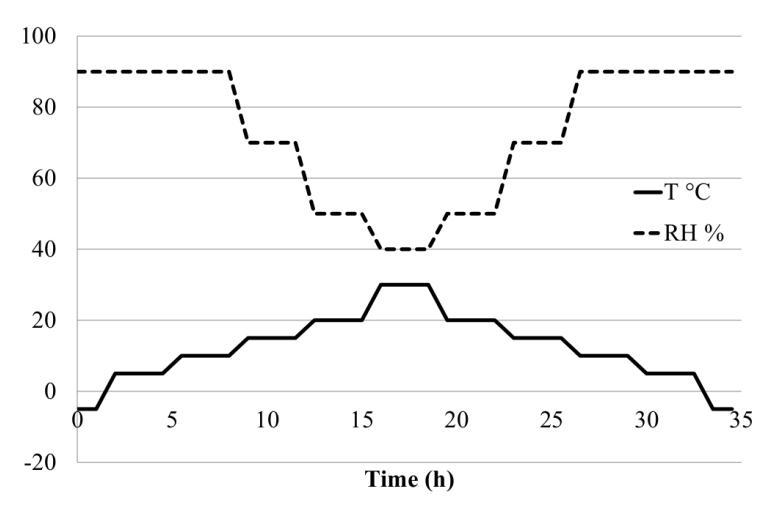
Figure 7. Diagram representative of the TH cycle (credit: Rescic).

The not treated and treated earthen bricks were exposed to artificial ageing in an Angelantoni Challenge 500 Climatic Chamber. The thermo-hygrometric conditions were simulated experimentally based on the cycle represented in Figure 7. This cycle was carried out by reprocessing original data recorded by "Rete di Monitoraggio Meteoidro-grafica" of ARPA Piedmont in the Alessandria Lobbi weather station over ten years. The data were averaged, and one-year behaviour was converted to an RH cycle of 35 h ranging from –5 °C to 30 °C and from 40 to 90% RH. The cycle was repeated 50 times. Colorimetric change, weight, and contact angle measurements were performed before and after accelerated ageing.

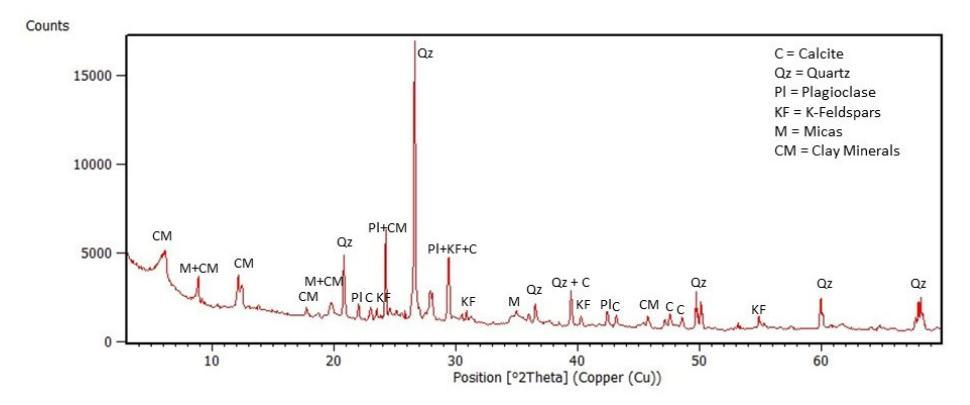
The grain size distribution of the earthen material (sand 24%, silt 45%, clay 31%) taken from the farmhouse under demolition was obtained through sieving. The main mineralogical composition of the earthen bricks, performed by X-ray diffraction, is as follows: quartz, feldspars, calcite, micas, and clay minerals (Figure 8).

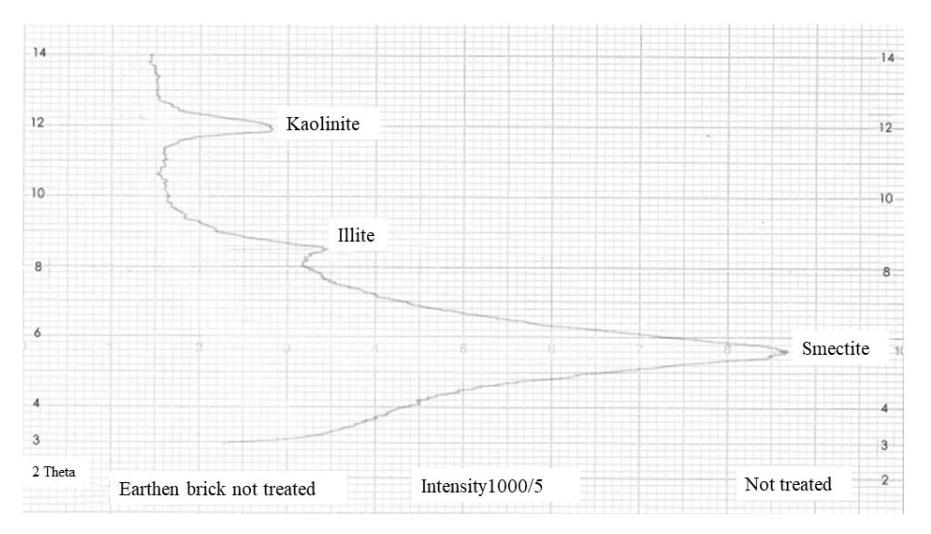
Figure 9. XRD diagram of the clay mineral fraction: Not treated sample.

The semi-quantitative composition of the clay fraction was as follows: kaolinite 35%, illite 20%, and smectite 45% (Figures 9–11).

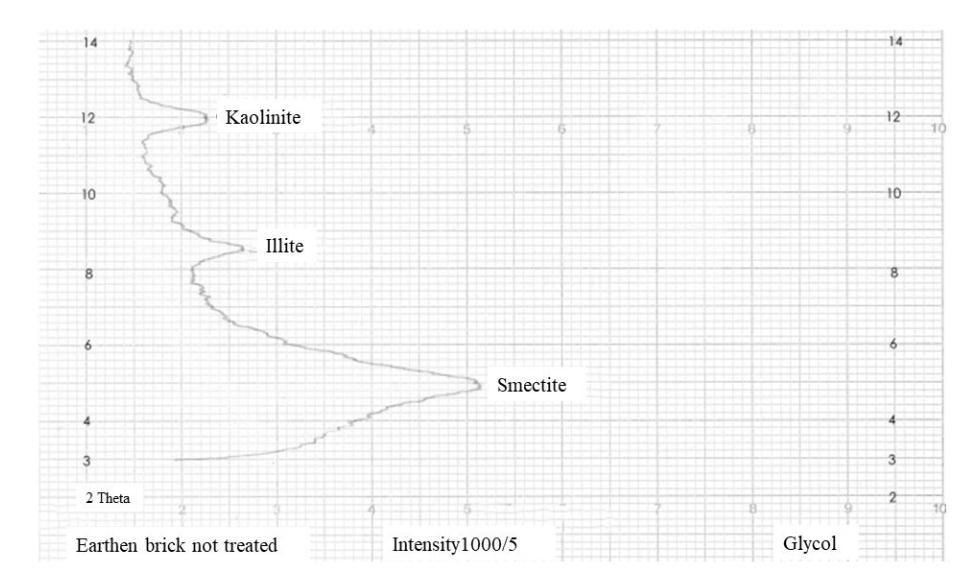
Figure 10. XRD diagram of the clay mineral fraction: glycol sample

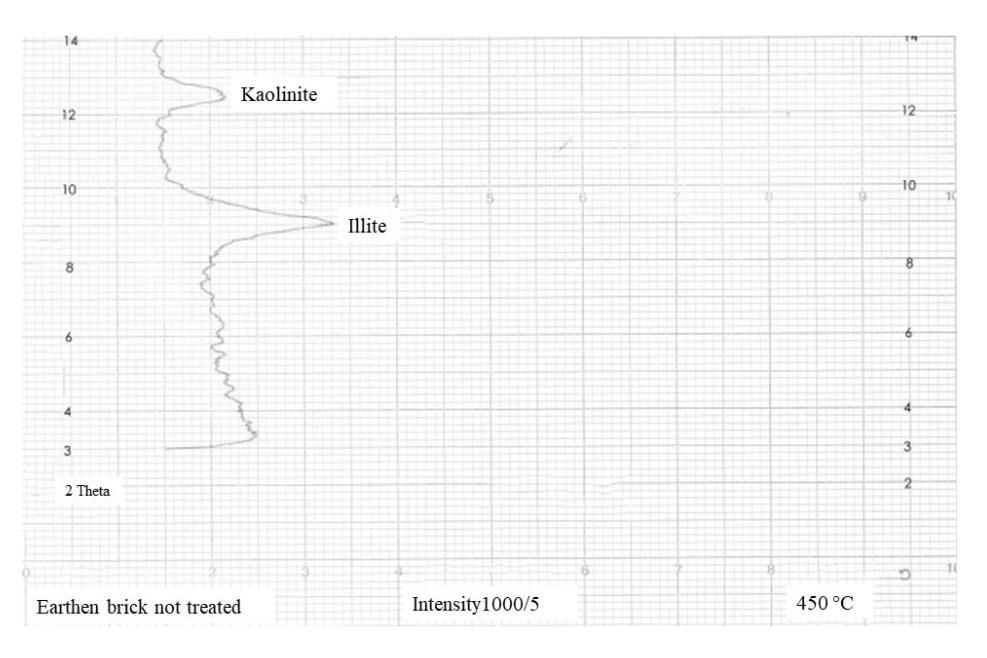
Figure 11. XRD diagram of the clay mineral fraction: sample at 450 °C

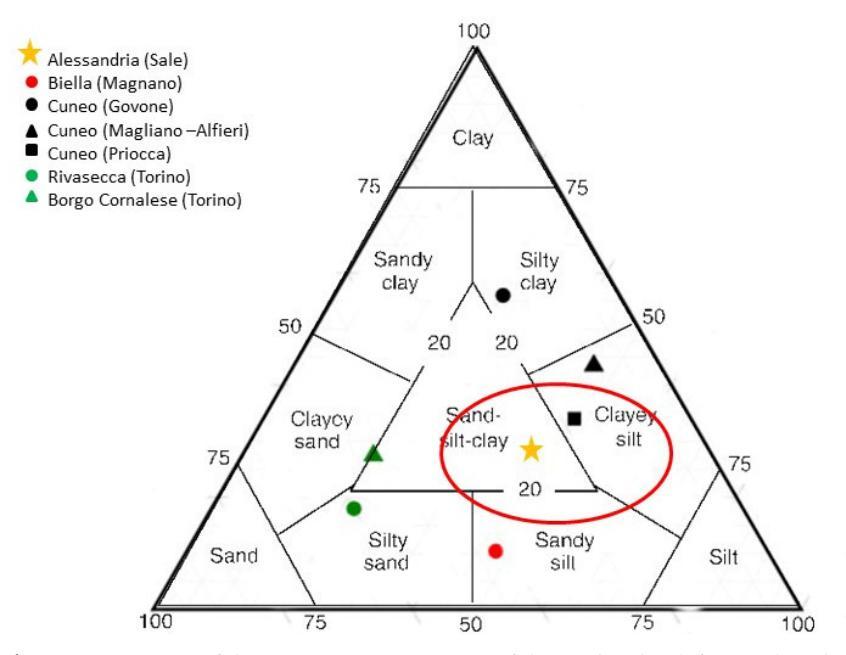
Figure 13. Diagram of the grain size composition of the earthen brick from Sale (Alessandria) compared with others from the Cuneo, Biella, and Turin provinces; within the red circle is the area of acceptability for adobe reported by CRAterre.

In fact, these bricks were characterised by a greater presence of the finest fraction (silt), as can be seen from the diagram shown in Figure 13, where the optimal granulometric distribution area is indicated as defined by CRATerre (Figure 13) [52].

The bricks from Sale and Priocca (Figures 12 and 13) lie in this area, while those of Govone and Magliano-Alfieri are more clayey. Another similarity with the bricks from the Cuneo area concerns the mineralogical composition of the clay fraction with the presence of illite-smectite and smectite expandable lattice minerals [53]. These data suggest that the results obtained from the present experiment could also be useful for applications on bricks of earthen material from the Cuneo area.

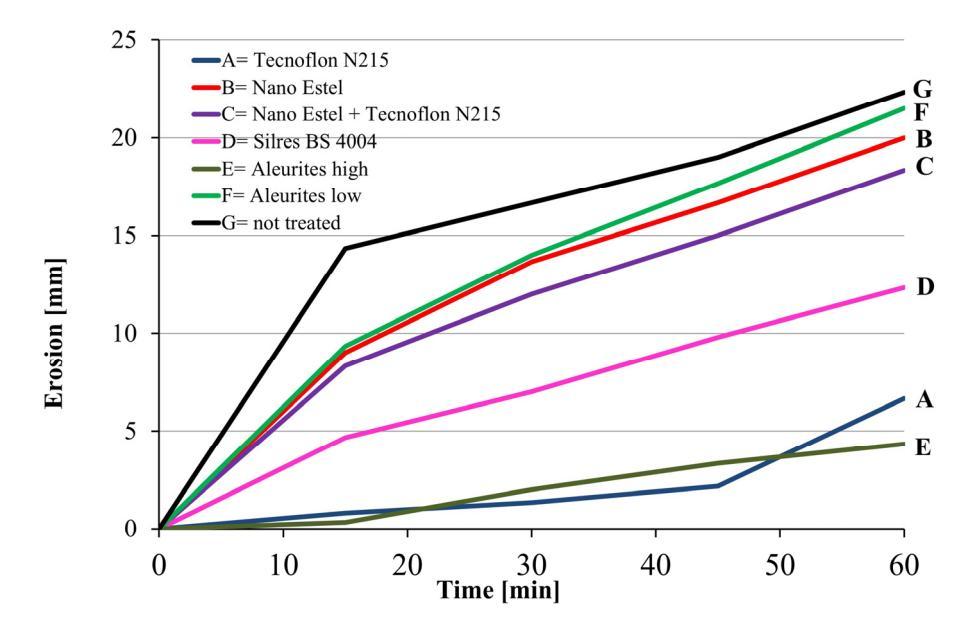
Figure 14. Spray erosion test diagram (credit: Mattone).

The results of the spray erosion tests are shown in Figure 14.

The results of the spray erosion test allow for the following considerations:

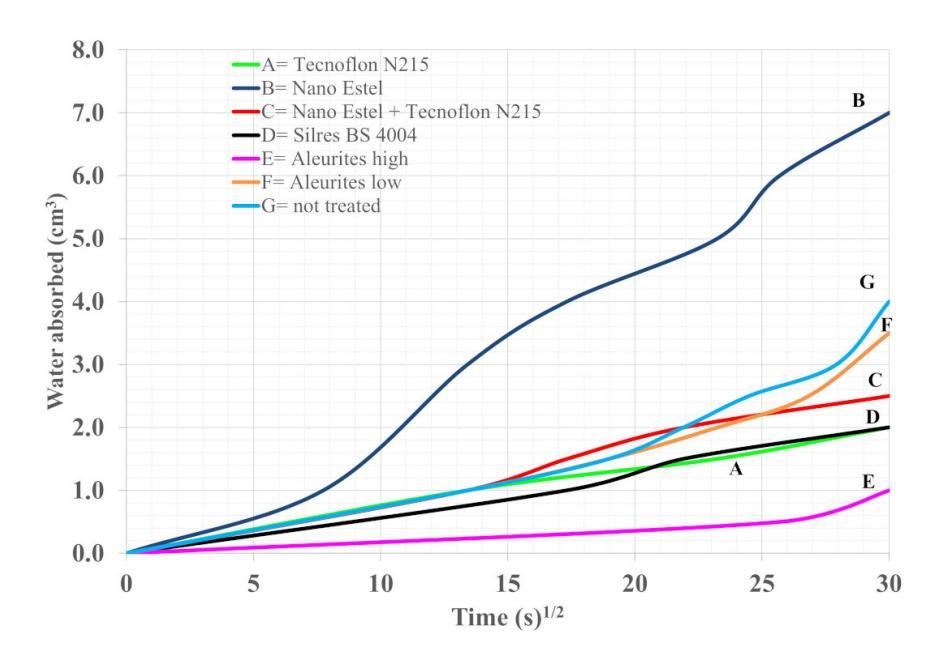
Figure 15. Water absorption diagram.

The results of the water absorption test with the Karsten method are shown in Figure 15.

The results of the water absorption test allow for the following considerations:

- Earthen brick B (Nano Estel) showed the worst results compared to the not treated brick (G). It absorbed the maximum amount of water (i.e., 7 cm³) and began to absorb from the first minute. This result is not unexpected for two reasons: nano silica is a consolidating but not a protective product, and second, it is applied in an aqueous solvent. The aqueous solvent could have caused partial melting of the earth with a reorganization of the matter that favoured the creation of a porous network more accessible to liquid water [47];

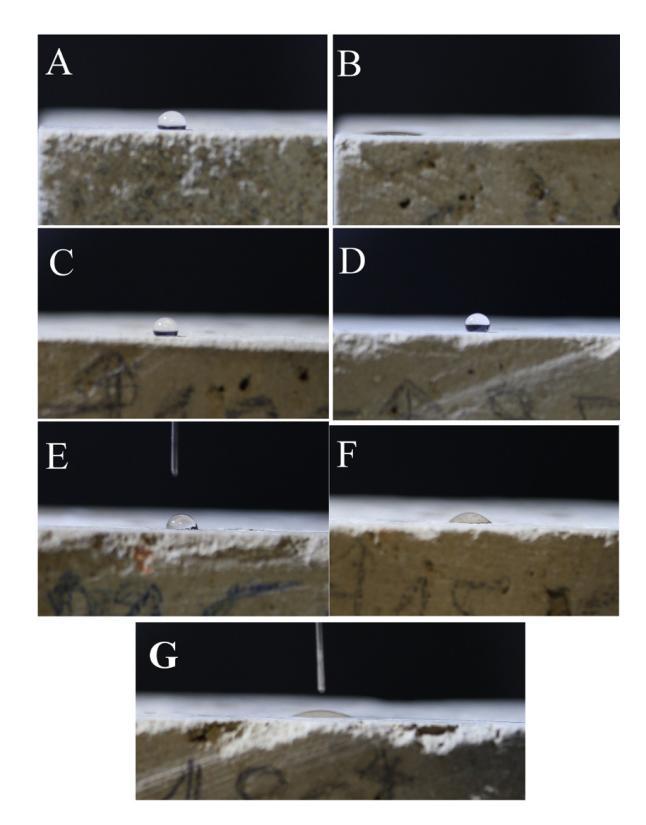
Figure 16. Contact angle of the earthen brick samples treated (**A**–**F**) and not treated (**G**). (A = Tecnoflon N215; B = Nano Estel; C = Nano Estel + Tecnoflon N215; D = Silres BS 4004; E = Aleurites high; F = Aleurites low; G = not treated) (credit: Rescic).

The conservative treatment products that performed best in this test were Tecnoflon N215(A), Nano Estel + Tecnoflon N215 (C), and Silres BS 4004 (D), namely, the products with well-known hydrophobic properties.

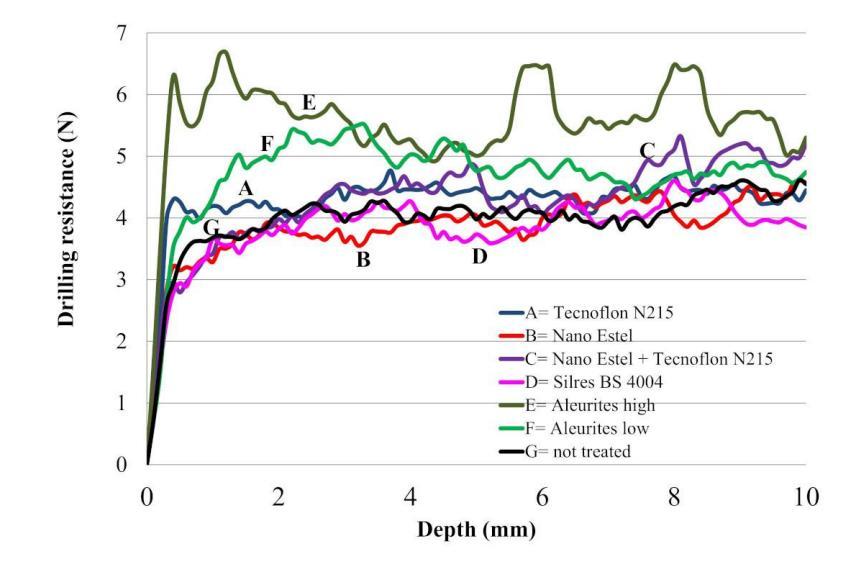
Figure 17. Drilling resistance profiles (A = Tecnoflon N215; B = Nano Estel; C = Nano Estel + Tecnoflon N215; D = Silres BS 4004; E = Aleurites high; F = Aleurites low; G = not treated) (credit: Rescic).

The results reported in Table 9 and Figure 17 show that:

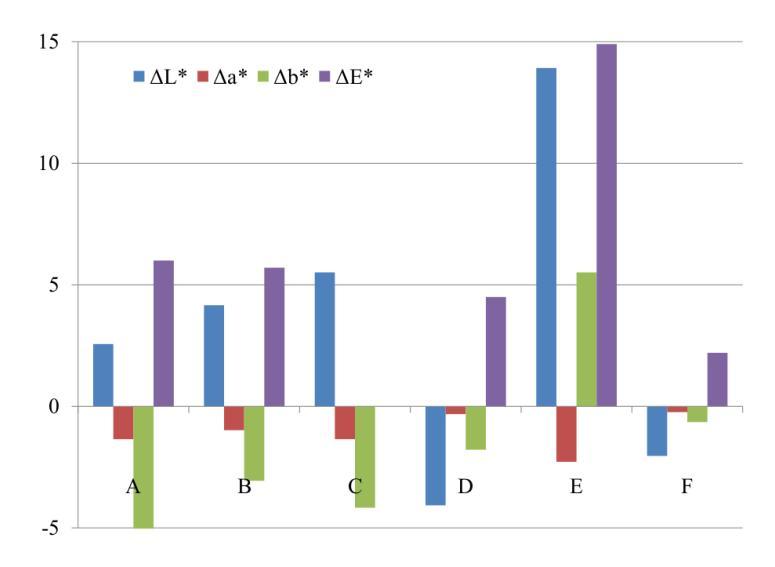
Figure 18. Average values of the variations in the chromatic parameters of the different treatments (A = Tecnoflon N215; B = Nano Estel; C = Nano Estel + Tecnoflon N215; D = Silres BS 4004; E = Aleurites high; F = Aleurites low; G = not treated) (credit: Luvidi).

All treatments, except for D and F, showed a total variation in colour perception (ΔE) appreciable with the naked eye ($\Delta E > 5$). In particular:

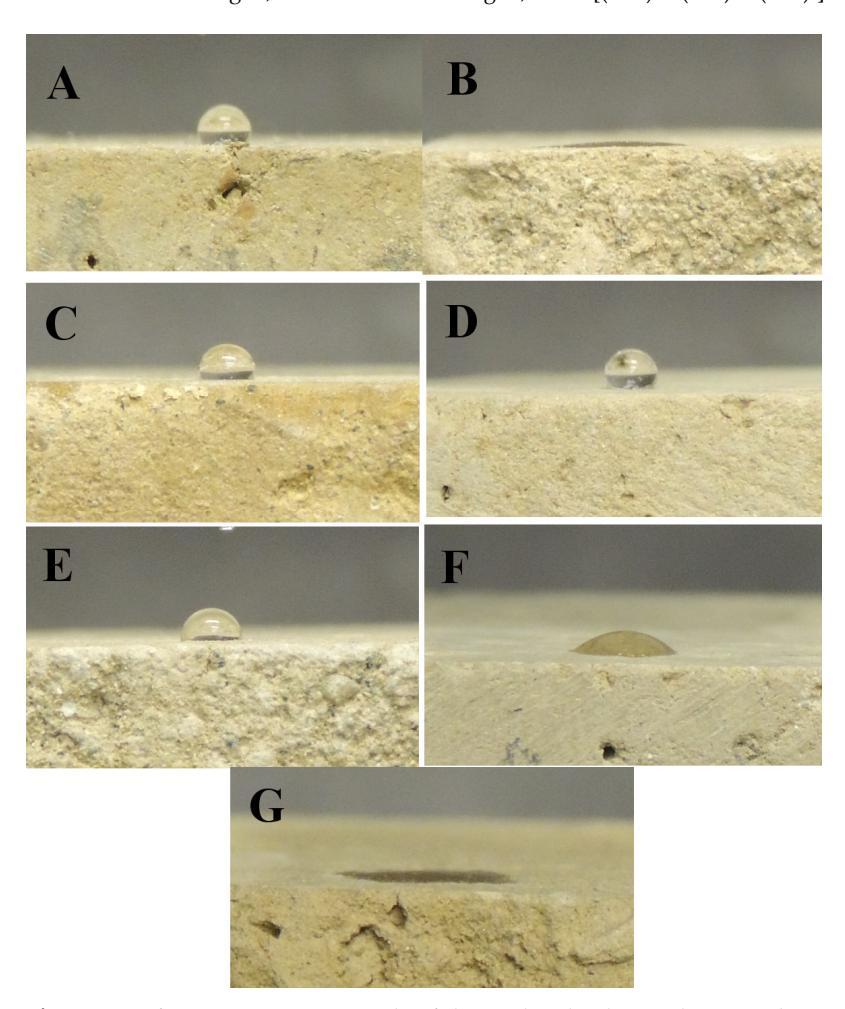
Figure 19. After ageing, contact angle of the earthen brick samples treated (**A**–**F**) and not treated (**G**). (A = Tecnoflon N215; B = Nano Estel; C = Nano Estel + Tecnoflon N215; D = Silres BS 4004; E = Aleurites high; F = Aleurites low; G = not treated) (credit: Rescic).

The untreated earthen brick appeared to be the only one with a slight worsening in its natural capacity of hydrophobicity, with a contact angle reduction and an increased absorption rate. The contact angle and the corresponding water absorption rate for all other treatments remained practically unchanged.
