Advanced non-destructive techniques for the diagnosis of historic buildings: the Loka-Hteik-Pan temple in Bagan

Erik Costamagna^{a,*}, Mario Santana Quintero^a, Nicoletta Bianchini^b, Nuno Mendes^b, Paulo B. Lourenço^b, Su Su^c, Yin Min Paik^c, Aungzaw Min^d

Abstract

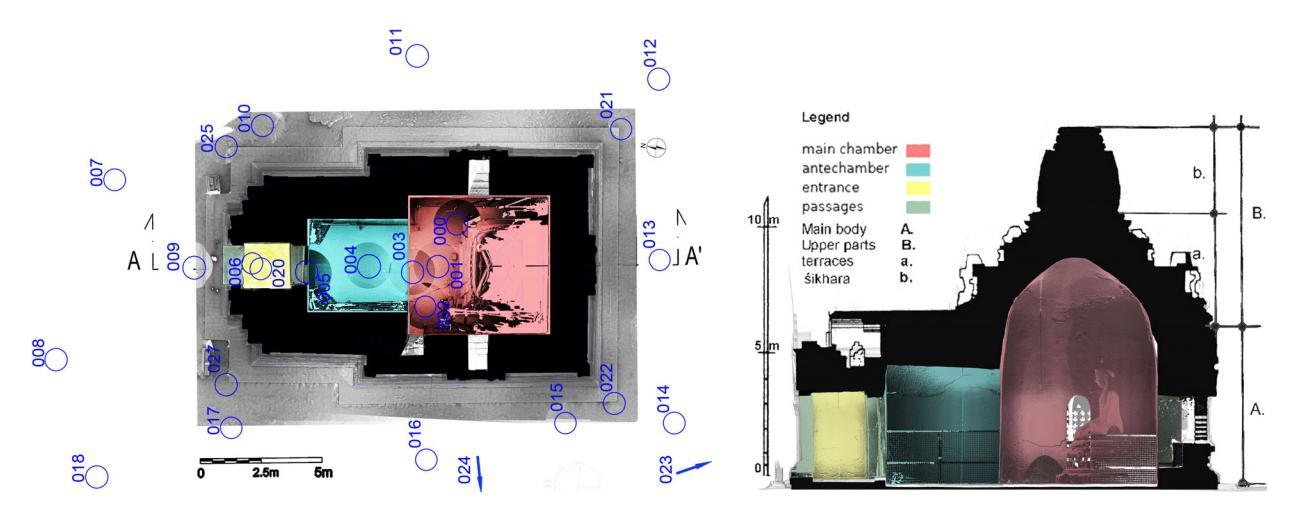
Figure 1: Loka-Hteik-Pan: vertical section and ground level plan with the scan locations from 2018. Source: updated from [19]

covered all the exterior façades and the interiors of the temple. Figure 1 shows the position of the scans of the 2018 survey: a loop scheme was set for the exteriors while the scans from the interiors follow linear sequence, from the antechamber to the main room. A similar approach was used for the 2016 survey. Figure 4 shows the point spacing of the registered point clouds, computed with Meshlab [26] as the average distance from each point to his neighbours. Datasets from 2018 survey are a bit denser, especially regarding the exteriors, because the number of scan was doubled from 9 scans in 2016 to 18 scans in 2018, while for the interiors the number was almost the same (6 scans in 2016 and 7 in 2018). The sparser dataset (2016 exteriors) has 95% of the samples with a point spacing between 2 and 8 mm. Figure 5 shows that, apart from the small differences within the surveys, uncertainty deriving from point clouds roughness is below $8 \, mm$ for 95% of the sampled data in the worst scenario (2016 exteriors). These point cloud statistics show a potential tolerance of the metric information being extracted from the data in line with the goal to detect spatial changes of $1 \, cm$ size (or bigger). 9-Point clouds were re-sampled in order to reduce the point cloud density. Points closer one to each other

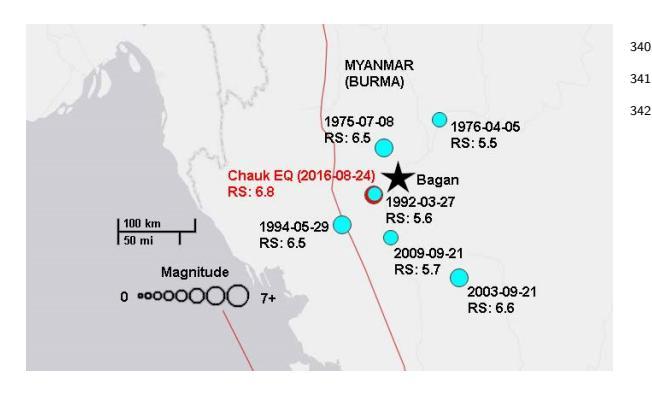
Figure 2: Location of the last strong seismic events (1975 – 2016). RS=Richter scale [20].

Due to the numerous seismic events, which hit Central Myanmar during 20th and 21th centuries (See Figure 2), Loka-Hteik-Pan temple, as well as many other Bagan temples, underwent several structural and non-structural interventions. The most significant changes occurred after Bagan earthquake (1975), when locals funded heavy strengthening projects [23]. According to Pichard [19], "a reinforced concrete belt at the top of the walls" was inserted along the perimeter walls of the main chambers. This description does not represent the entire intervention that was made: three beams made of reinforced concrete, not continuous, were located at each corners of the main chamber and of the antechamber along the height of the structure. This work was supposed to be done in order to reestablish the connection between the walls.

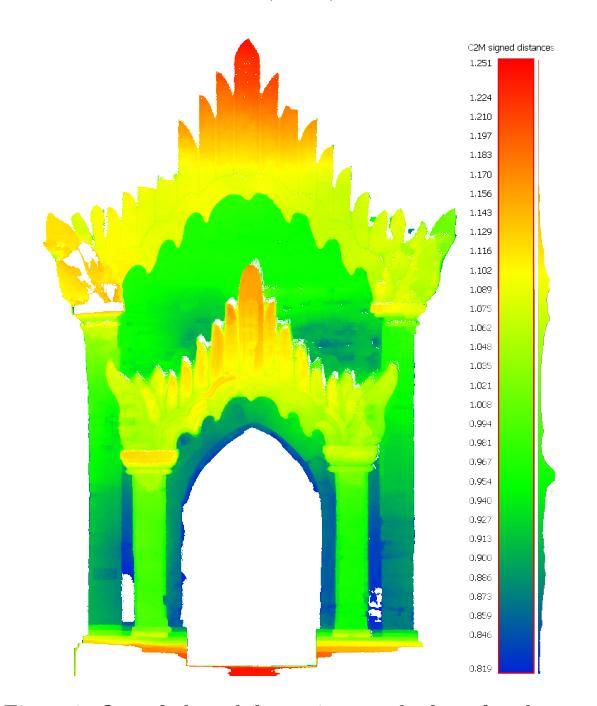
Figure 3: Out-of-plane deformations on the front façade tympanum. C2M distances are computed from a vertical plane fitted on the horizontal profile of the façade.

panum of the North façade is visibly affected by
out-of-plane deformations and some parts of this element have been reattached more recently, by using
cement based mortar (Fig 3). Due to the orienta-

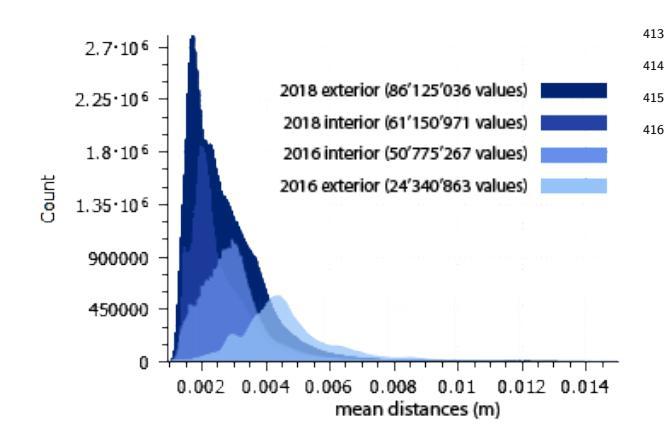
Figure 4: Point clouds densities. X axis show the average distances between points (m) and Y axis the values count (number of points for each point spacing value).

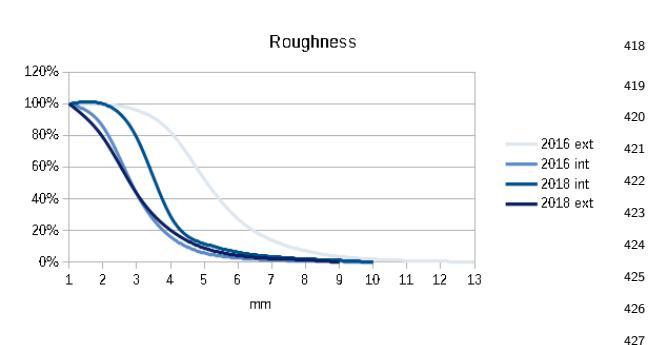
Figure 5: Point clouds roughness. X axis shows the distances and Y axis the percentage of points with that roughness value. Point clouds roughness is calculated as a distance $\pm d$ from each point to a plane fitted on his neighbours within a radius r = d.

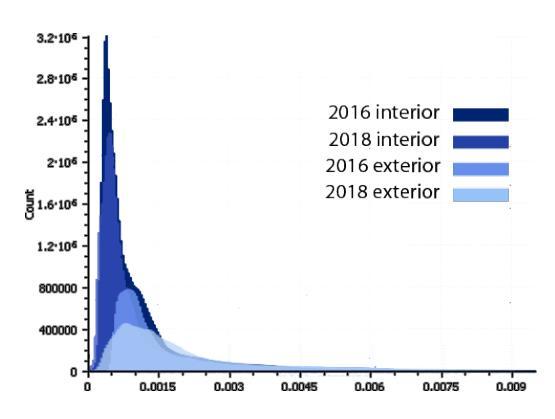
Figure 6: Standard deviations of the point clouds used for the comparison test with the M3C2 method (search radius r = 2 cm). Values show the deviation of the points from the tangent plane computed locally from the normals.

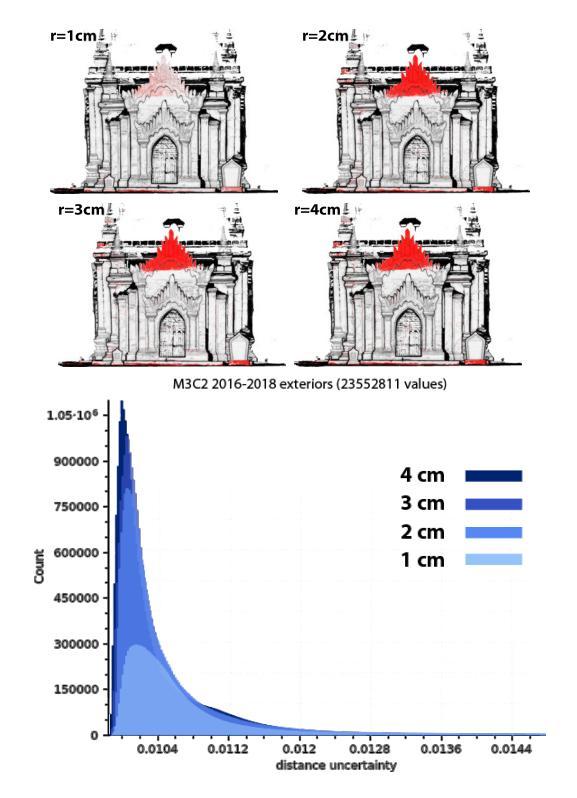
Figure 7: Distance uncertainties on the same M3C2 comparison tested with different search radius values and the effect on significant changes detection in the front façade (red points).

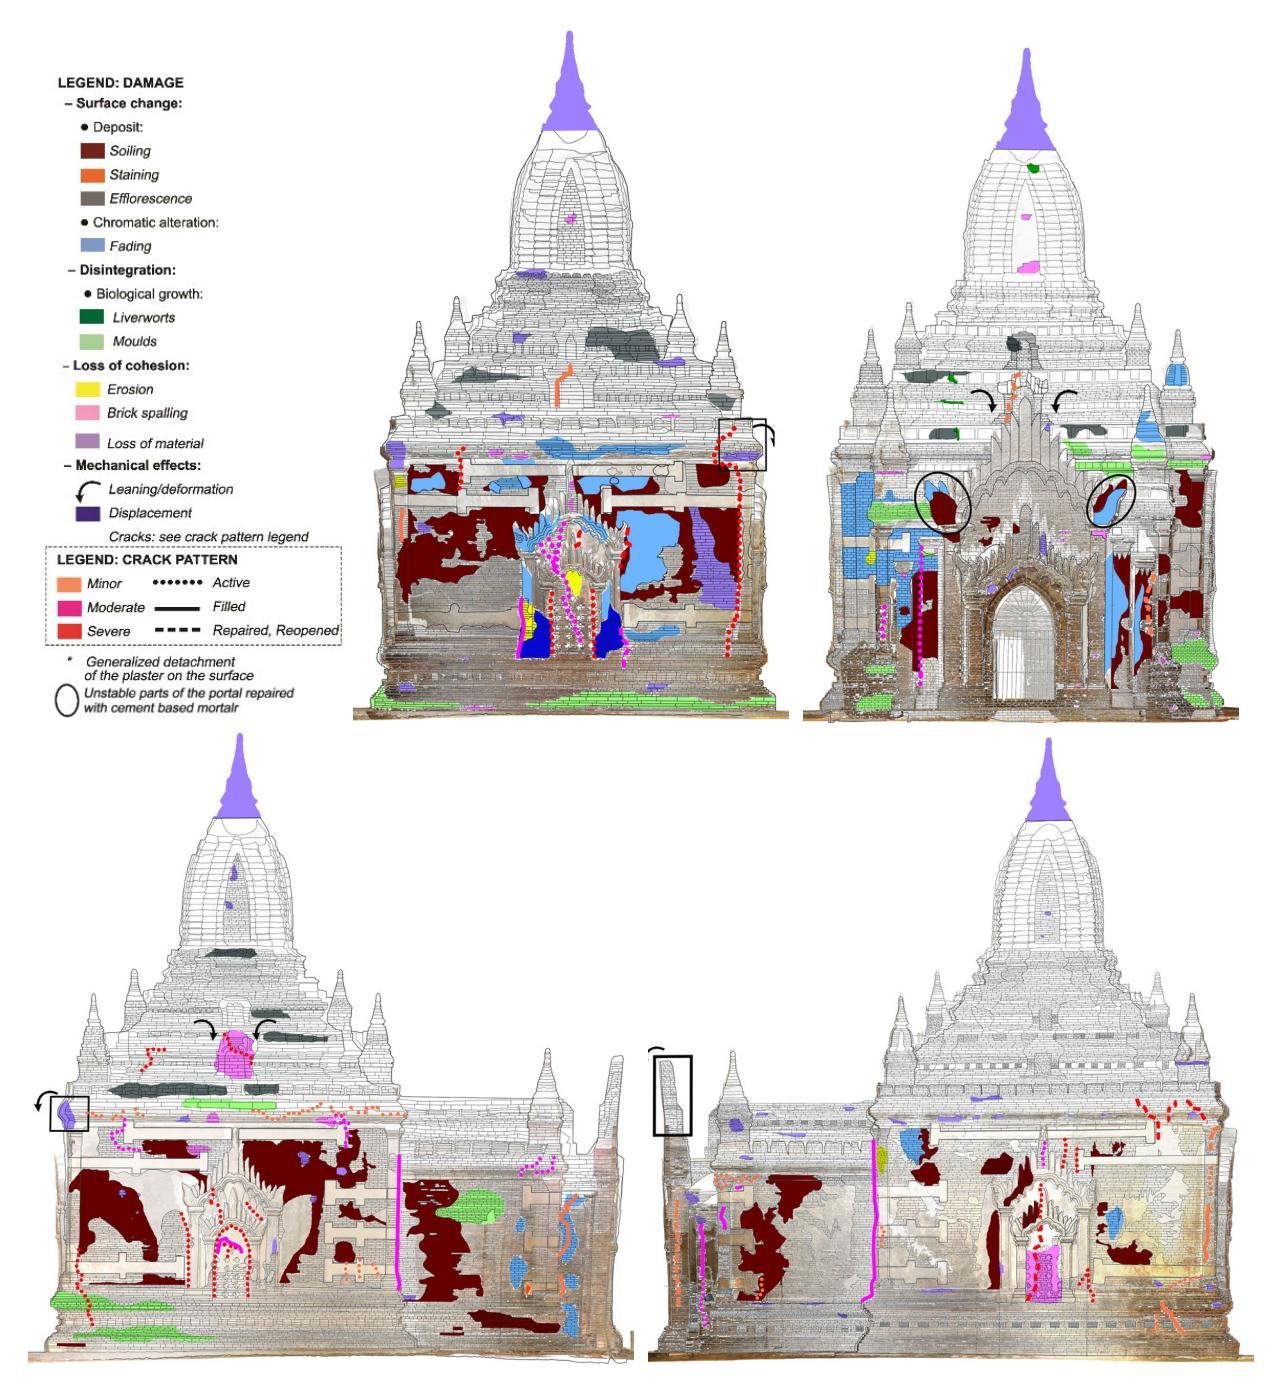
Figure 8: Deterioration mapping on the building elevations superimposed on the coloured point clouds from the 2018 survey.

the masonry walls. The results of sonic tests allowed to estimate that the average Young's modulus of the masonry walls of the temple is equal 0.46 GPa, in which the highest value is 1.1 GPa (recent masonry with cement based mortar) and the lowest value is 0.25 GPa (deteriorated original masonry). The lowest value, corresponding to the most damaged part of the structure detected by the damage survey (Figure 8), has been discarded.

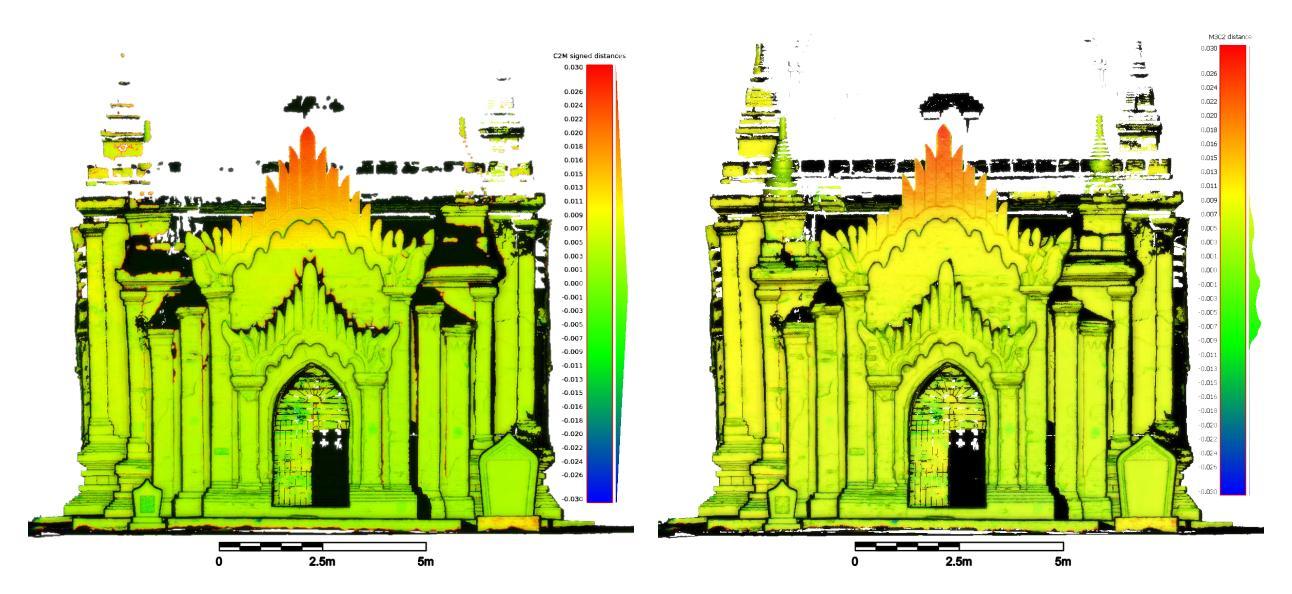
Figure 9: C2M (left) and M3C2 (right) exteriors comparisons, front view. Scale bar spans from -30 to +30 mm. On its right the distribution of the sample. Significant changes correspond to a forward movement of the upper part of the tympanum.

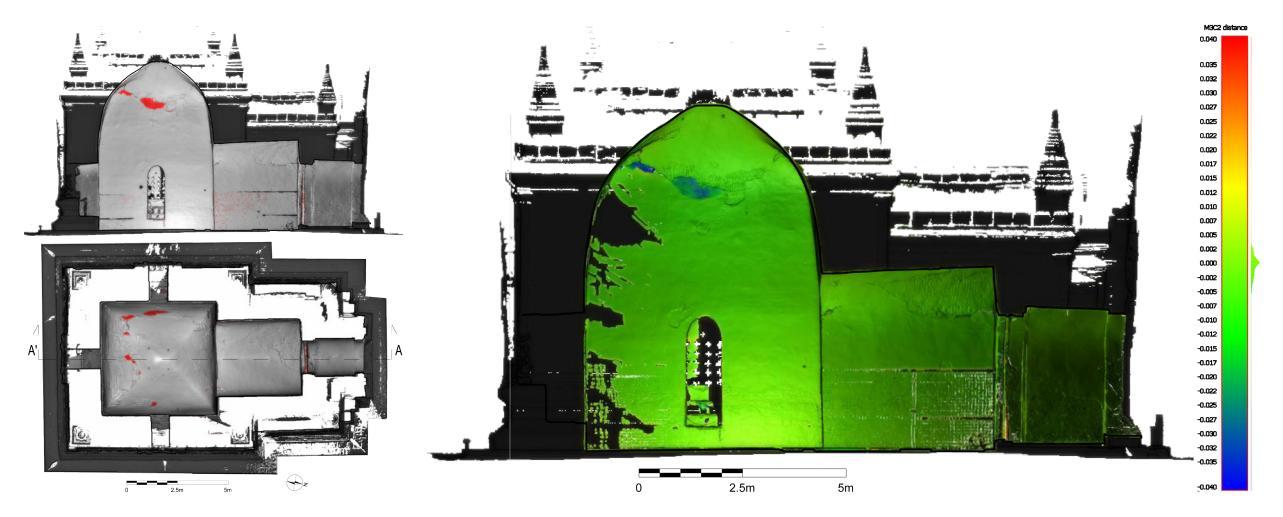
Figure 10: M3C2 interiors comparison, vertical section. Scale bar spans from -40 to +40 mm, on its right the distribution of the sample. Changes bigger than uncertainties are highlighted in red and correspond to plaster detachments in the main chamber vault. Outliers are visible in the lower portion of the antechamber (due to the barriers) and the door between the entrance and the antechamber.

Figure 10 shows a map of the deformations oc-

$_{513}$ curred in the interiors measured with the M3C2 $_{553}$ $_{514}$ method. Here the main deformations are in the $_{554}$ main room, where small portions of the wall coating, up to $4 \, cm$ thickness, detached after 2016. In figure 9 results of the exteriors comparison on the front façade performed with both the methods (C2M and M3C2) are shown. In the exteriors the main significant changes occurred in the upper par of the tympanum which tilted forward after the 2016 earthquake. At the top of the tympanum the measured displacement along the perpendicular direction was of thereabout $3 \, cm$.
