Roughness and SEM Analysis of Manual and Ultrasonic Instrumentation over Different Crown Materials for Dental Implants Restorations

Abstract: The use of new prosthetic materials makes it necessary to establish adequate hygienic protocols. It was decided to make prosthetic crowns from four different materials: composite, lithium disilicate, metal ceramic, and zirconium, and to evaluate the effects on the surfaces of four different instruments through SEM and roughness analysis: manual steel curette, manual titanium curette, ultrasonic steel insert, and ultrasonic peek insert. Forty crowns were made, ten of each type of material. For each material, five crowns were manually instrumented with steel inserts (curette 11-12, PDT, Missoula, USA) and titanium (Wingrove 3-4, PDT, Missoula, USA) on the lingual and buccal surfaces, respectively, and the other five crowns were instrumented with an ultrasonic peek insert (ICS-IC1, Mectron, Carasco, Italy) on the buccal surface and steel (PS, EMS, Nyon, Switzerland) on the lingual surface. At this point, surface roughness analysis was carried out. The data were analyzed with a Kolmogorov-Smirnov test. Therefore, it was decided to conduct two an

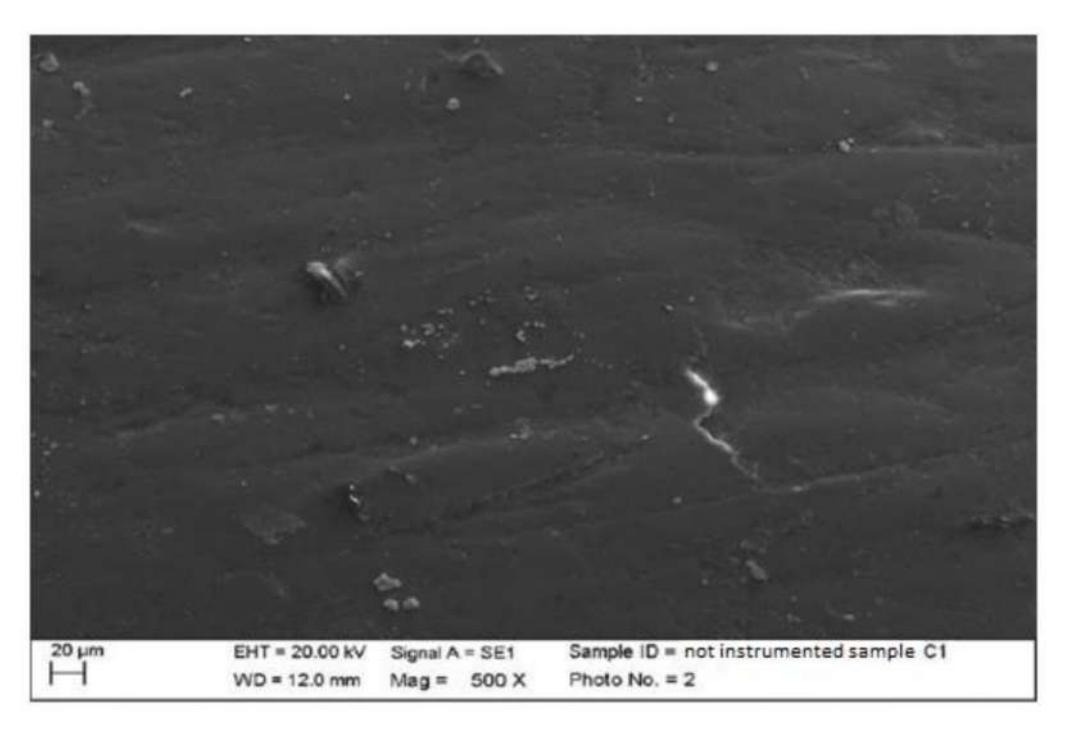
Figure 1. Non-instrumented composite sample C1 ($500 \times$).

There were processing residues on the composite, but to a lesser extent than on the ceramic, as can be seen in the following images. Some streaks and concavities with clear edges that represent the irregularity of the surface of the prosthetic element were clearly visible in the highest magnifications ($500 \times$, $2000 \times$) (Figure 1). In the second sample, it is possible to notice at the $500 \times$ magnification the presence of slight surface incisions caused by the tools used for the final polishing of the composite element (Figure 2).

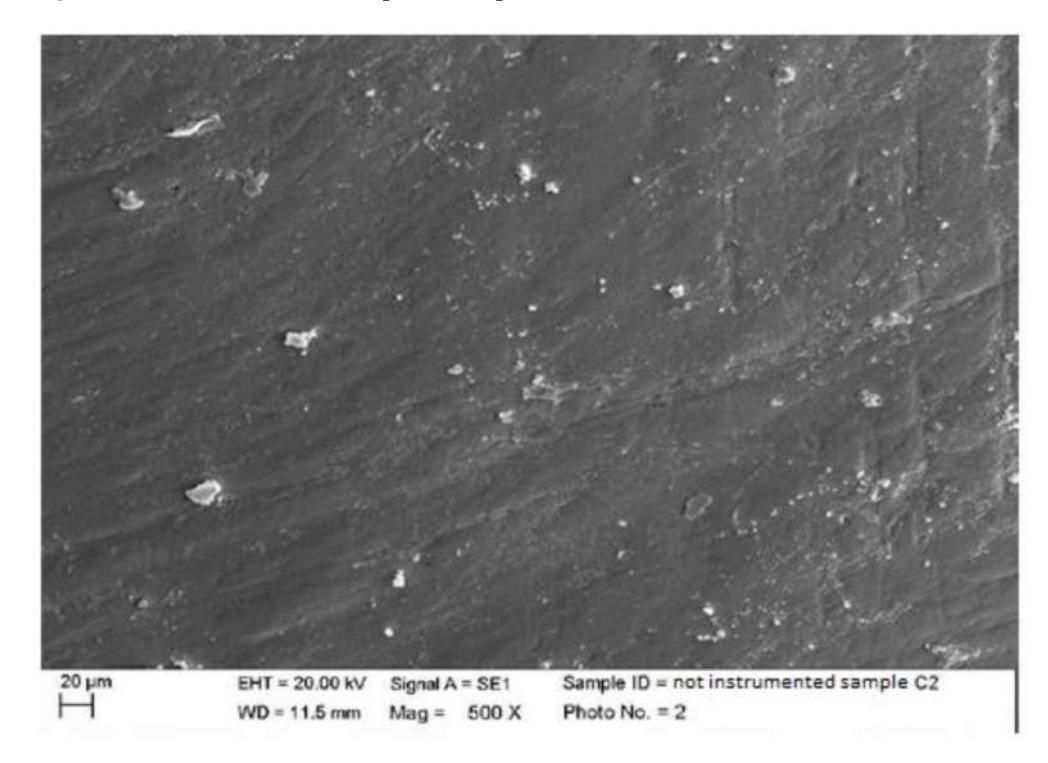
Figure 2. Non-instrumented composite sample C2 (500×).

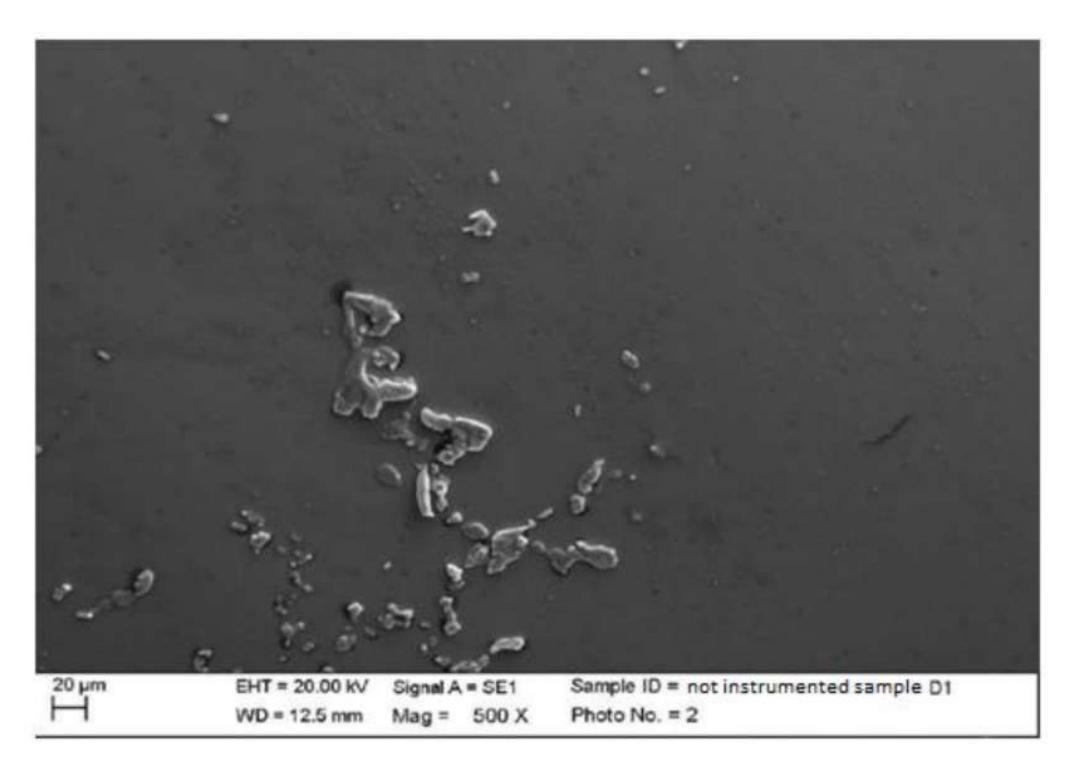
Figure 3. Non-instrumented disilicate sample D1 ($500 \times$).

The surface of the lithium disilicate had a very smooth appearance. Processing residues, especially subsurface, were present, but in smaller quantities than the other materials; however, the dimensions of the individual particles were larger (Figure 3).

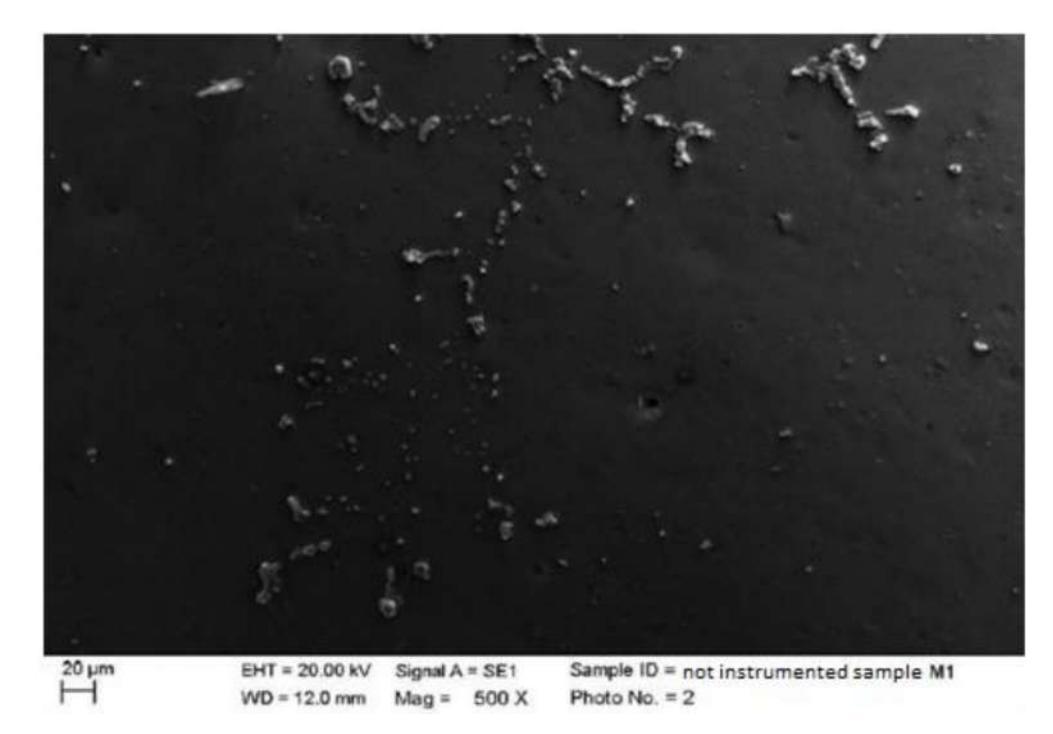
Figure 4. Non-instrumented ceramic sample M1 (500×).

As for the elements made of ceramic material with a metal substructure, we could see, in an increasingly defined manner as the magnification increased ($500 \times$), residues from the processing of the material itself. In particular, the residues incorporated within the structure of the material were visible to the maximum degree ($2000 \times$) as if they were covered by a thin film. There were also small depressions, which confirmed that the ceramic material was a hard but, at the same time, fragile material (Figure 4).

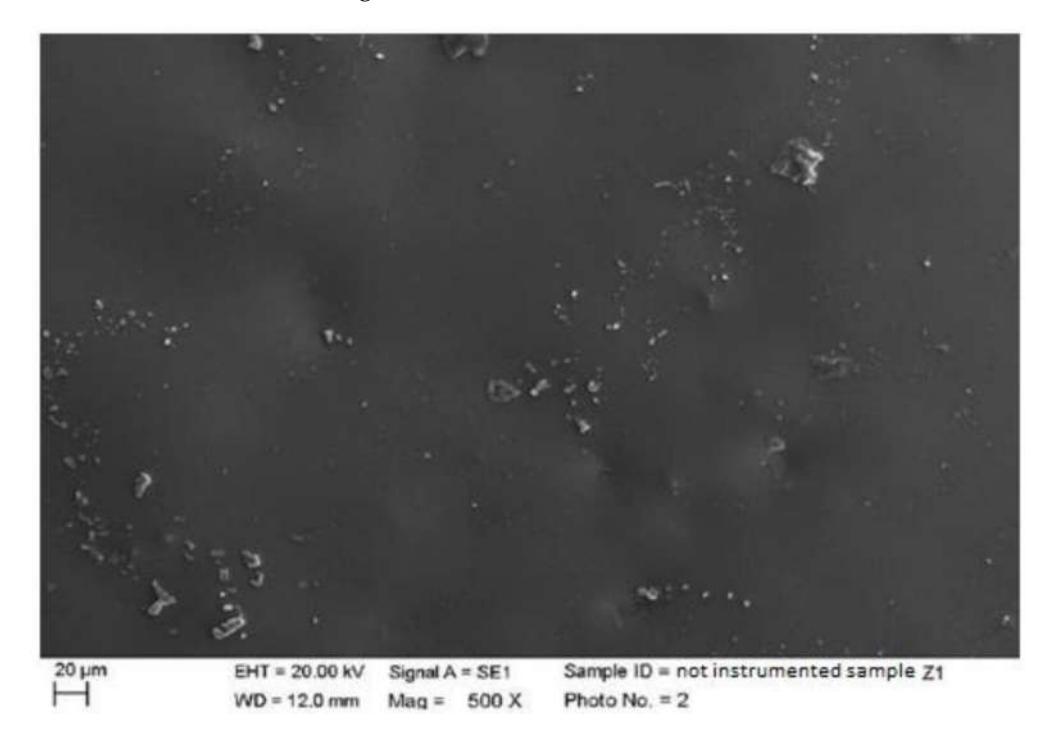
Figure 5. Non-instrumented zirconium sample Z1 (500×).

Zirconium, similar to lithium disilicate, had a surface with few processing residues of rather large dimensions. Similar to ceramic, on the other hand, it had a fracture area with clear edges caused by the finishing process of the element and determined by the greater hardness of this material (Figure 5).

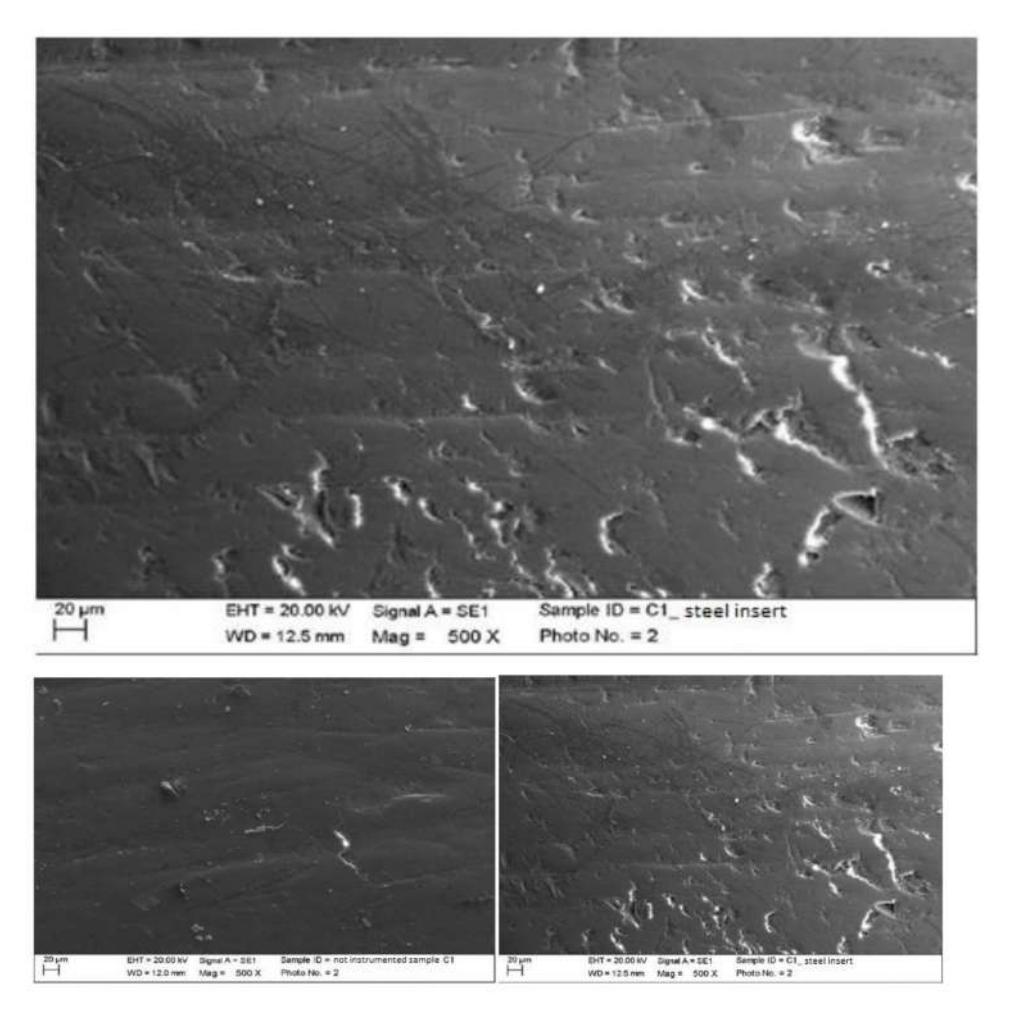
Figure 6. Instrumented composite sample C1 with steel insert ($500 \times$). Comparison before/after instrumentation.

Instrumented composite with steel insert (PS, EMS, Nyon, Switzerland) mounted on Mini Piezon ultrasonic motor (EMS, Nyon, Switzerland).

The classic insert created light linear scratches on the surface without leaving accumulations of steel. The other irregularities were not due to the instrumentation, but to the finishing treatment of the material. Surface processing residues were removed from the treatment (Figure 6).

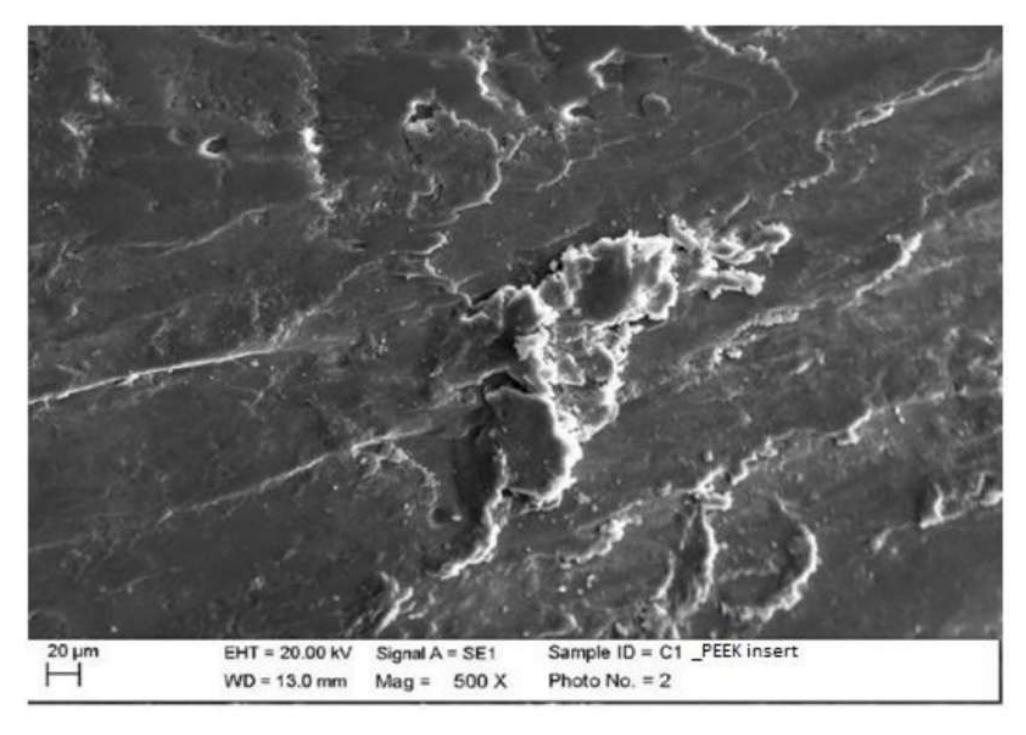
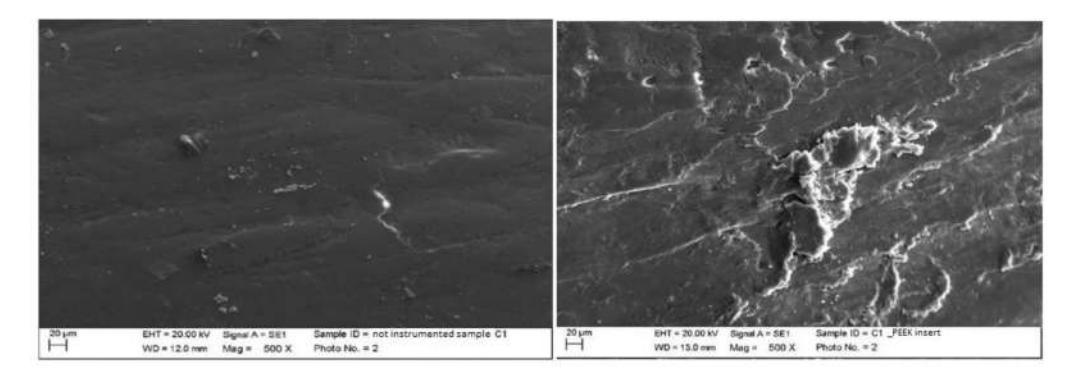
Figure 7. Instrumented composite sample C1 with peek insert ($500 \times$). Comparison before/after instrumentation.

Instrumented composite with peek insert (ICS-IC1, Mectron, Carasco, Italy) mounted on MultiPiezo ultrasonic motor (Mectron, Carasco, Italy).

The peek on the composite material created important alterations by partially removing processing residues. The smaller residues were completely removed, but some surface irregularities remained. However, with the simple surface analysis, we could not define whether the alterations were due to etching or the deposition of the instrumentation material (Figure 7).

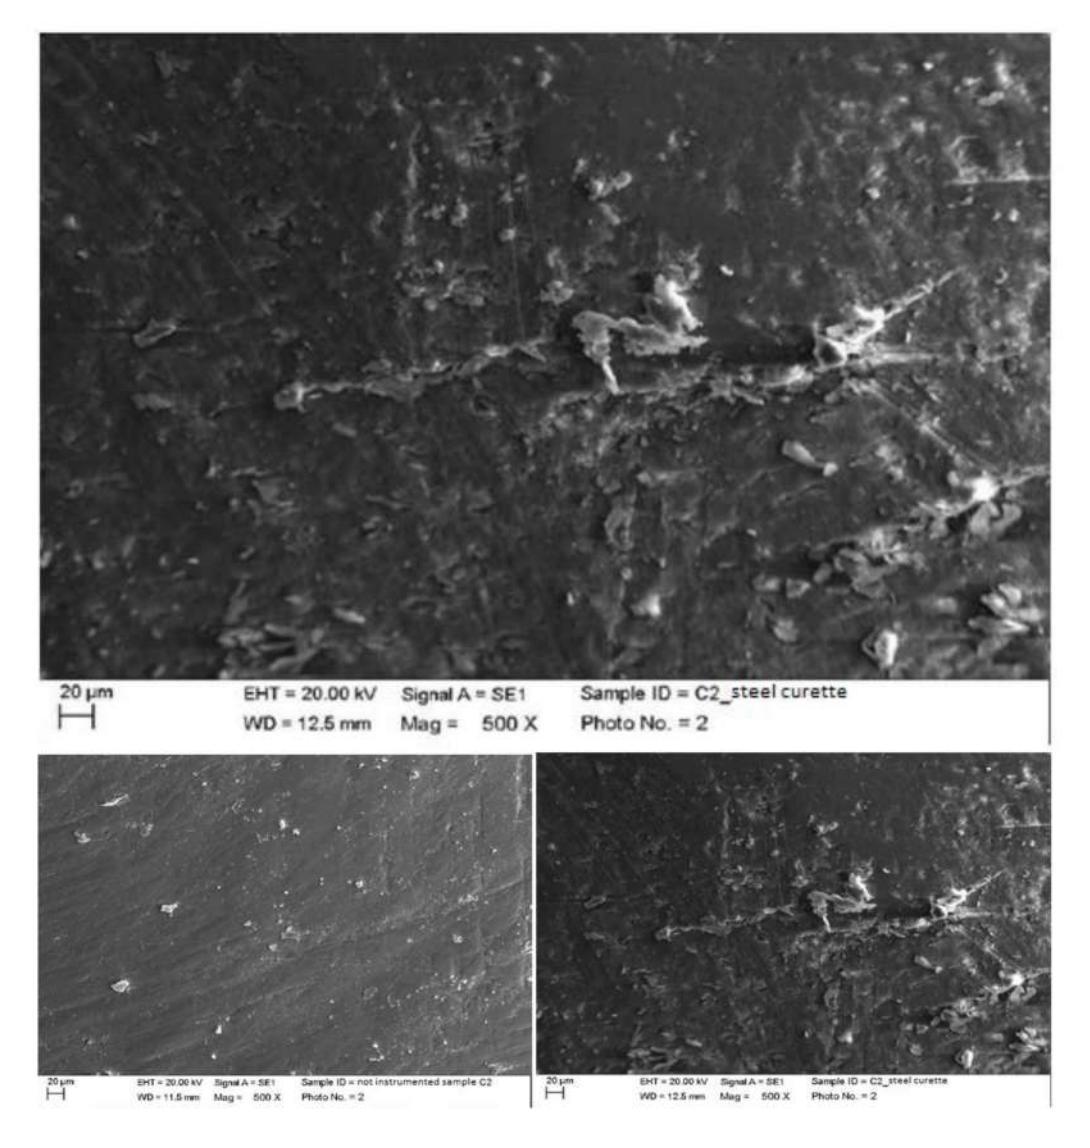
Figure 8. Instrumented composite sample C2 with steel curette ($500 \times$). Comparison before/after instrumentation.

Instrumented composite with steel curette (PDT, Missoula, MT, USA).

The classic curette did not create important alterations to the surface of the material; it removed some residues, but left others (Figure 8).

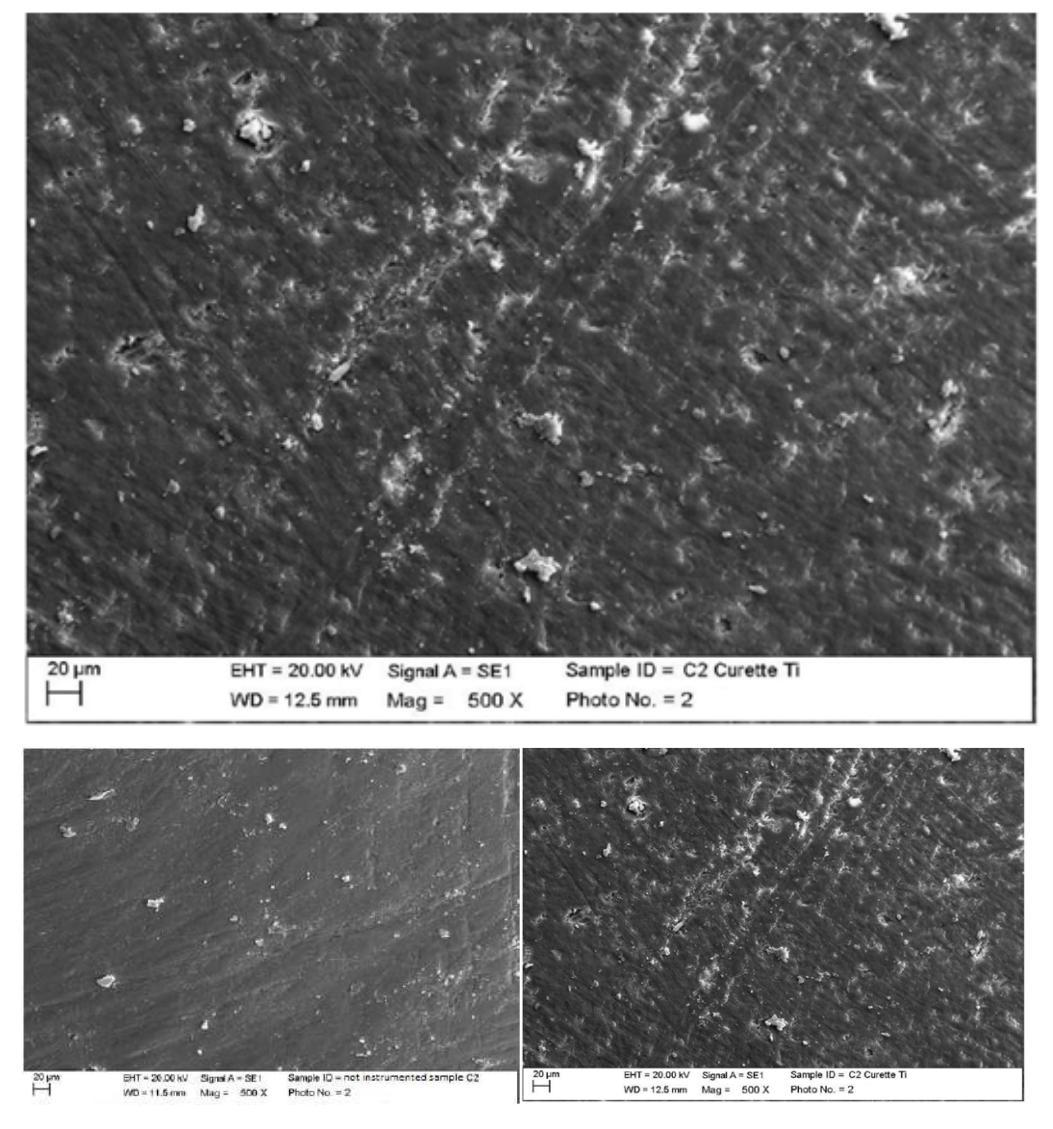
Figure 9. Instrumented composite sample C2 with titanium curette ($500 \times$). Comparison before/after instrumentation.

Instrumented composite with titanium curette (Wingrove 3-4, PDT, Missoula, MT, USA). The titanium curette created deeper incisions than the classic curette, completely removing finishing residues (Figure 9).

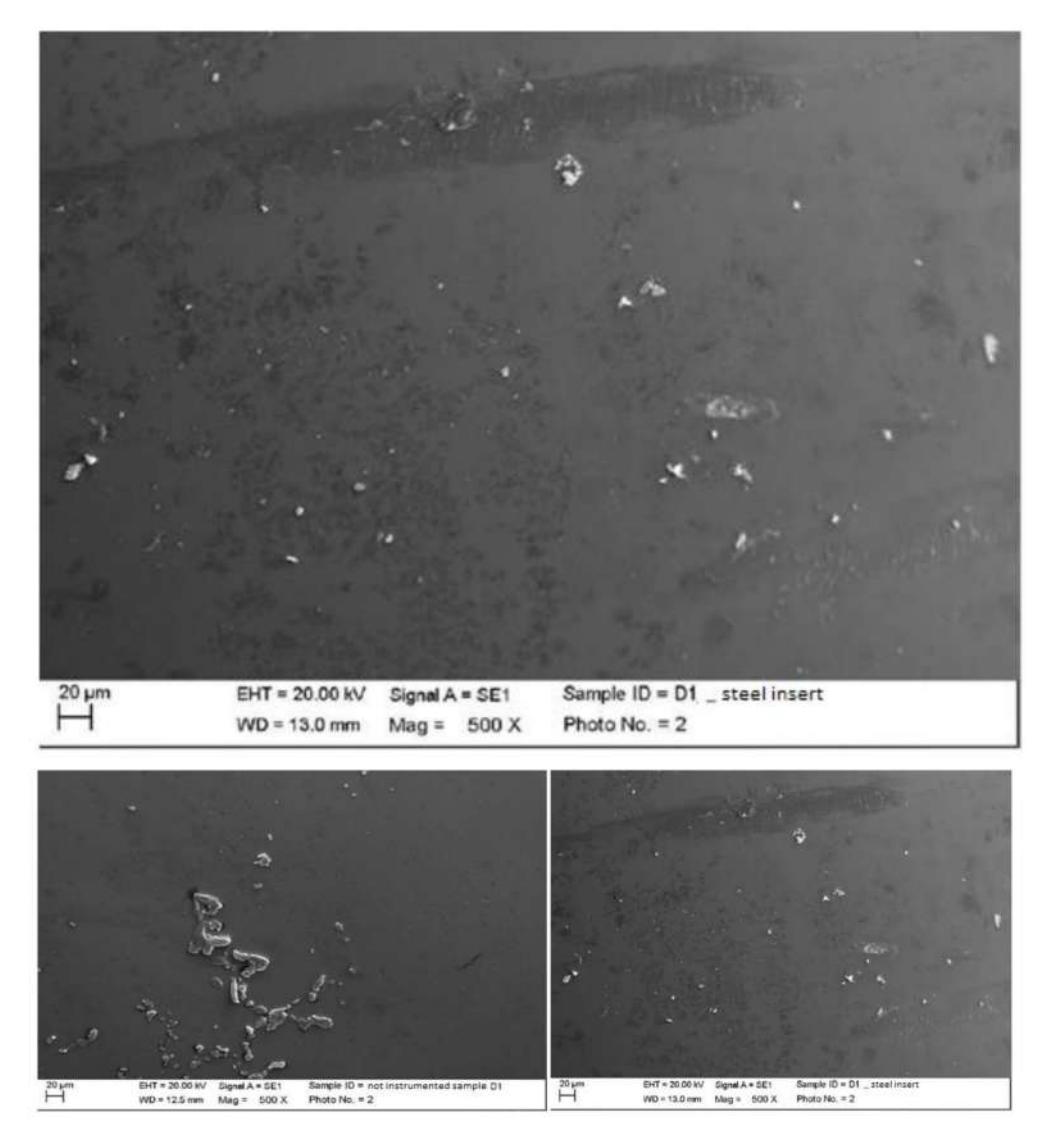
Figure 10. Instrumented disilicate sample D1 with steel insert ($500 \times$). Comparison before/after instrumentation.

Instrumented disilicate with classic steel insert (PS, EMS, Nyon, Switzerland) mounted on Mini Piezon ultrasonic motor (EMS, Nyon, Switzerland).

The classic insert did not particularly alter the disilicate, also leaving processing residues, which was probably due to the fact that the residues themselves were larger than the other materials. There were slight scratches on the surface visible only at large magnifications (Figure 10).

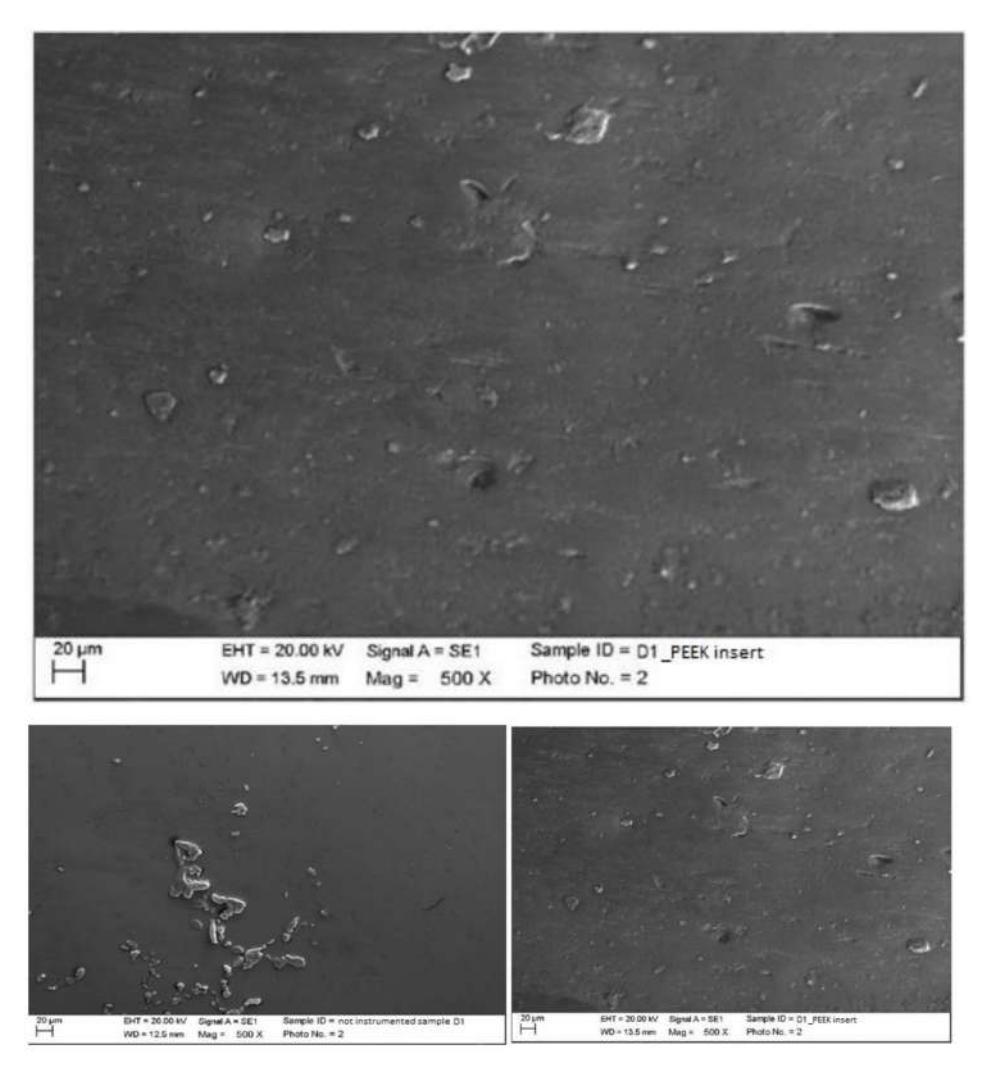
Figure 11. Instrumented disilicate sample D1 with peek insert ($500 \times$). Comparison before/after instrumentation.

The peek created major alterations on the surface of the lithium disilicate. In fact, the dendritic formations (or primary crystals) representing the origin of the material were clearly visible, exposed precisely following the instrumentation of the surface itself. However, it was not possible with surface analysis to establish whether the formations were abraded disilicate or residual peek; to verify this, chemical–physical analysis of the surface should be carried out. A photo was taken at 3800 magnification, where it is possible to see in detail the areas from which the crystals were formed (Figure 11).

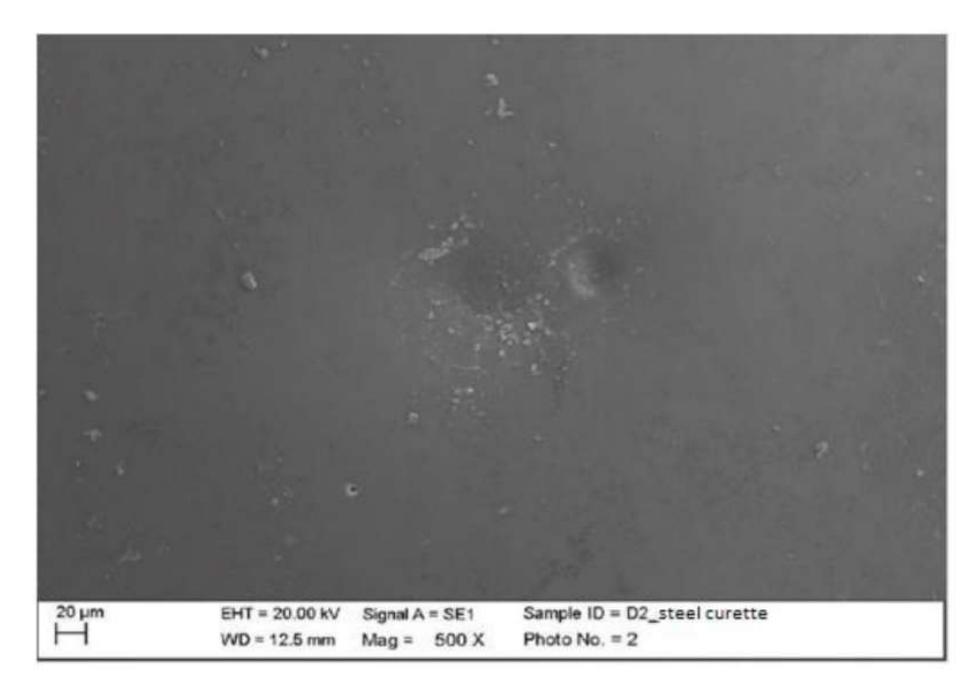
Figure 12. Instrumented disilicate sample D2 with steel curette ($500 \times$).

Instrumented disilicate with steel curette (PDT, Missoula, MT, USA).

The classic curette created almost no effect on the disilicate, other than the slight accumulation of the instrumentation materials (Figure 12).

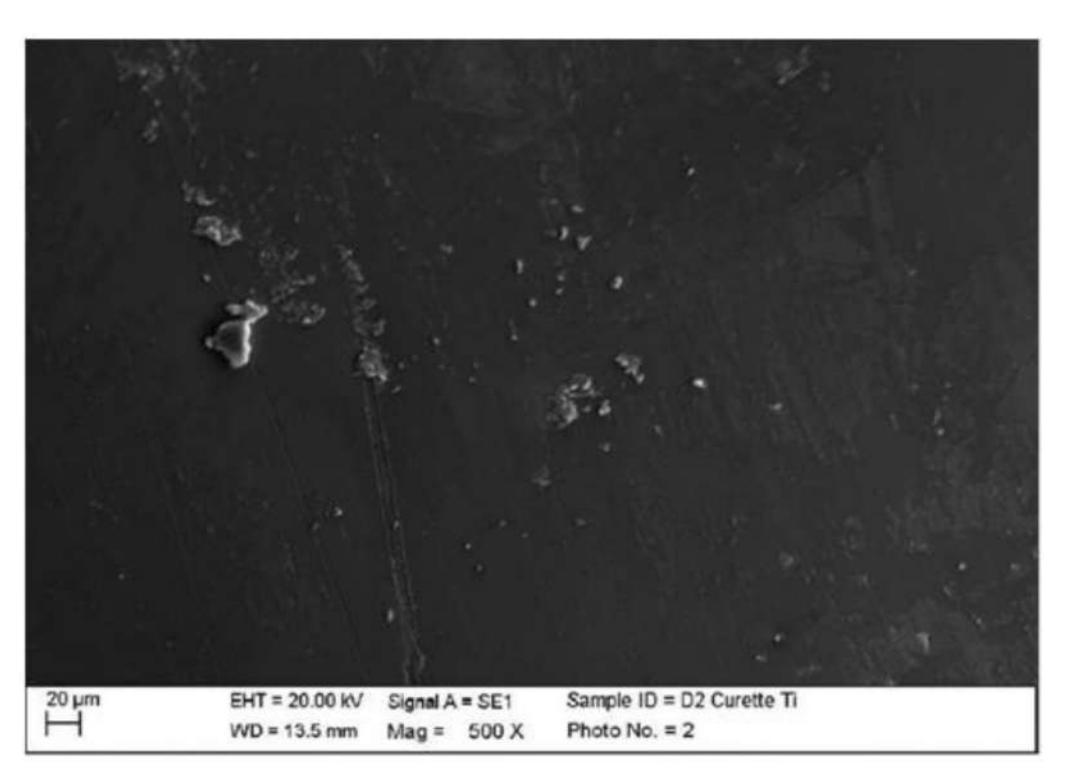
Figure 13. Instrumented disilicate sample D2 with titanium curette (500×).

Instrumented disilicate with titanium curette (Wingrove 3-4, PDT, Missoula, MT, USA). The titanium curette created important and deep surface incisions while leaving instrumentation residues embedded within the grooves, which could be partly titanium pieces and partly pieces of silicone residues (Figure 13).

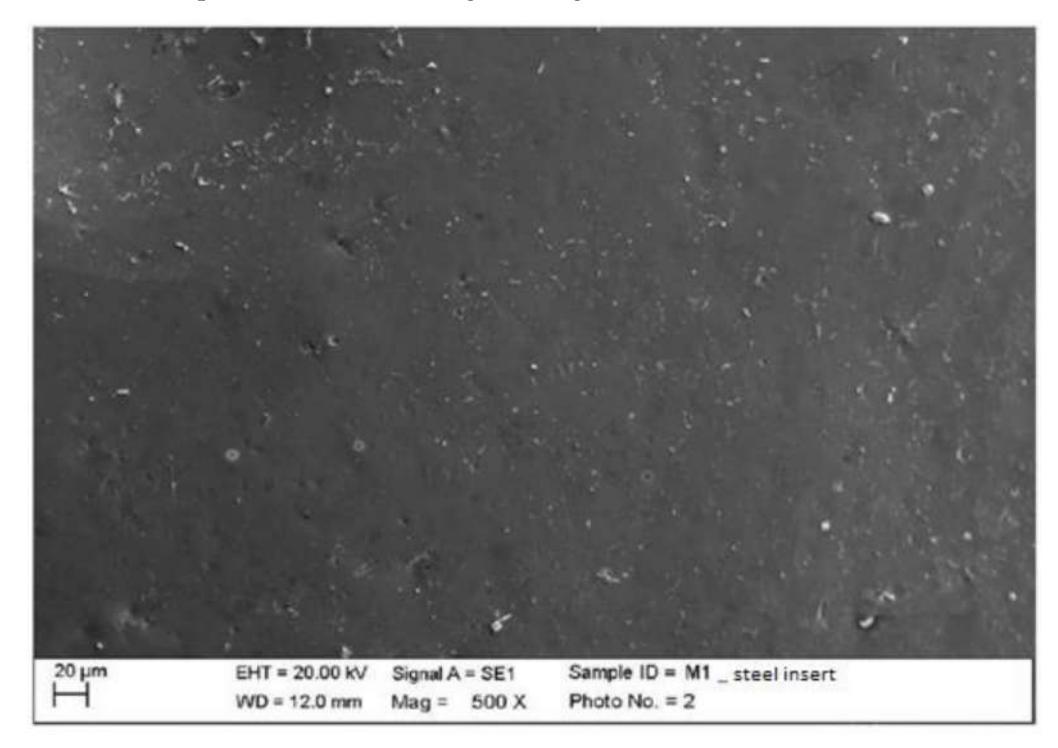
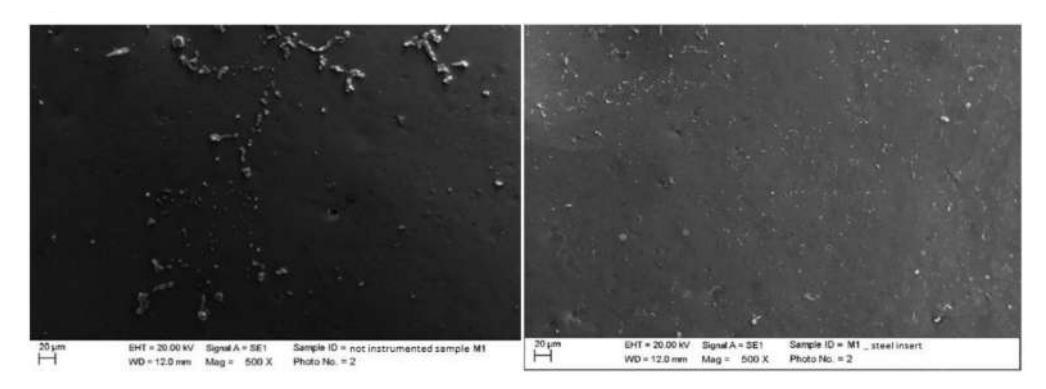
Figure 14. Instrumented ceramic sample M1 with steel insert ($500 \times$). Comparison before/after instrumentation.

Instrumented ceramic with steel insert (PS, EMS, Nyon, Switzerland) mounted on Mini Piezon ultrasonic motor (EMS, Nyon, Switzerland).

The classic insert eliminated finishing residues by replacing them with other instrumentation residues. The elimination of residues was clearly visible at the higher magnification, which was comparable to a thin flaking film (Figure 14).

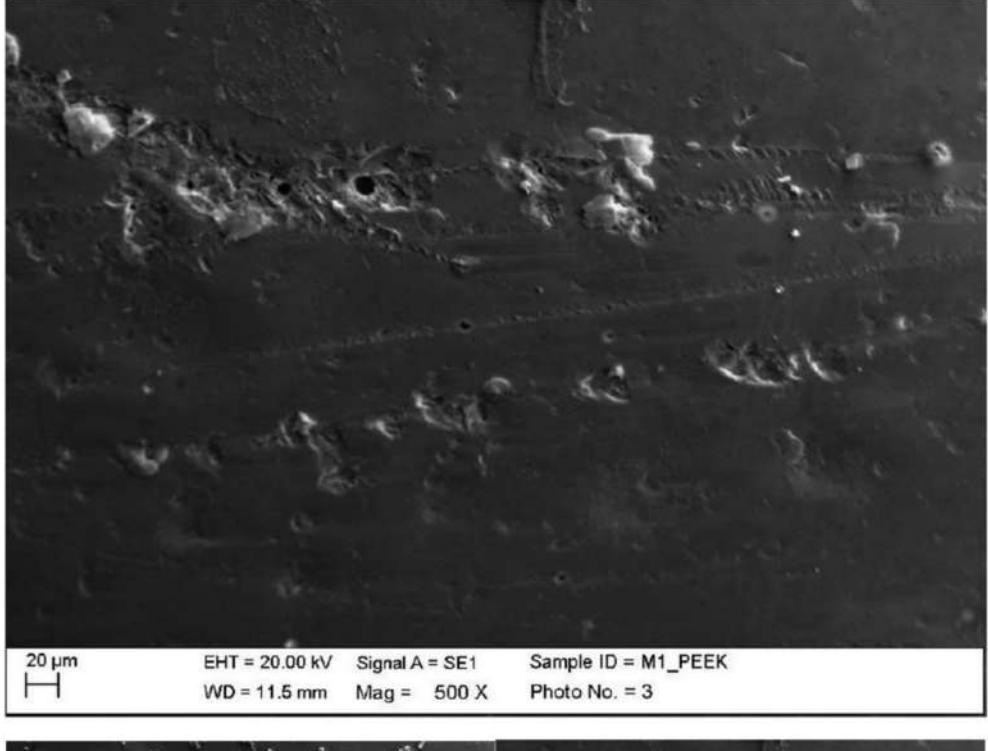
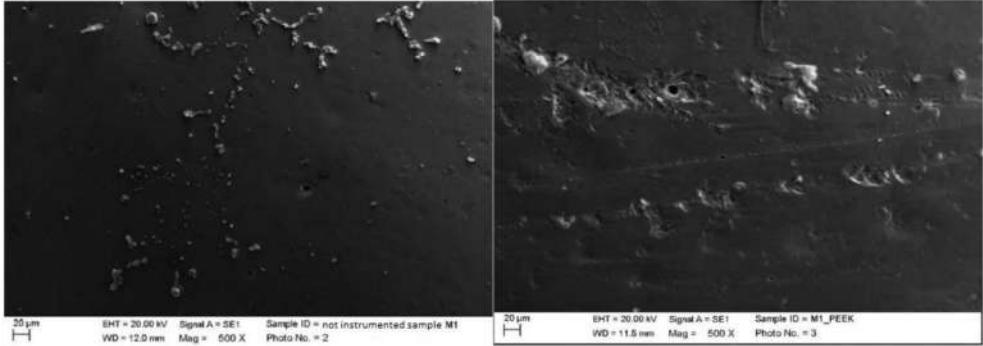
Figure 15. Instrumented ceramic sample M1 with peek insert ($500 \times$). Comparison before/after instrumentation.

Instrumented ceramic with peek insert (ICS-IC1, Mectron, Carasco, Italy) mounted on ultrasonic motor, MultiPiezo (Mectron, Carasco, Italy).

The peek on the ceramic created horizontal and vertical alterations, but it was again not possible to establish the origin of these changes (Figure 15).

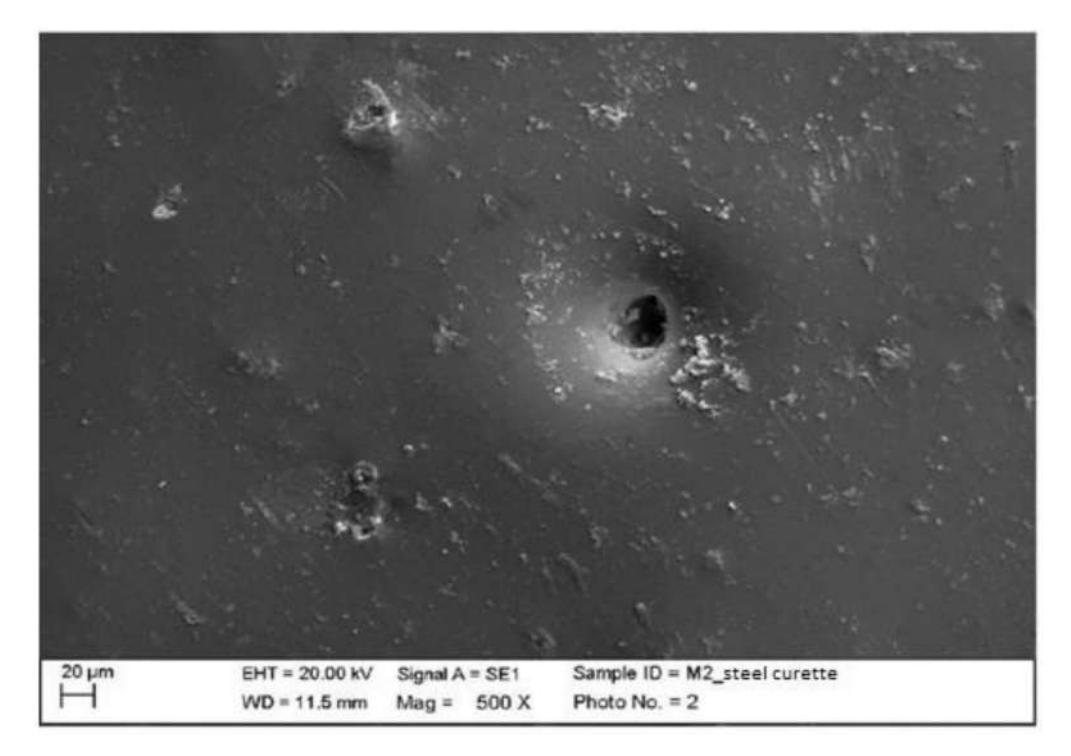
Figure 16. Instrumented ceramic sample M2 with steel curette $(500 \times)$.

Instrumented ceramic with steel curette (PDT, Missoula, MT, USA).

The classic curette, being ceramic, a very hard material, hardly created any negative effects on the surface. The crater visible in photo X was due to the ceramic material itself, which was hard and brittle, but was not related to manual instrumentation (Figure 16).

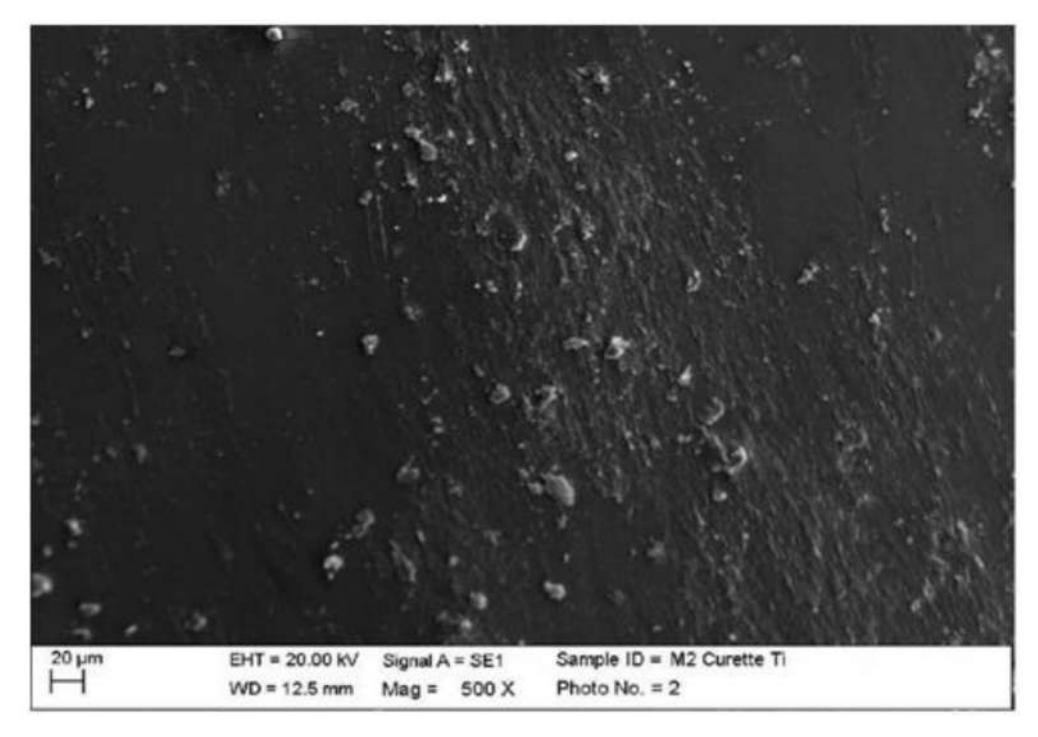
Figure 17. Instrumented ceramic sample M2 with titanium curette ($500 \times$).

Instrumented ceramic with titanium curette (Wingrove 3-4, PDT, Missoula, MT, USA). The titanium curette did not create particular damage but left numerous large residues, both ceramic and titanium (Figure 17).

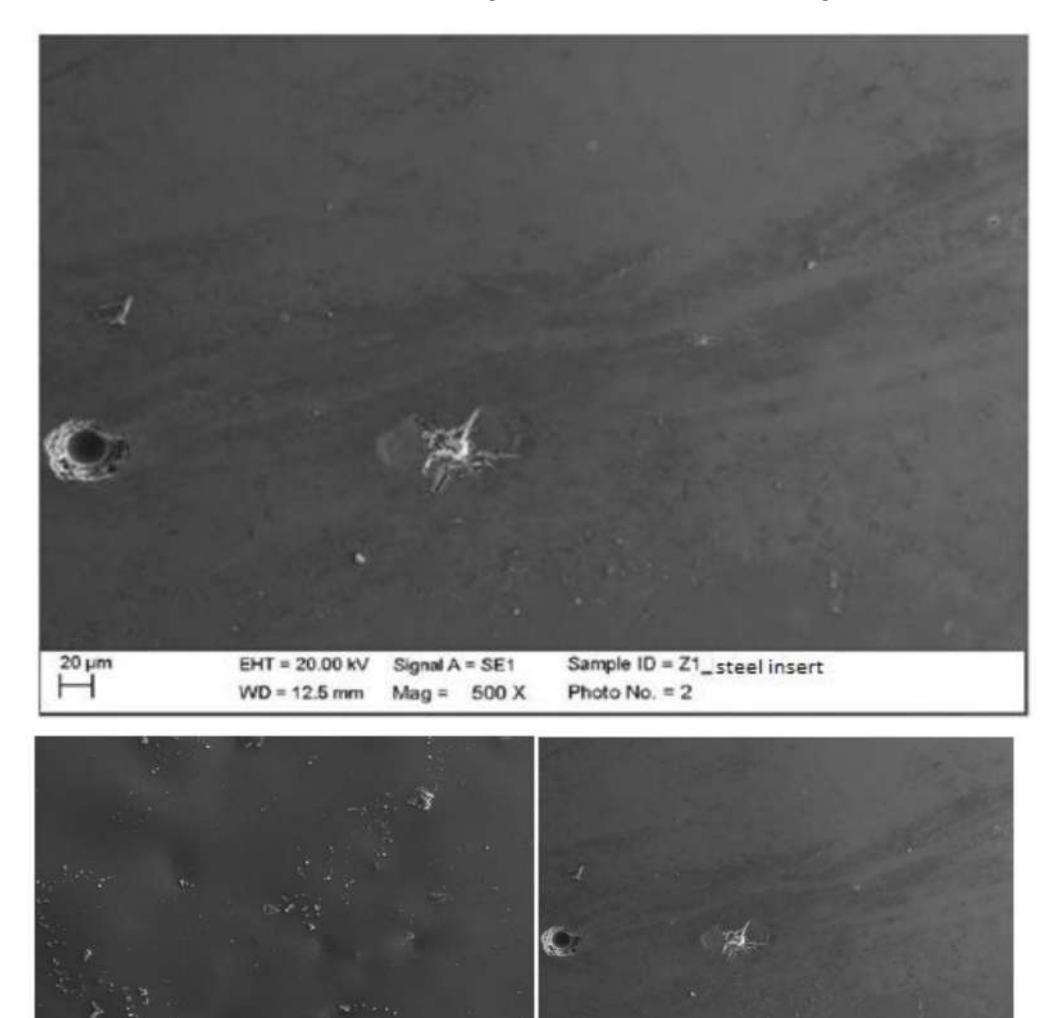
Figure 18. Instrumented zirconium sample Z1 with steel insert ($500 \times$). Comparison before/after instrumentation.

Instrumented zirconium with steel insert (PS, EMS, Nyon, Switzerland) mounted on Mini Piezon ultrasonic motor (EMS, Nyon, Switzerland).

The classic insert created a large fracture, clearly visible at 2000 magnification, in an area that was previously irregular. The crater visible in image 5.42 was not due to the instrumentation, but, as seen previously in the ceramic, to the hardness/fragility of the material (material defect). The trimming residues were removed (Figure 18).

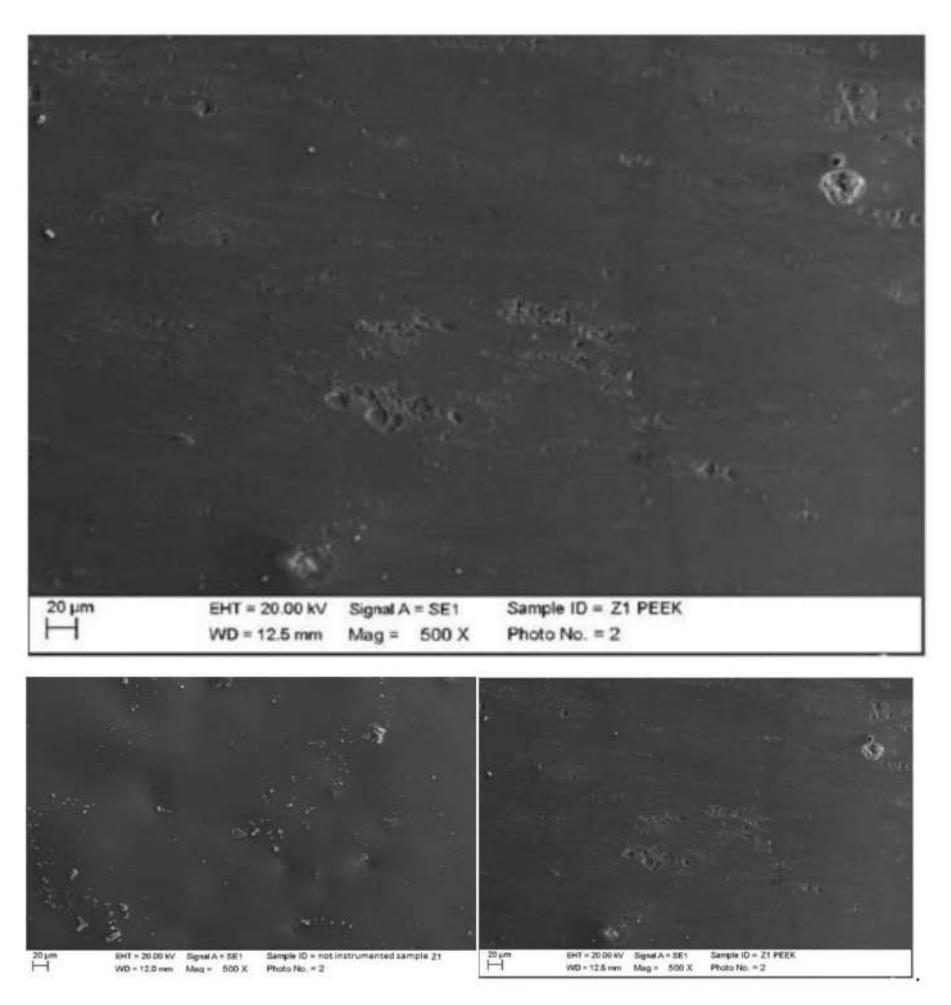
Figure 19. Instrumented zirconium sample Z1 with peek insert ($500 \times$). Comparison before/after instrumentation.

Instrumented zirconium with peek insert (ICS-IC1, Mectron, Carasco, Italy) mounted on ultrasonic motor, MultiPiezo (Mectron, Carasco, Italy).

The peek created alterations on the zirconium; however, it was not possible to establish the cause. The instrumentation areas were clearly visible (Figure 19).

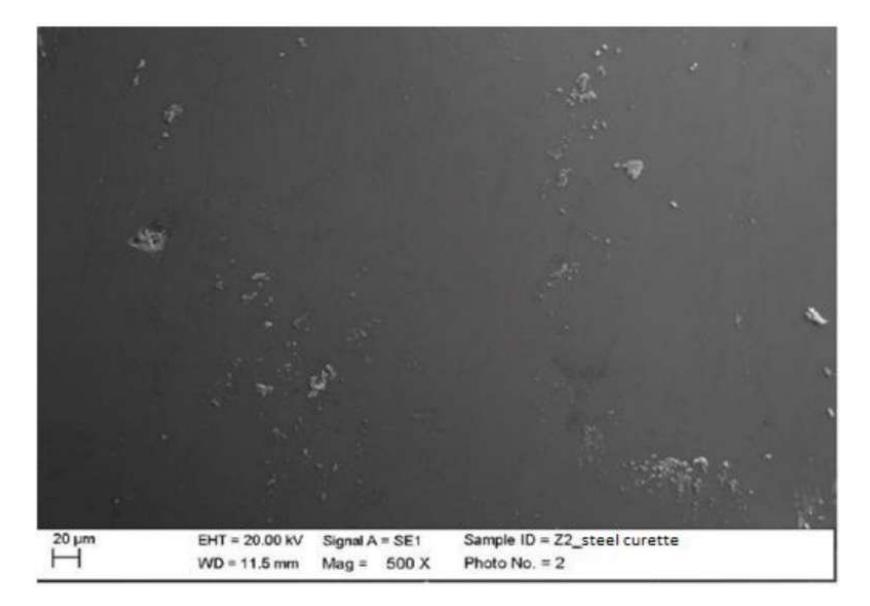
Figure 20. Instrumented zirconium sample Z2 with steel curette ($500 \times$).

Instrumented zirconium with steel curette (PDT, Missoula, MT, USA).

At maximum magnification, incisions and surface residues were visible on the zirconium part treated with a steel curette (Figure 20).

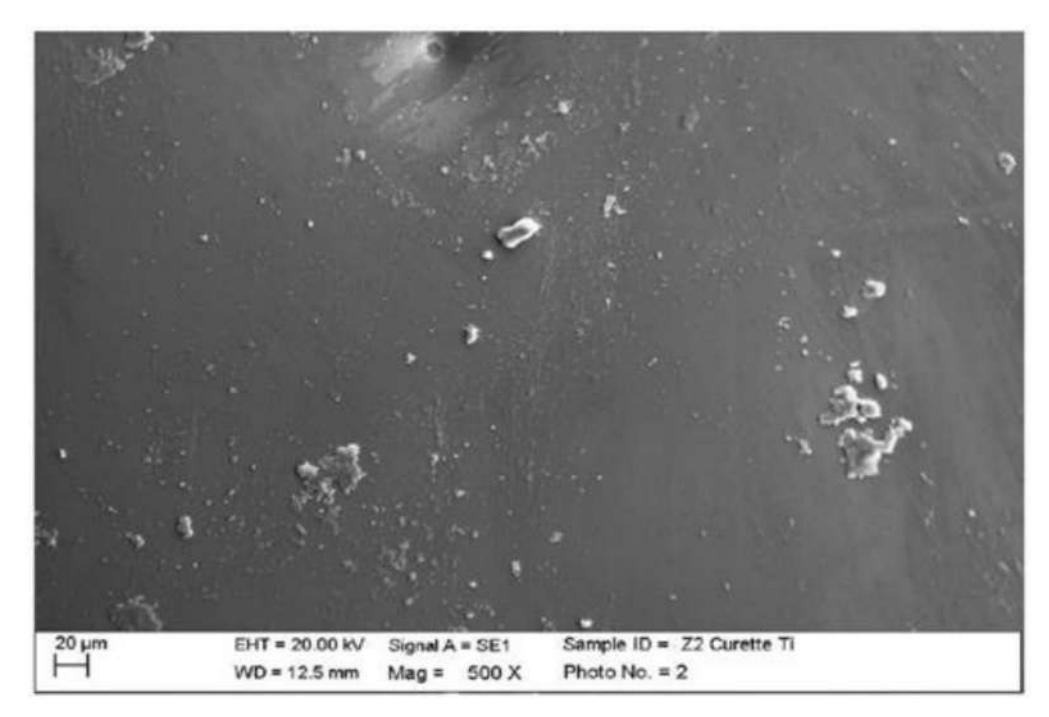
Figure 21. Instrumented zirconium sample Z2 with titanium curette $(500 \times)$.

Instrumented zirconium with titanium curette (Wingrove 3-4, PDT, Missoula, MT, USA). The titanium curette created slight superficial incisions visible at higher magnifications, leaving few processing residues. On the left side of the enlargement, 2000 super-surface residues from finishing were still visible (Figure 21).
