Roughness and SEM Analysis of Manual and Ultrasonic Instrumentation over Different Crown Materials for Dental Implants Restorations

Abstract: The use of new prosthetic materials makes it necessary to establish adequate hygienic protocols. It was decided to make prosthetic crowns from four different materials: composite, lithium disilicate, metal ceramic, and zirconium, and to evaluate the effects on the surfaces of four different instruments through SEM and roughness analysis: manual steel curette, manual titanium curette, ultrasonic steel insert, and ultrasonic peek insert. Forty crowns were made, ten of each type of material. For each material, five crowns were manually instrumented with steel inserts (curette 11-12, PDT, Missoula, USA) and titanium (Wingrove 3-4, PDT, Missoula, USA) on the lingual and buccal surfaces, respectively, and the other five crowns were instrumented with an ultrasonic peek insert (ICS-IC1, Mectron, Carasco, Italy) on the buccal surface and steel (PS, EMS, Nyon, Switzerland) on the lingual surface. At this point, surface roughness analysis was carried out. The data were analyzed with a Kolmogorov-Smirnov test. Therefore, it was decided to conduct two an

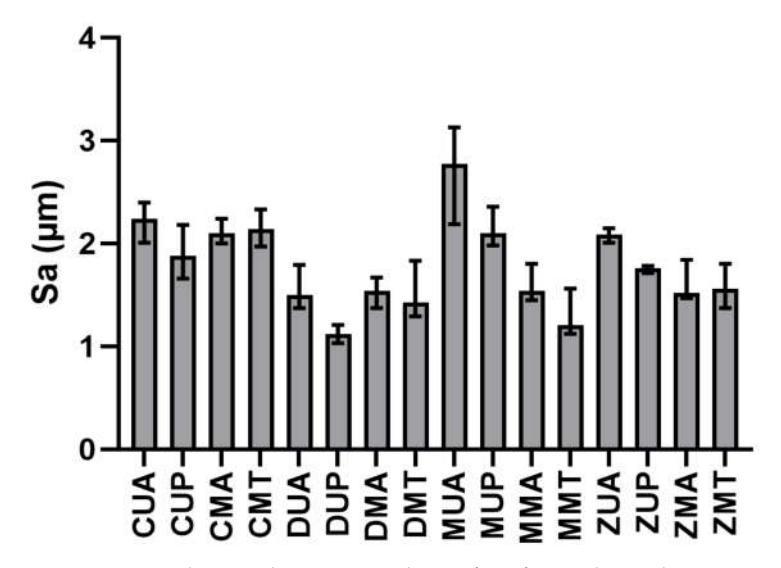
Figure 22. Median and extreme values of Sa for each combination. The material (C: composite, D: lithium disilicate, M: metal ceramic, Z: zirconium ceramic) and instrumentation (UA: ultrasonic-steel, UP: ultrasonic-peek, MA: manual-steel, MT: manual-titanium) are indicated along the abscissa axis.

Two Kruskal -Wallis tests were performed in the statistical analysis of the roughness values. In both cases, the 80 tests (five measurements × four materials × four instruments) were divided into four groups: composite, lithium disilicate, metal ceramic, and zirconium ceramic for material analysis, and ultrasonic-steel, ultrasonic-peek, manual-steel, and manual-titanium for instrumentation analysis. The null hypothesis, i.e., that all groups of samples came from the same distribution, was rejected in both tests, confirming the significance of the influence of both the material and the instrumentation (p < 0.05). The bar diagrams representing the median, maximum, and minimum values of Sa for each combination of material and instrumentation are shown in Figure 22, the legend of which is shown in Table 1.

The Kruskal-Wallis test confirmed that not all groups were from the same population, but did not provide information about which groups differed from each other. To determine between which materials and equipment there was a significant difference, a Bonferroni post hoc test was performed (Tables 2 and 3). *p*-values less than 0.05 corresponded to pairs of materials and instruments that had a significant difference.
