Behavior of a simple beam grillage structure on damaged supports

Behavior of a simple beam grillage structure on damaged supports --Manuscript Draft--

Valerio De Biagi^{1*}

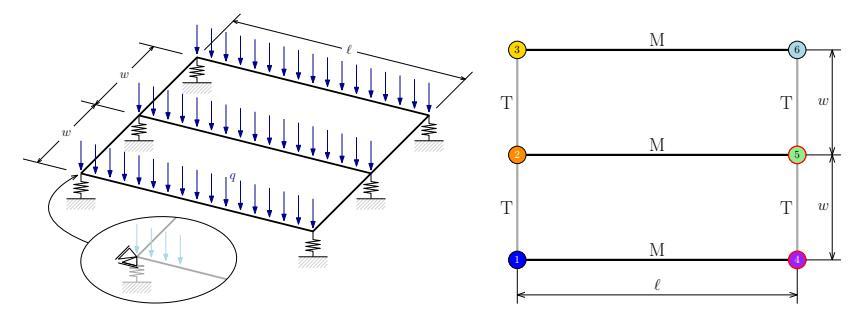
- main beams, only. The system is supported on vertical springs, to simulate the axial stiffness of the ground (if the grillage is part of a foundation system) or
- ⁹⁰ of a substructure (to simulate supported floors and bridge decks). The system is horizontally constrained at each node, as illustrated in the box of Figure 1.

Fig. 1 Sketch of the reference grillage.

- 1. The damage occurs on a corner support. In this case, a non-symmetric damage configuration is studied. Figure 1 depicts, on the right-hand side, a plan view of the grillage. Five nodes, i.e., i = 1/3, 5, 6 are supported by intact springs with stiffness k (i.e., $k_1 = k$ and so forth), while the node 4 is supported by a defective spring with stiffness $k_4 = k/10$. Consequently,

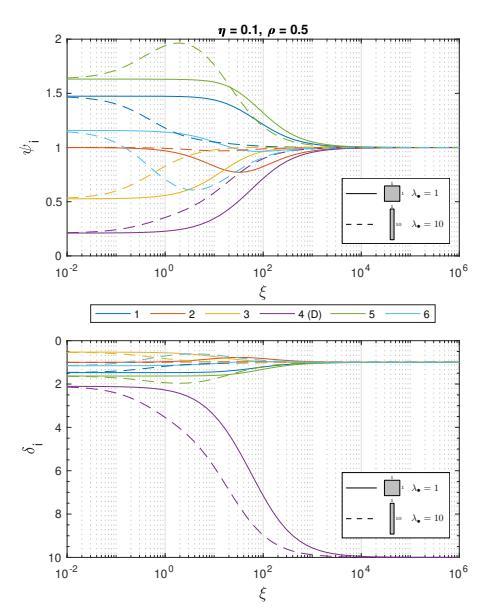
Figure 3.4 shows the values of the normalized reactions and displacements for both square ($\lambda_{\bullet} = 1$, with continuous lines) and rectangular ($\lambda_{\bullet} = 10$, 154 with dashed lines) cross-sections. The non-symmetric damage configuration

accounts for the damage on the corner support (node 4). The results are related to the geometrical configuration with $\eta = 0.1$ and $\rho = 0.5$. It clearly emerges

Fig. 2 Damage on support no.4. Normalized reactions (top) and support displacements (bottom) in a grillage with $\eta = 0.1$ and $\rho = 0.5$ in a range $\xi = [10^{-2}; 10^6]$. Continuous curves relate to a grillage with square ($\lambda_{\bullet} = 1$) elements, while dashed lines to a structure with rectangular ($\lambda_{\bullet} = 10$) elements.

that the value of ξ influences the values of reactions and displacements. In particular, three regimes are individuated. For stiffnesses smaller than a threshold

reactions are similar and close to 1, while all the normalized displacements are unitary, except the one of node 4 with the defective spring for which a value 10 (equal to ξ/ξ_4) is observed. In between, a transition regime between

the two limit situations is observed, with reactions reaching local maxima or minima, clearly evident in the reactions of nodes 5 and 6 of the rectangular

cross-section structure. Similar considerations can be drawn for displacements. ¹⁶⁸ The case proposed in Figure 3.4 is just an example of what it is observed for other η and ρ values.

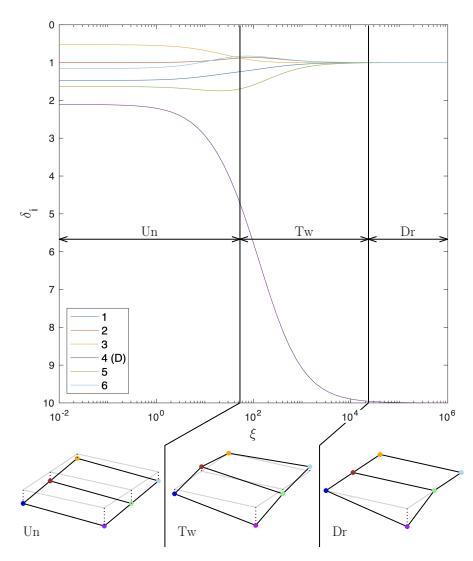
observed. Starting from the right-hand side, i.e., large ξ , a drop-like response (named as Dr) emerges, with node 4 experiencing the largest displacements,

only. The sketch below depicts this structural response which is observed for a large range of ξ -values, for $\xi \geq 2.2 \cdot 10^4$. For smaller ξ -values, a twist-like

Fig. 3 Normalized displacements for a grillage with $\eta = 0.1$, $\rho = 0.5$ and $\lambda_{\bullet} = 1$ (square cross-section). Three displacement regimes are individuated: uniform rotation (Un), twist (Tw) and drop (Dr). Note that y-axis scale is in a reverse order; for the colors of the supports refer to Figure 1.

$_{180}$ behavior (Tw) is observed: the vertical displacement of node 2 is smaller than

the one of node 3, with $\delta_2 < 1$, meaning that, apparently, the node goes up. In an opposite way, the vertical displacement of node 6 is smaller than the one of node 5, with $\delta_6 < 1$. It clearly emerges that a part of the grillage under-

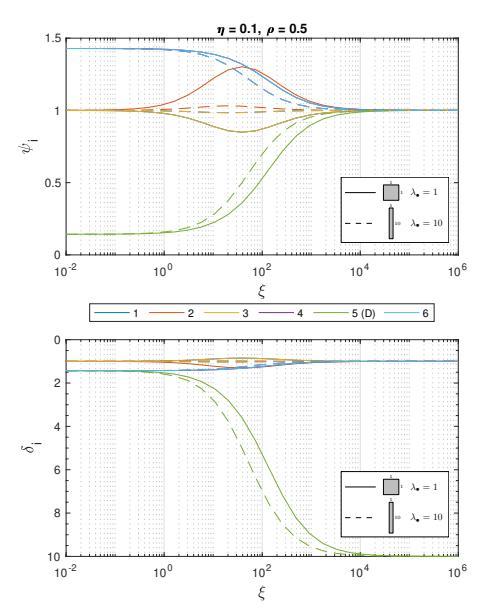
Figure 4 depicts the values of the normalized reactions and displacements for both square ($\lambda_{\bullet} = 1$, with continuous lines) and rectangular ($\lambda_{\bullet} = 10$, with 190 dashed lines) cross-sections. The symmetric damage configuration accounts for the damage on the support of the central node (node 5). The results are 192 related to the geometrical configuration with $\eta = 0.1$ and $\rho = 0.5$. As expected from the previous analysis related to corner damage, the results are affected 194 by the value of ξ . Three regimes can be individuated. For $\xi < 1$, the values of support displacement and reactions are constant and almost independent 196 from ξ . The normalized reactions in nodes 4 and 6 compensate the drop on node 5 drops to roughly $\psi_5 = 0.15$, while the effects on the opposite nodes are 198 completely negligible, i.e., $\psi_i \approx 1$ for i = 1, 2, 3. Similar trends are observed for $\xi > 10^4$, where all the reaction forces are equal and all the displacement, 200 except the one of node 5, are unaffected by the defective support. In between, i.e., $1 < \xi < 10^4$, a transition is observed. The central support on the opposite 202

Fig. 4 Damage on support no.5. Normalized reactions (top) and support displacements (bottom) in a grillage with $\eta = 0.1$ and $\rho = 0.5$ in a range $\xi = [10^{-2}; 10^6]$. Continuous curves relate to a grillage with square ($\lambda_{\bullet} = 1$) elements, while dashed lines to a structure with rectangular ($\lambda_{\bullet} = 10$) elements. The curves related to nodes/reactions 4 and 6 are superposed; similarly, the curves related to nodes/reactions 1 and 3 are superposed.

side is pushed down with a larger reaction force, while the corner supports (nodes 1 and 3) raises, resulting in a reduction of the reaction.

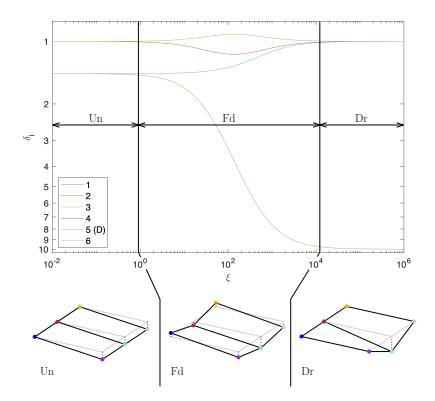
Observing the displacement regimes reported in Figure 5, a folding-like (Fl) regime is observed since nodes 1 and 3 moves upwards, while node 2 goes down with respect to the undamaged position, for which $\delta_i = 1$. A similar trend,

Fig. 5 Normalized displacements for a grillage with $\eta = 0.1$, $\rho = 0.5$ and $\lambda_{\bullet} = 1$ (square cross-section). Three displacement regimes are individuated: uniform tilting (Un), folding (Fl) and drop (Dr). Note that y-axis scale is in a reverse order; for the colors of the supports refer to Figure 1.

²⁰⁸ shifted downwards is observed for nodes 4, 5 and 6. This regime is observed in the interval $1 < \xi < 10^4$. For lower ξ a uniform tilting (Un) emerges, while for larger ξ a drop (Dr) of node 5 is noted. As expected, the reaction forces and displacement regimes are symmetrical with respect to the longitudinal axis of

the grillage (i.e., the line passing through nodes 2 and 5).

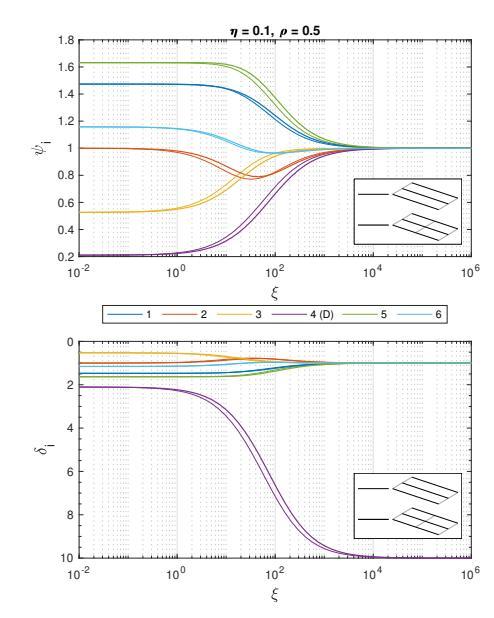
- beam. The damaged configuration accounts for a reduction of vertical stiffness on node 4, namely $\xi_4 = \xi/10$. Figure 6 shows the results of the analysis: thin
- ²¹⁸ curves refer to a grillage structure without the transverse beams, while thick curves to a structure with transverse beams. It is noted that the observed
- ²²⁰ trends are not affected by the presence of the additional elements: considering that the threshold between uniform (Un) and twisting-like (Tw) behaviors cor-
- responds to the ξ for which $\delta_2 = \delta_3$, or alternatively, $\psi_2 = \psi_3$, the presence of

Fig. 6 Damage on support no.4. Normalized reactions (top) and support displacements (bottom) in a grillage with $\eta = 0.1$, $\rho = 0.5$ and $\lambda_{\bullet} = 1$ (square cross-section) in a range $\xi = [10^{-2}; 10^6]$. Thick curves relate to the grillage with additional transverse beams.

the additional transverse beams moves rightwards the threshold point. In fact, thin yellow-red curves of Figure 6 intercept at $\xi \approx 15$, while thick yellow-red curves at $\xi \approx 24$.

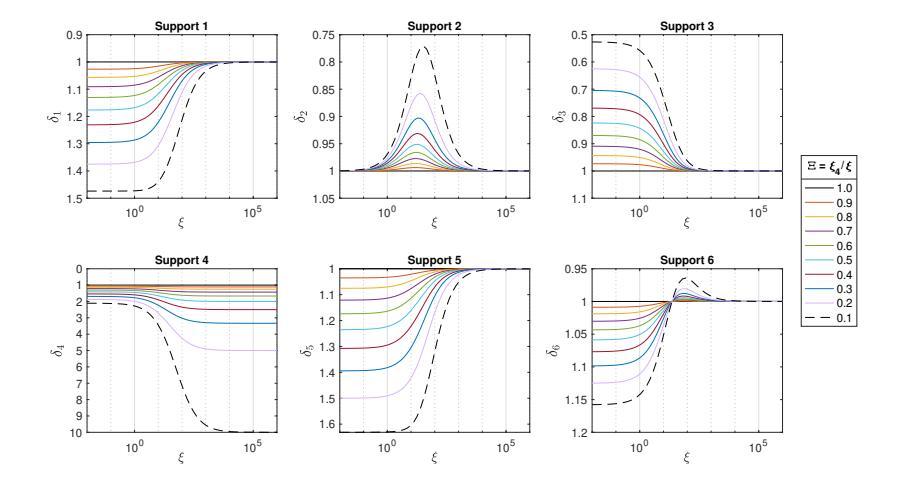
Figure 7 plots the vertical displacements of the six nodes on a grillage subjected to a vertical stiffness reduction on support no.4. Various damaged-to-non damaged stiffness ratios, namely $\Xi = \xi_4/\xi$, are considered in the range [0.1; 1].

Fig. 7 Damage on support no.4. Normalized support displacements in a grillage with $\eta = 0.1$ and $\rho = 0.5$ with square cross-section ($\lambda_{\bullet} = 1$) in a range $\xi = [10^{-2}; 10^6]$. Each curve corresponds to a damaged-to-non damaged stiffness ratio, ξ_4/ξ . Note that y-axis is in reverse order.

For $\xi_4/\xi = 1$, thick continuous black line, the support is not damaged: it clearly emerges that the structural behavior of the grillage is not affected by

- the stiffness of the supports (which, in this case, are equal). For $\xi_4/\xi = 0.1$, i.e., $\xi_4 = \xi/10$, thick dashed black line, the curves are identical to the ones depicted in the bottom plot of Figure . Intermediate curves refer to interme-
- diate damaged stiffnesses. An identical behavior is observed in each support: the intermediate curves have the same trend of the thick dashed black curves
- and the values of the displacements δ_i are scaled. This shows that the magnitude of the damage does not affect the observed trends, but it magnifies the

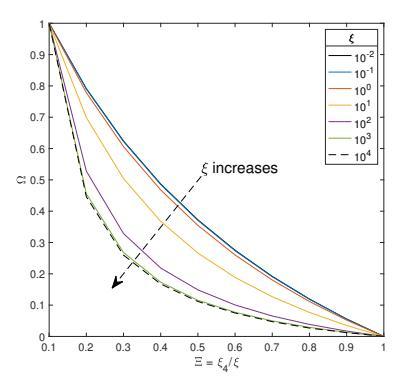
276 and the corresponding curve for $\Xi = 0.1$. Figure 8 shows the values of Ω for various ξ on a grillage structure with damaged support no.4. It clearly emerges that the increase in damage, i.e., the reduction from $\Xi = 1 \rightarrow 0.1$ does not presupposes a perfectly linear effect on the displacements. This is a result of the mutual interaction between the elements and the supports and is a common trend in statically indeterminate structures [30, 31]. Different evolutions are observed for different values of ξ . For low ξ a quasi-linear trend between the

Fig. 8 Values of the ratio Ω computed with Eqn. (6) for a grillage with $\eta = 0.1$, $\rho = 0.5$ and square cross-section ($\lambda_{\bullet} = 1$), damaged on support no.4.

ends of the curve is observed, while a pronounced nonlinear trend is noted for high ξ . The observed results agree with the previous findings on statically

indeterminate structures: with reference to the previous works by the Author, a linear evolution in the effects of the damage refers to a structure which is not complex, while a nonlinear trend is a evidence of structural complexity [30, 31]. In this sense, for high ξ , the grillage tends to behave as "complex",
