### Stress corrosion cracking of additively manufactured alloy 625

Stress corrosion cracking of additively manufactured alloy 625 / Cabrini, M.; Lorenzi, S.; Testa, C.; Carugo, F.; Pastore, T.; Manfredi, D.; Biamino, S.; Marchese, G.; Parizia, S.; Scenini, F.. - In: MATERIALS. - ISSN 1996-1944. - ELETTRONICO. - 14:20(2021). [10.3390/ma14206115]

# Article Stress Corrosion Cracking of Additively Manufactured Alloy 625

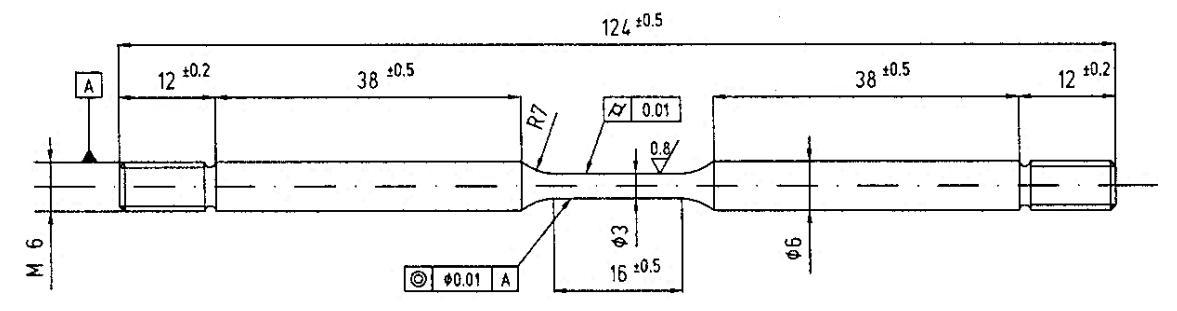
Figure 1. Geometry of the SSRT specimens (all values are in mm).

SSRT tests were also conducted using round dogbone samples whose geometry is schematically reported in Figure 1, by means of a homemade SSRT testing machine with four independent loading stations. The load was applied through an electric motor and reduction gears that could impose displacement rates between  $5 \times 10^{-7}$  and  $5 \times 10^{-3}$  mm/s. The calibration of the cells was performed independently. Acquisition system (spider 8 HBM Italy, Milano, Italy) recorded the load and a function of time. A strain rate of either  $3.15 \times 10^{-6}$  s<sup>-1</sup> or  $3.15 \times 10^{-5}$  s<sup>-1</sup> was chosen.

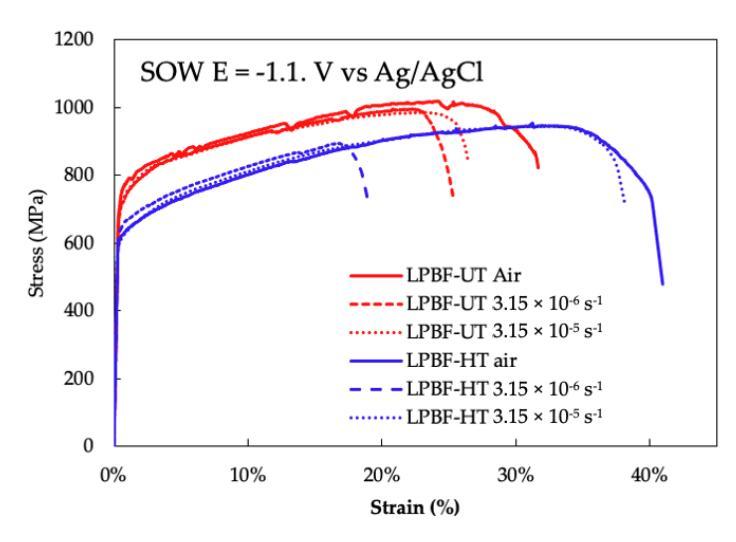
**Figure 2.** SSRT results of LPBF-UT (red line) and LPBF-HT (blue line) at  $3.15 \times 10^{-6} \text{ s}^{-1}$  in air, at  $3.15 \times 10^{-6} \text{ s}^{-1}$  in SOW under cathodic protection, and at  $3.15 \times 10^{-5} \text{ s}^{-1}$  after hydrogen pre-charging.

The SSRT curves are shown in Figure 2. The UT-LPBF specimen (red curves in Figure 2) tested in air at  $3.15 \times 10^{-6}$  s<sup>-1</sup> showed a very pronounced plastic region achieving 1018 MPa of ultimate stress and 32% of strain to failure. The tests in SOW were carried out at the same cathodic polarisation, -1.1 V vs. SCE, and had the same duration (about 16 h), but with two different strain rates: the first at  $3.15 \times 10^{-6}$  s<sup>-1</sup> and the second at  $3.15 \times 10^{-5}$  s<sup>-1</sup>; in this last case the specimen was pre-charged with hydrogen before starting the tensile test. The cathodic polarised specimen tested at the lower strain rate presented a reduction of the total strain with respect to the specimen tested in air, achieving a value equal to 25%, the specimen pre-charged with hydrogen showed less reduction of ductility (26%). The heat treatment (blue curves in Figure 2) decreased the yield and maximum stress of all specimens, and increased the ductility, which in air was 61% of total strain. The differences between the reduction of ductility with respect to air are more evident in these specimens (LPBF-HT): the specimens cathodically polarised in SOW and strained at  $3.15 \times 10^{-5}$  s<sup>-1</sup> presented a total elongation of 22%, whereas the pre-charged specimen showed a total strain of 50%. The reduction of area values are in agreement with the total elongation values, as summarized in Table 3.

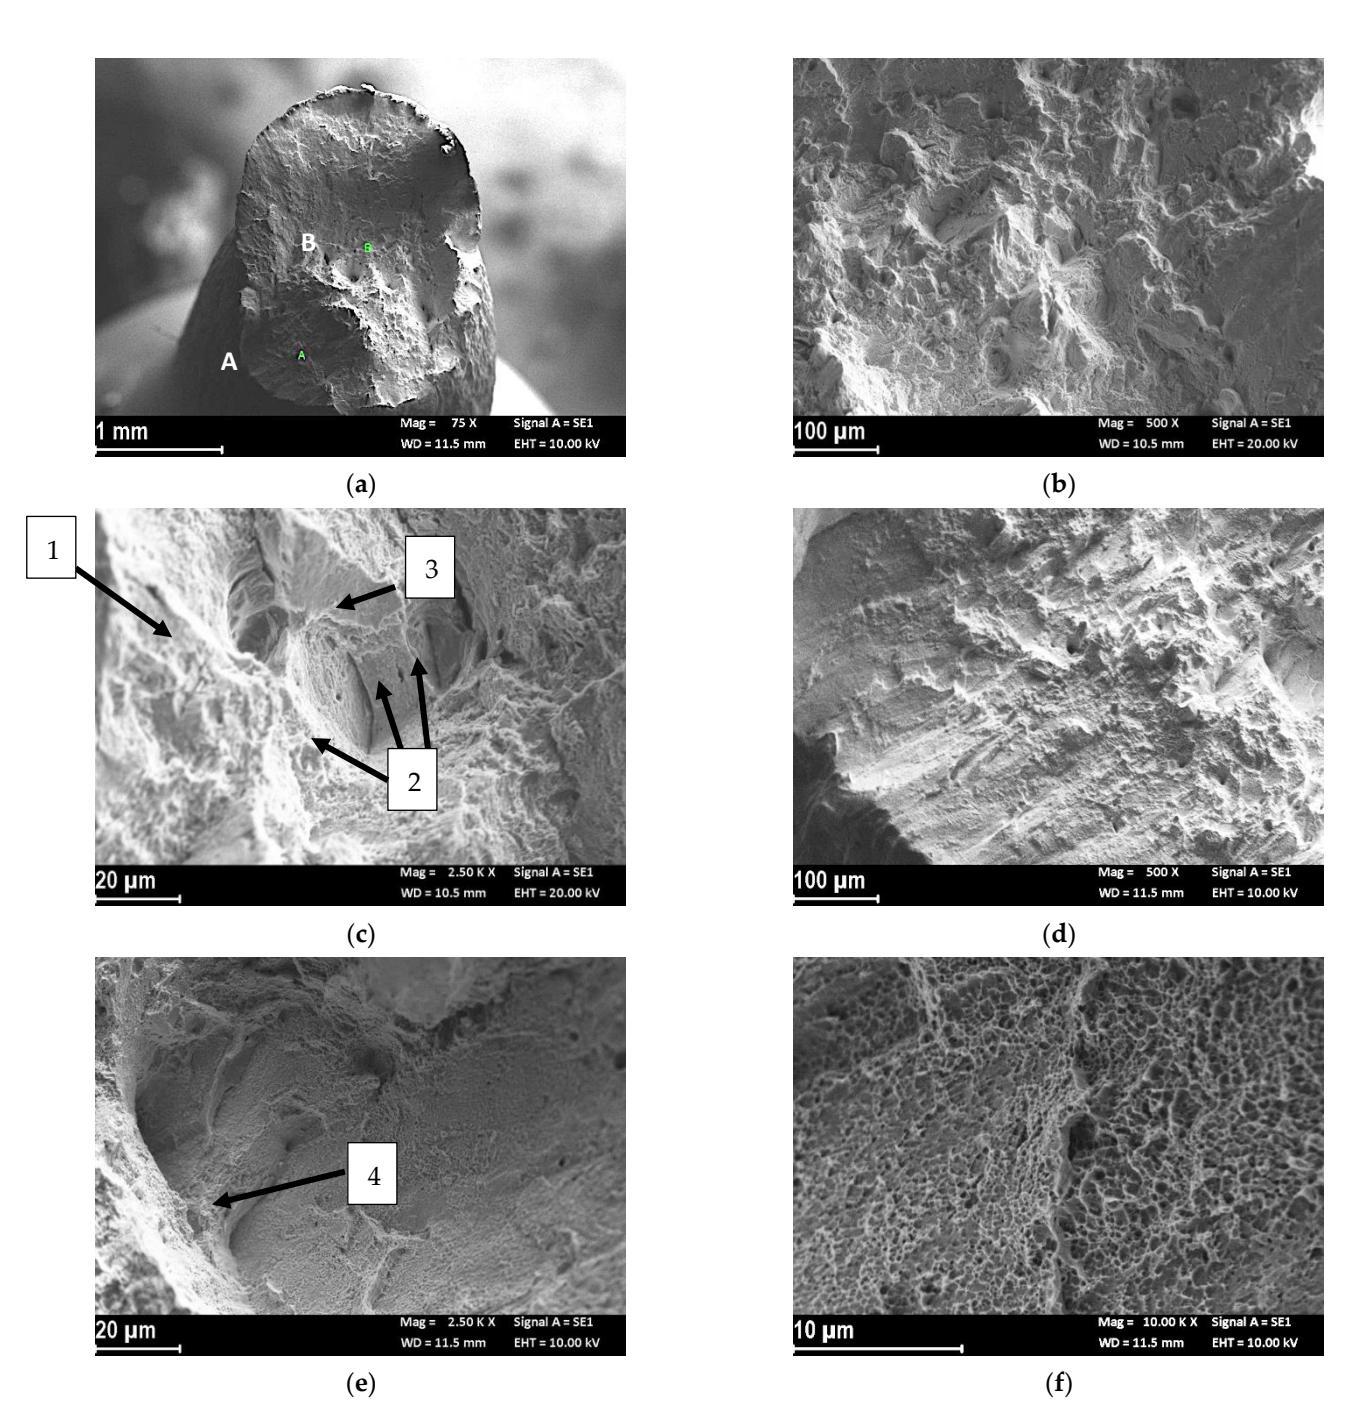
**Figure 3.** Secondary electron fractographic analysis of the UT-LPBF specimen after the SSRT test in air: (**a**) macro image; (**b**) close-up of the center of the specimen (zone B in (**a**)); (**c**) close-up at higher magnification of Figure 3b, the arrows indicate: (1) presence of large dimple associated to inclusion, (2) edge of the melt pool, and (3) low toughness zone; (**d**) close-up of zone A of (**a**) fracture zone of shearing; (**e**) close-up of (**d**) in which is evident the separation of the melt pools, (**f**) close-up of zone (4) in (**e**) in which are evident micro dimples in the separation of the melt pools.

Figure 3 shows the fracture morphology of the UT-LPBF specimen tested in air. The specimen did not have a perfectly regular cone/cup fracture surface (Figure 3a). In the center of the specimen, the fracture was characterized by irregular dimples of different sizes (zone B in Figure 3a and close up of Figure 3b,c) sometimes associated with inclusions (zone 1 in Figure 3c), or, more frequently to the border of the melt pools (zone 2 in Figure 3c). Analyzing the center of the specimen at high magnifications, areas of low toughness and points of cleavage almost appeared (zone 3 in Figure 3c). At the border of the specimen (zone A in Figure 3a) the fracture mode was due to shearing (Figure 3d). On the shearing zone there were micro-separations corresponding with either the edge of the melting pool (zone 4 in Figure 3e), or the dimples (Figure 3f). The different cracking behavior in different regions suggested that there were some zones more ductile than others in the specimen, as it was possible to observe by the sharp decrease in the stress vs. strain curves (Figure 2).

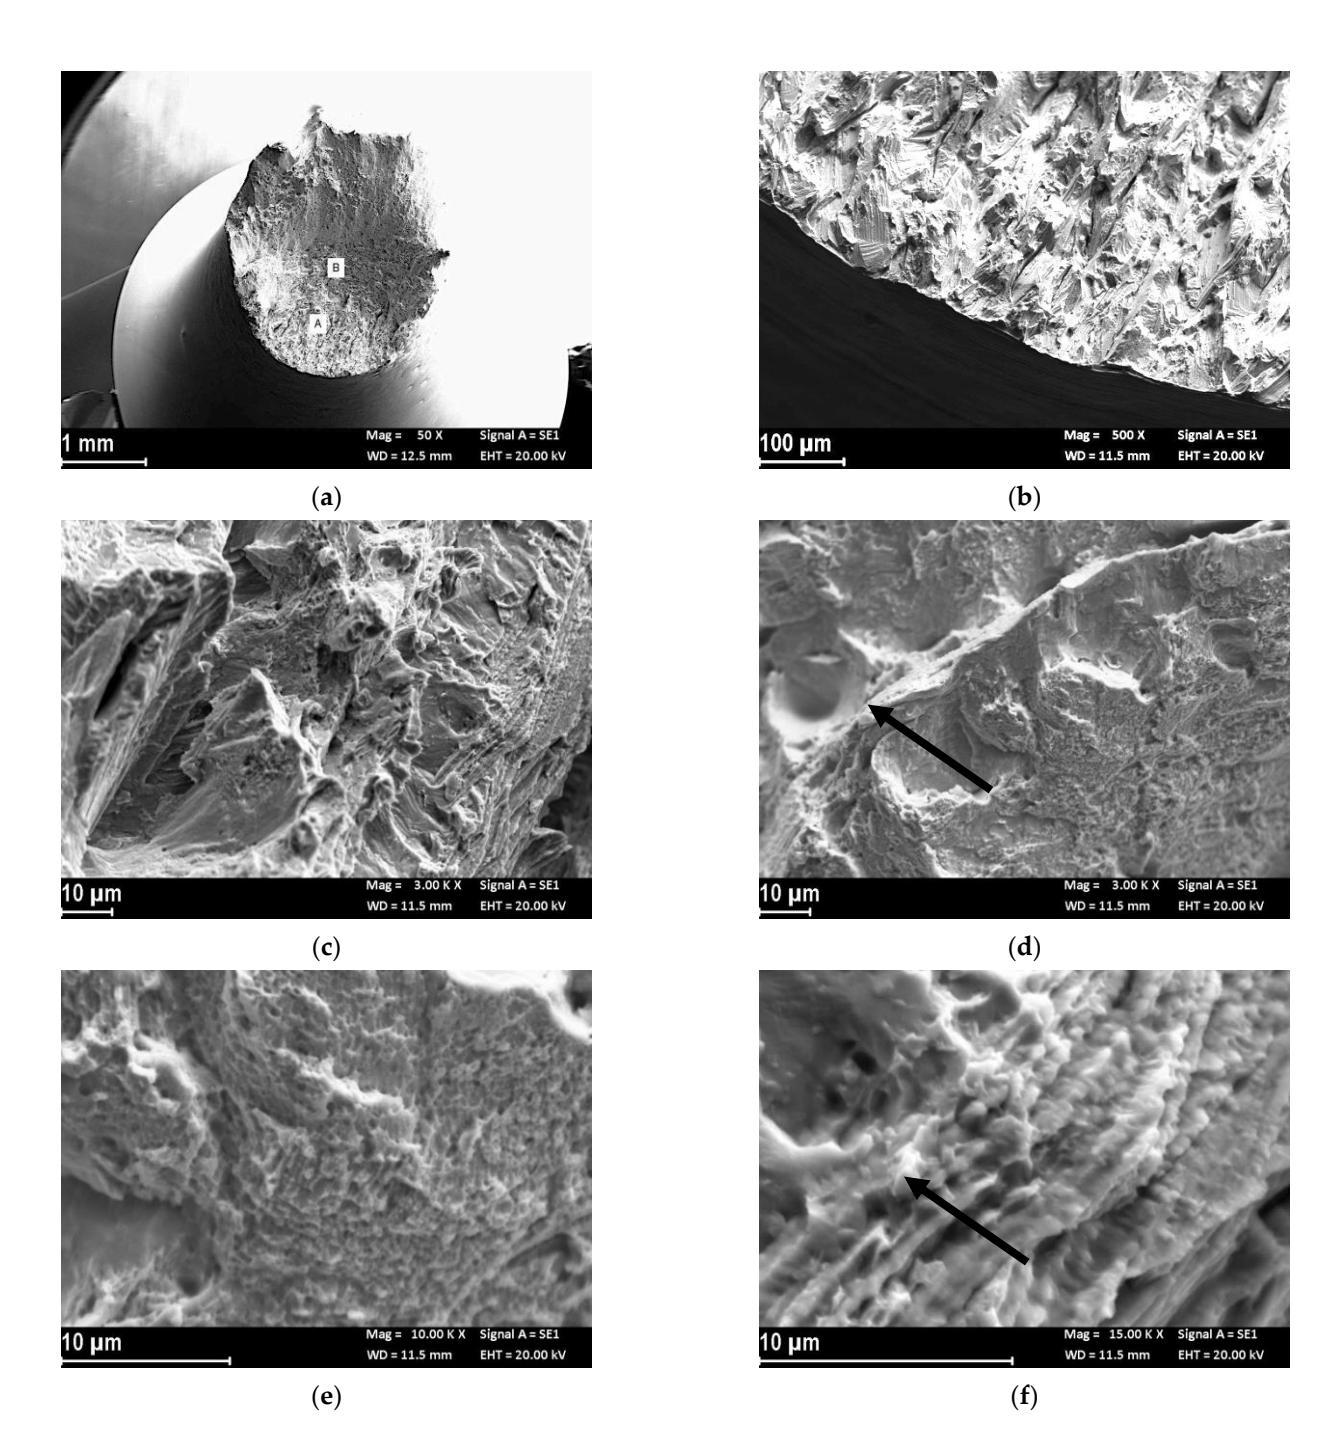
**Figure 4.** Secondary electron images of the fracture surface of UT-LPBF specimen after the SSRT test at strain rate  $3.15 \times 10^{-6} \text{ s}^{-1}$  in SOW and cathodic polarization at -1.1 V vs. Ag/AgCl: (**a**) macro image; (**b**) close-up of the trigger zone (zone A in (**a**)) with brittle morphology; (**c**) close-up of (**b**) in which is evident a quasi-cleavage growth, (**d**) close-up of (**b**) in which is evident the separation of the melt pool (arrow) and presence of dimples in the upper melt pool; (**e**) close-up of the center of the specimen (zone B in (**a**)), presence of dimples and brittle zone; (**f**) close-up at higher magnification of (**e**) in which are evident the presence of intermetallic precipitates.

Figure 4a reports the macro image of the UT-LPBF specimen after the test in SOW and cathodic polarization of -1.1 V vs. Ag/AgCl. The specimen still showed plastic deformation, as can be seen from the reduction of area percentage shown in Table 3, but the fracture surface had a flat trigger area (zone A of Figure 4a), which extended to the center of the specimen (zone B of Figure 4a) and the final break was due to sliding by shearing. The trigger zone had a quasi-cleavage aspect (Figure 4b), which is typical of hydrogen embrittlement phenomena. The higher magnification details (Figure 4c) show the alternation of flat areas and small dimples. Microfractures were evident at the separations of the fusion wells, which changed the fracture propagation (Figure 4d). The fracture surface at the center of the specimen (zone B of Figure 4e). The high-magnification image shows the presence of small intermetallic precipitates on the flat facets (Figure 4f).

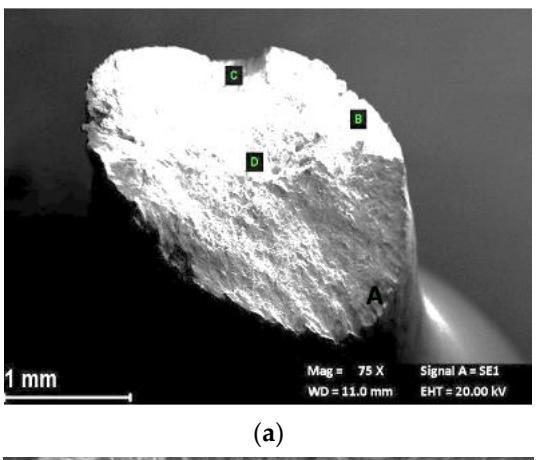
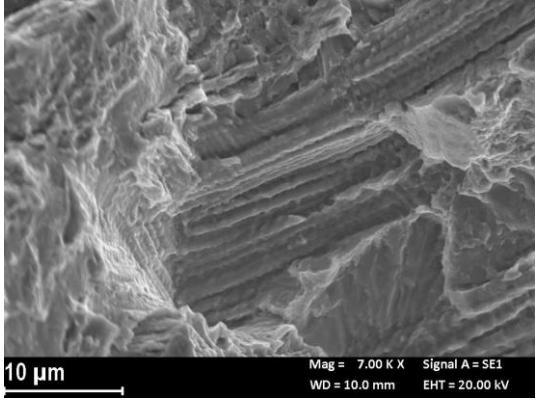
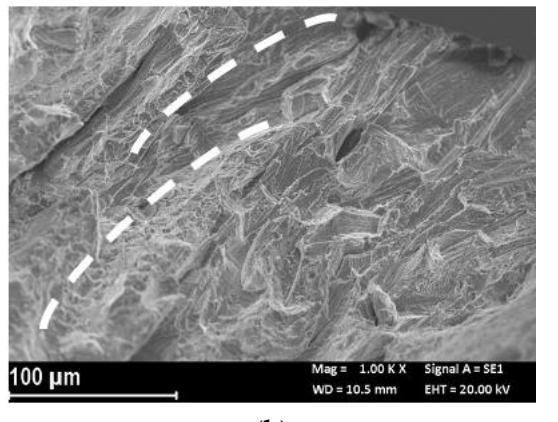
**Figure 5.** Fractographic analysis of the UT-LPBF specimen after the SSRT test at strain rate  $3.15 \times 10^{-5}$  s<sup>-1</sup> in SOW and cathodic polarization at -1.1 V vs. Ag/AgCl after 16 h of hydrogen pre-charging: (**a**) macro image; (**b**) close-up of zone A, and (**c**) a similar morphology is observed in zone C; close-up of zone B; zone D in (**a**) is fully ductile.

Figure 5a shows the macro image of the fracture surface of the UT-LPBF specimen pre-charged with hydrogen for 16 h and then strained at  $3.15 \times 10^{-5}$  s<sup>-1</sup>. The fracture surface had some small trigger areas with a morphology typical of hydrogen embrittlement (zone A, B and C of Figure 5a; the close-up of zone A is shown in Figure 5b, the close-up of zone B is shown in Figure 5c), while the central area had a mixed fracture consisting of numerous dimples, small brittle facets and rare areas of quasi-cleavage. The final breakage of the specimen occurred by sharing. The value of the normalized reduction of area was very similar to that obtained in the previous case. At high magnification for areas A (Figure 5b), B (Figure 5c) and C of the specimen, a morphology similar to that observed in Figure 4 could be noted, with many brittle facets arranged perpendicularly to the direction of propagation of the fracture (along the dendritic growth) that occasionally jumped on a different plane, and a separation of the border of the melting pool (dotted line in Figure 5b).

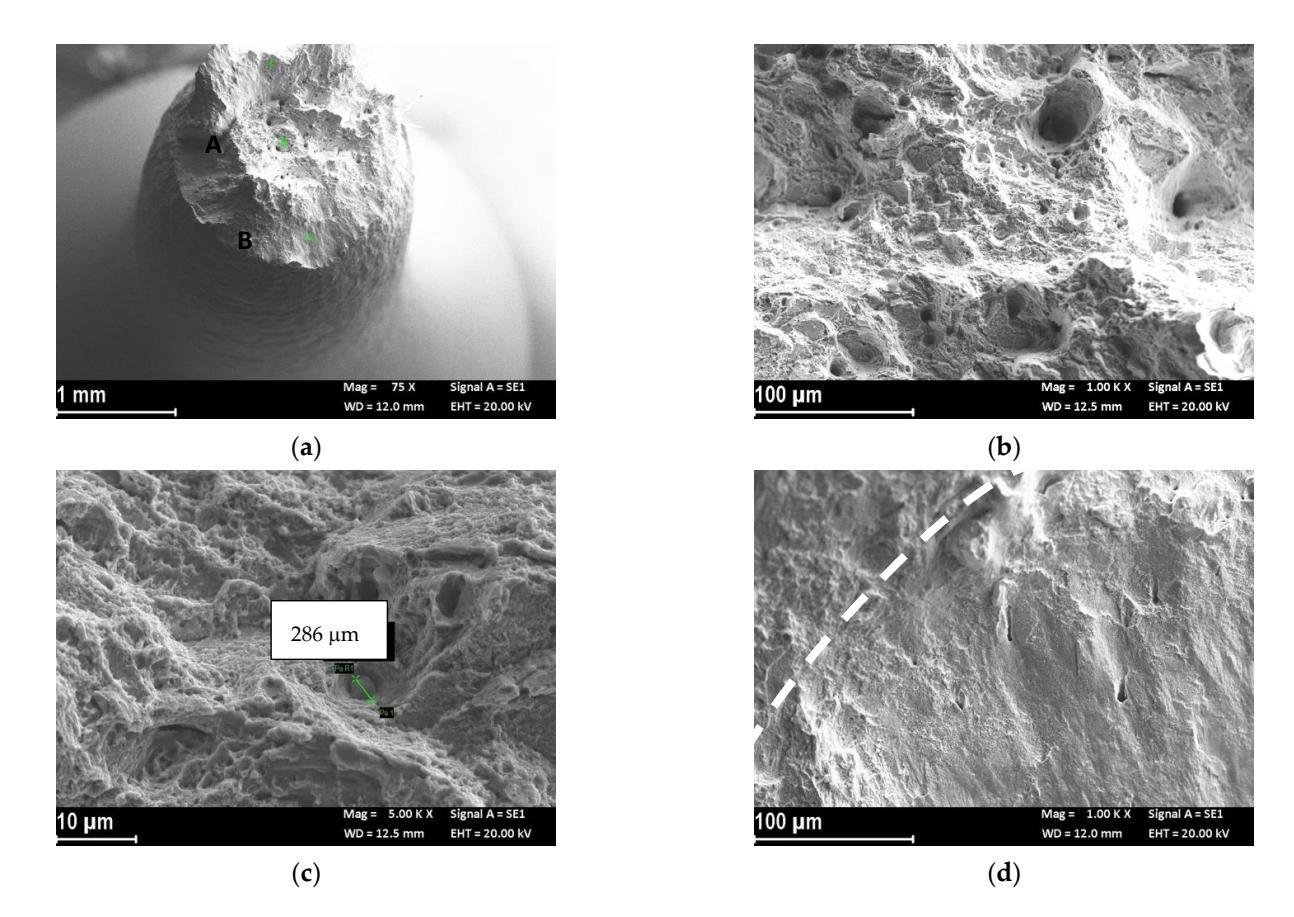
**Figure 6.** Fractographic analysis of the HT-LPBF specimen after the SSRT test in air: (**a**) macro image; (**b**) close up of the center of the specimen (zone A in (**a**)) with presence of dimples; (**c**) close-up of a large precipitate in (**b**); (**d**) close-up of the border of the specimen (zone B in (**a**)) in which is evident the change of fracture growth in the corresponding edge of the melt pool.

Figure 6a shows the fracture surface of the heat-treated specimens tested in air. The fracture surface had a typical cup and cone shape with a morphology in the center characterized by dimples of very variable dimensions (Figure 6b). Larger dimples were sometimes associated with large-sized precipitates (Figure 6c). The final fracture, also in this case, occurred by sliding by sharing (Figure 6d), with separations between the melt pools (dotted line in Figure 6d).

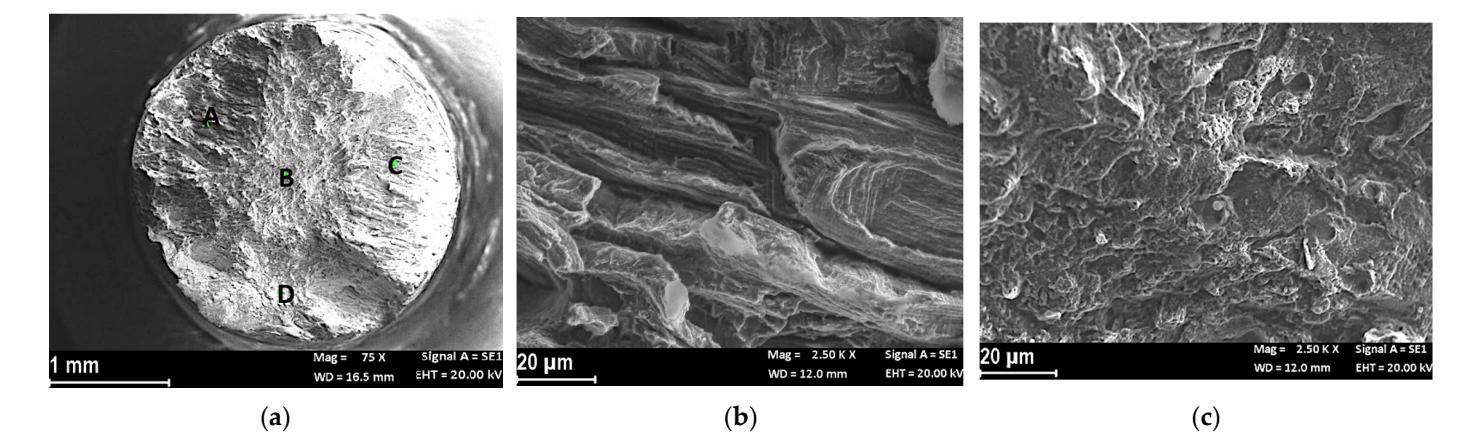
**Figure 7.** Fractographic analysis of the HT-LPBF specimen after the SSRT test at strain rate  $3.15 \times 10^{-6} \text{ s}^{-1}$  in SOW and cathodic polarization at -1.1 V vs. Ag/AgCl: (a) macro image; (b) close-up of the trigger of the fracture (zone A of (a)—zone C has the same morphology of zone A; (c) close-up of the center of the specimen (zone B of (a)—a similar morphology is present in zone D of (a)).

The fracture surface of the heat-treated specimen at the end of the SSRT test with strain rate  $3.15 \times 10^{-6}$  s<sup>-1</sup> cathodically polarized at -1.1 V vs. Ag/AgCl in SOW was totally flat (Figure 7a); there were two large trigger zones by hydrogen embrittlement (denoted with A in the Figure 7a) with a morphology similar to the UT specimens (Figure 7b), with flat facets arranged in a radial direction, separated by longitudinal microfractures and flat areas of cleavage. Even the center of the specimen appeared with a quasi-cleavage morphology (areas B and C—close-up in Figure 7c), with a sporadic presence of small dimples.

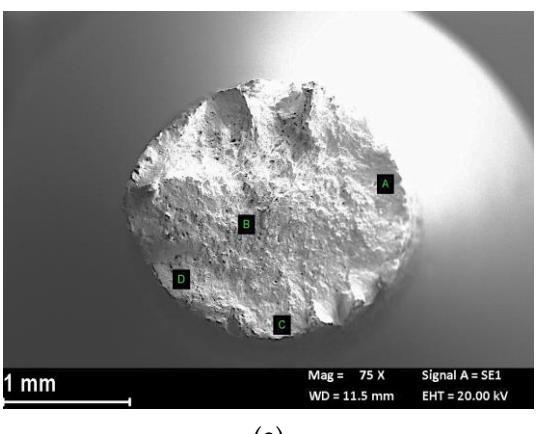
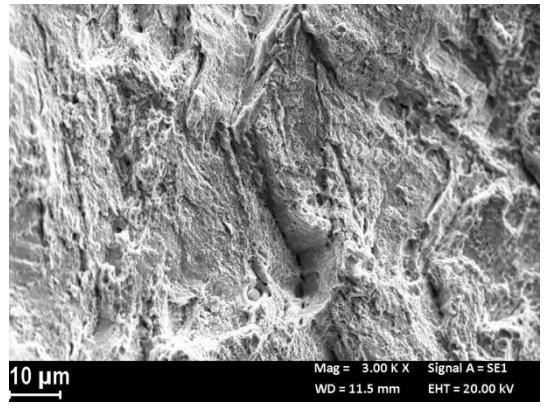
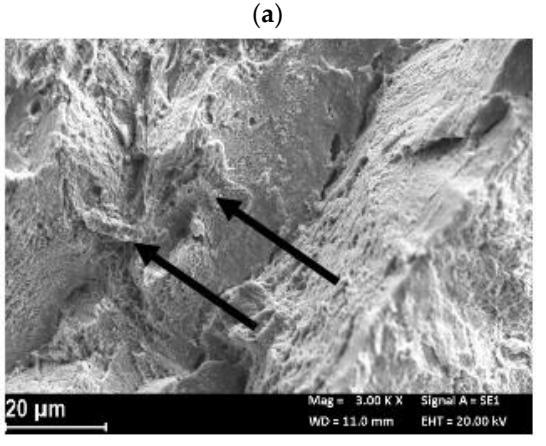
**Figure 8.** Fractographic analysis of the HT-LPBF specimen after the SSRT test at strain rate  $3.15 \times 10^{-5} \text{ s}^{-1}$  in SOW and cathodic polarization at -1.1 V vs. Ag/AgCl after 16 h of hydrogen pre-charging: (**a**) macro image; (**b**) close up of the trigger of the fracture (zone A in (**a**)); (**c**) close-up of the center of the specimen (zone B in (**a**)), the arrows indicate second phases.

Finally, Figure 8a shows the fracture surface of the specimen preloaded with hydrogen for 16 h and then subjected to an SSRT test at a strain rate of  $3.15 \times 10^{-5}$  s<sup>-1</sup>. Contrary to the previous case, the fracture surface showed necking, with small triggers of HE on the lateral surface (zones C and D of Figure 8a) with a mixed morphology with dimples and small areas of quasi-cleavage (Figure 8b). Conversely, the center of the specimen displayed mainly small dimples, but with separations along the longitudinal axis of quasi-cleavage (Figure 8c).

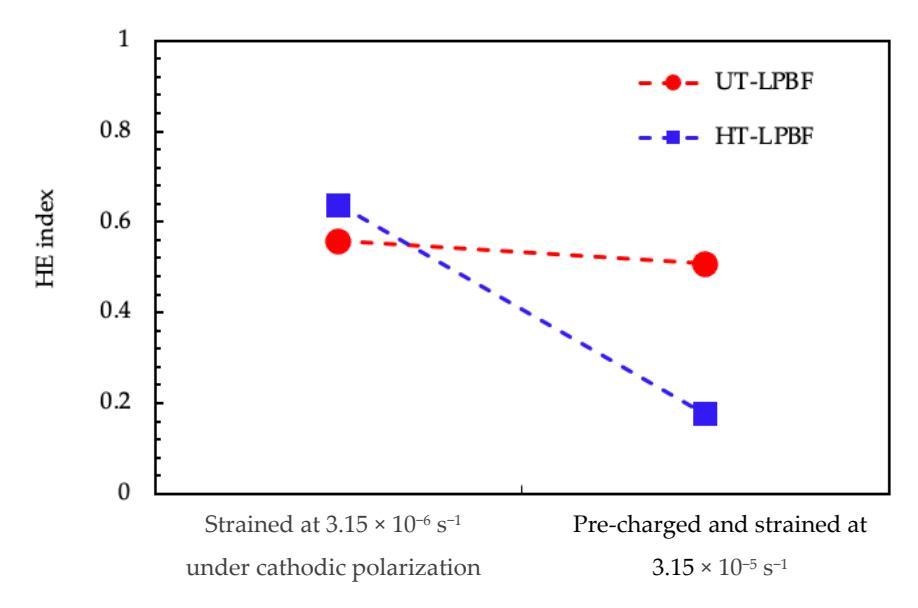
Figure 9. Hydrogen embrittlement index for the LPBF specimens after SSRT tests.

Alloy 625 underwent hydrogen embrittlement in SOW when cathodically polarized, as summarized in Figure 9 where the  $HE_{index}$  were reported. However, despite every specimen displaying evidence of hydrogen embrittlement, the highest susceptibility was generally identified for the cathodically polarized samples tested at  $3.15 \times 10^{-6} \text{ s}^{-1}$ .
