Review on the Experimental Characterization of Fracture in Active Material for Lithium-Ion Batteries

Review on the Experimental Characterization of Fracture in Active Material for Lithium-Ion Batteries / Pistorio, Francesca; Clerici, Davide; Mocera, Francesco; Soma, Aurelio. - In: ENERGIES. - ISSN 1996-1073. - 15:23(2022), p. 9168. [10.3390/en15239168]

### **Review Review on the Experimental Characterization of Fracture in Active Material for Lithium-Ion Batteries**

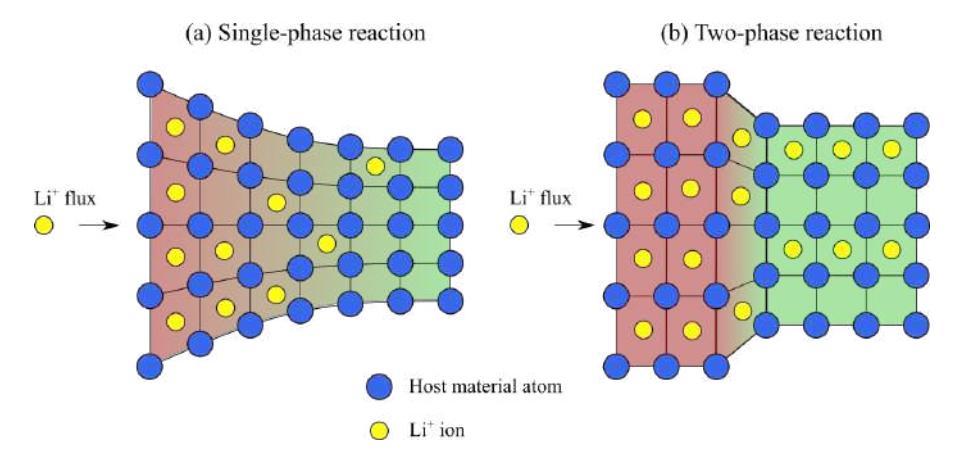
**Figure 1.** Mechanical stress resulting from inhomogeneous concentration due to (**a**) single phasereaction and (**b**) phase transition.

Then, the inhomogeneous lithium concentration within the particle causes differential deformation of the lattice structure, leading to diffusion-induced stress (DIS) [8–13,21]. Furthermore, some materials show a two-phase behavior, i.e., two phases with a different lithium content coexist in the same particle, causing a significant strain mismatch at the interface between them, and thus stress, as illustrated in Figure 1b.

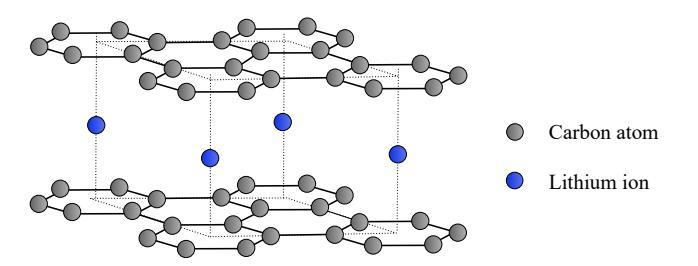
**Figure 2.** Crystalline structure of lithiated graphite. Lithium ions are depicted in blue and intercalate between the graphene planes. Carbon atoms are depicted in gray.

The structure of graphite is characterized by a stacking sequence of graphene layers, where carbon atoms are arranged in a hexagonal pattern. Lithium intercalates in the graphite structure occupying the interstitial defects between the graphene planes, as shown in Figure 2.
