Integrated 3D Mapping and Diagnosis for the Structural Assessment of Architectural Heritage: Morano's Parabolic Arch

Article Integrated 3D Mapping and Diagnosis for the Structural Assessment of Architectural Heritage: Morano's Parabolic Arch

This paper illustrates an integrated approach to 3D mapping and structural diagnosis by means of non-destructive testing for the preservation of a historical industrial monument: the parabolic arch of Morano sul Po. This paper reports the results of the non-destructive test campaign carried out on the structure and focuses on the procedures for structuring an integrated approach, which served as the basis to provide guidelines for its conservation.

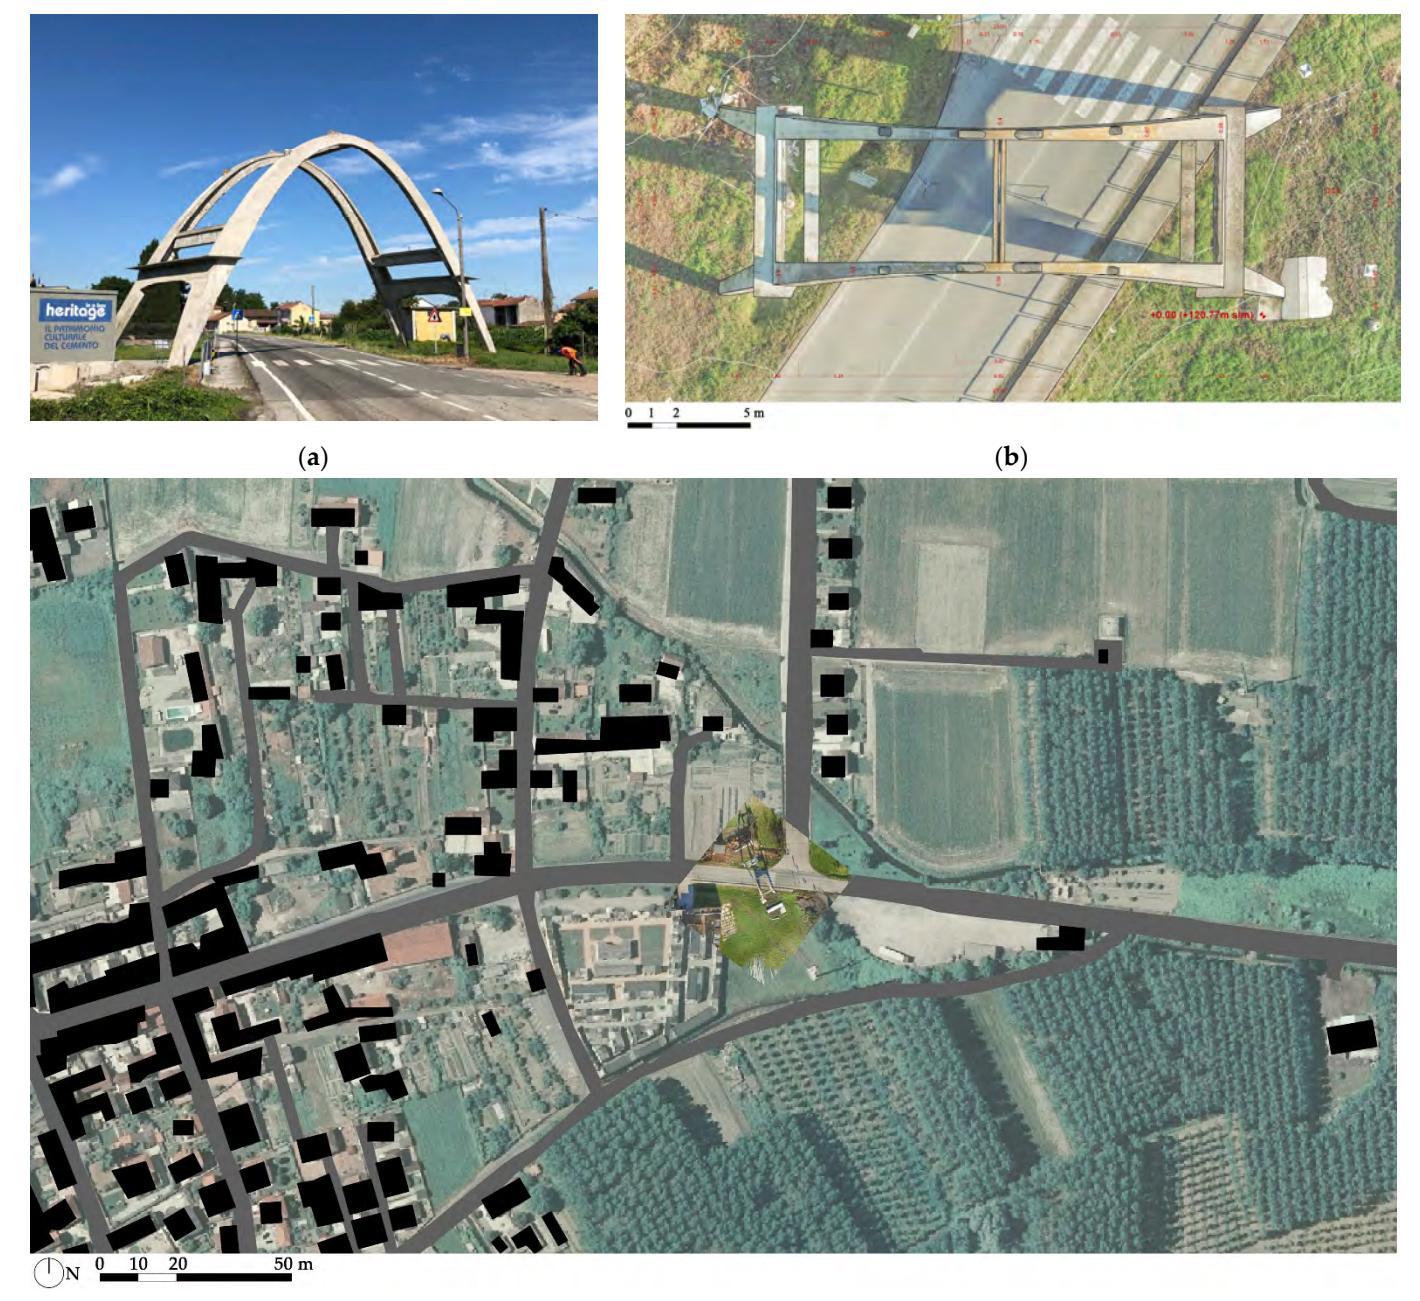
Figure 1. (a) Current view of Morano's Arch; (b) plan view from a UAV-photogrammetry-based orthophoto; (c) UAV orthophoto (0.005 m) overlaid on a regional orthophoto (GSD: 0.5 m), with buildings (black) and roads (grey) from a regional CTRN.

The arch of Morano sul Po (Italy) is located in the suburbs of the city of Casale Moferrato, along the state road no. 31bis (Figure 1). The parabolic concrete arch, together with the protection structure that was dismantled at the end of the last century, was conceived and realized to protect the road from the potential falling of the trolleys, or the carried raw material, of the cableway that is used to connect the mine sites in Coniolo Vecchio and Borino with the factory sites of Morano sul Po [6]. Figure 2a, which was taken from a historical postcard, shows the original configuration of the arch. The design of the concrete arch was appointed to Ing. Guido Sarti, who also provided the structural design of other parts of the cement factory, such as the clinker storage hall and silos, together with the design of the new cableway, which was realized in the period between 1951 and 1952, adopted the same path of the existing one, and was designed by Ing. Gualino in 1908. The structure is similar to one of the first parabolic clinker warehouses, built in the 1920s in the close town of Casale Monferrato, and that had recently undergone an extensive experimental campaign for its condition assessment [7,8].

In 2018, following a donation, the structure returned to the ownership of the Municipality of Morano after about forty years. In the summer of 2020, to avert the risk of falling fragments on the roadway, the removal of unstable surface layers was conducted on the arch using a pressure washer. In addition, the exposed reinforcing bars were treated with passivating paint. Recently, thanks to a grant from the Luoghi della Cultura 2018 call of the Compagnia di San Paolo, the structure became part of the Concrete Heritage Box initiative (Figure 1a) [9].

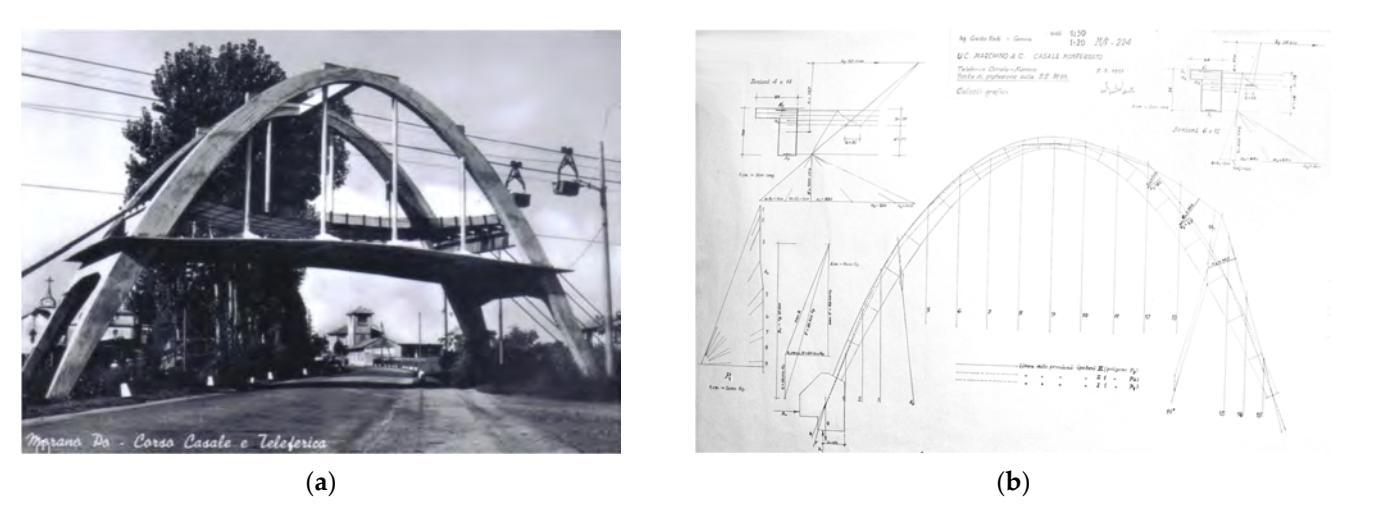
Figure 2. (a) Historical postcard showing the original configuration of the arch, where the shielding roofs were present; (b) original drawing with the graphic tracing of the thrust line of the arch.

Fortunately, some of the structural drawings of the arch are still available. Figure 2b shows an excerpt of such design drawings, from which is possible to recognize the graphical procedure for the determination of the thrust line of the arch, which was made with three distinct loading configurations. In addition, the graphical determination of the neutral axis and the stress field in some of the arch sections due to eccentric compression was obtained using the Mohr–Guidi method.

The determination of the depth of carbonation was carried out in accordance with the provisions of EN 14630:2007 [34] using a 1% phenolphthalein solution in ethyl alcohol as a reagent. In order to minimize structural disturbance, the in situ test was conducted by taking advantage of the holes drilled with the percussion drill, which had already been used for direct verification of the cover thickness and for corrosion testing to minimize the removal of the original concrete. Carbonation testing was performed at multiple locations on the columns. At all locations, the carbonation depth was detected to be within 3 mm, as shown in. Given the age of the structure, the limited carbonation depth could be attributed to previous coatings that were installed in the past, as confirmed by the historical photograph (Figure 2a).

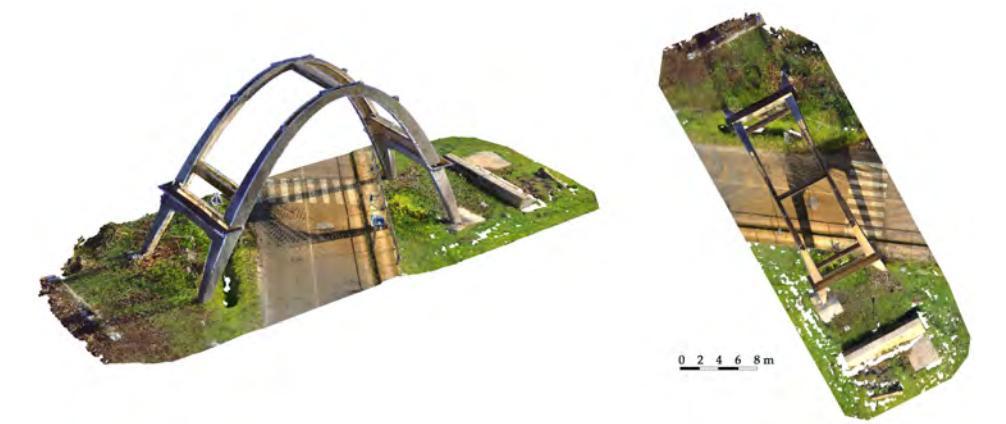
Figure 3. Two views of the LiDAR point cloud derived from the registration of the 19 acquired scans.

- 2. The LiDAR scans were merged (Figure 3) by exploiting the consolidated registration strategy, which consists of a preliminary alignment of the point clouds using an ICP algorithm, and then a rigid roto-translation of the block composed by the registered scans using the coordinates of the measured markers. The results were close to the usual residuals for similar surveys: the observed accuracy of the control points was ≈ 6 mm.

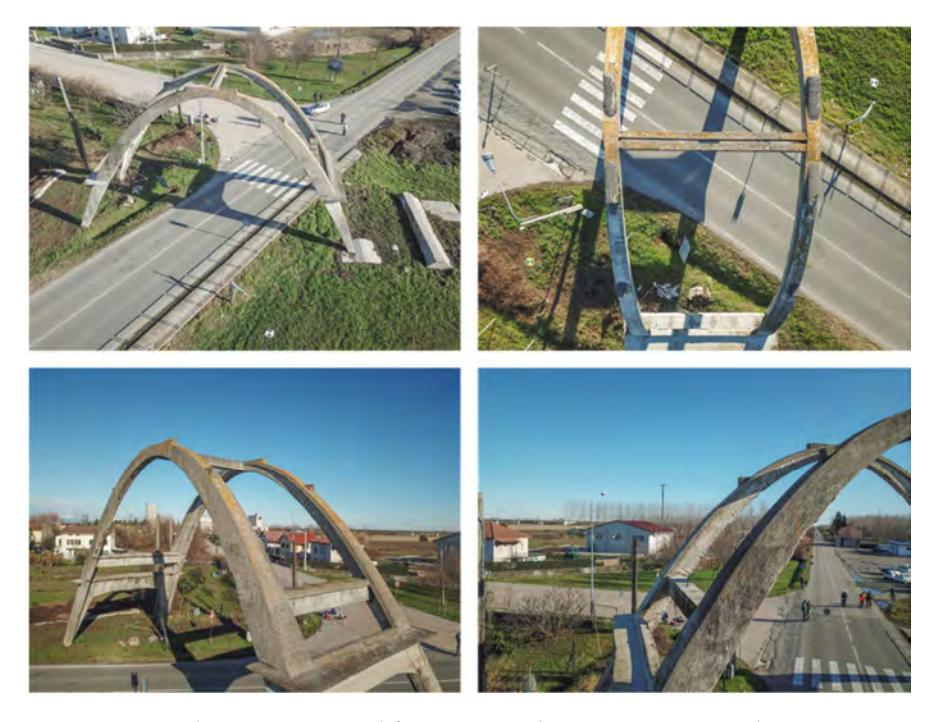
Figure 4. Digital images acquired from an aerial perspective using the micro UAV system, which enabled the acquisition of the extrados and the higher surfaces of the concrete arch.

3. The photogrammetric survey was carried out by integrating the acquisitions from both a micro UAV (Figure 4) and a DSLR (digital single lens reflex) camera using all of the images (more than 600). Regarding the image-based approach, an SfM solution was adopted. This type of 3D reconstruction is widely used in the field of imagebased documentation of heritage buildings since it allows for the generation of dense and accurate point clouds that are characterized by high-resolution radiometry. This feature represents a very useful tool for restorers and conservators since it enables them to consider elements related to the material consistency of a building, thus facilitating its study and diagnostic investigations. The Agisoft Metashape platform (Version 1.8.1) was employed for this operation since it is one of the most commonly adopted and user-oriented software solutions in the field of image-based documentation of heritage buildings. The subsequent pipeline was managed without criticalities (Table 1): image masking, interior orientation of the camera, relative orientation of the images and tiepoints extraction, georeferencing and bundle adjustment using the acquired ground control points, accuracy evaluation using both control and check points, and dense point cloud generation (Figure 5).

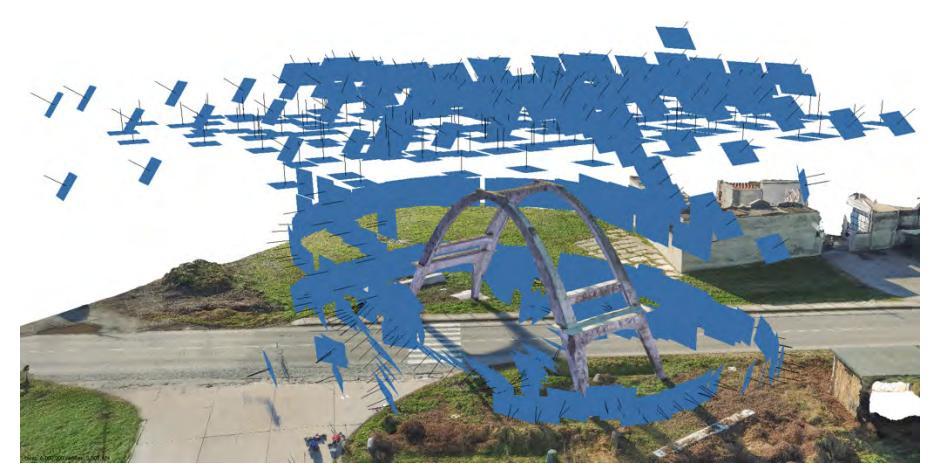
Figure 5. Oriented images (after the relative and absolute orientation) and photogrammetric dense point cloud.

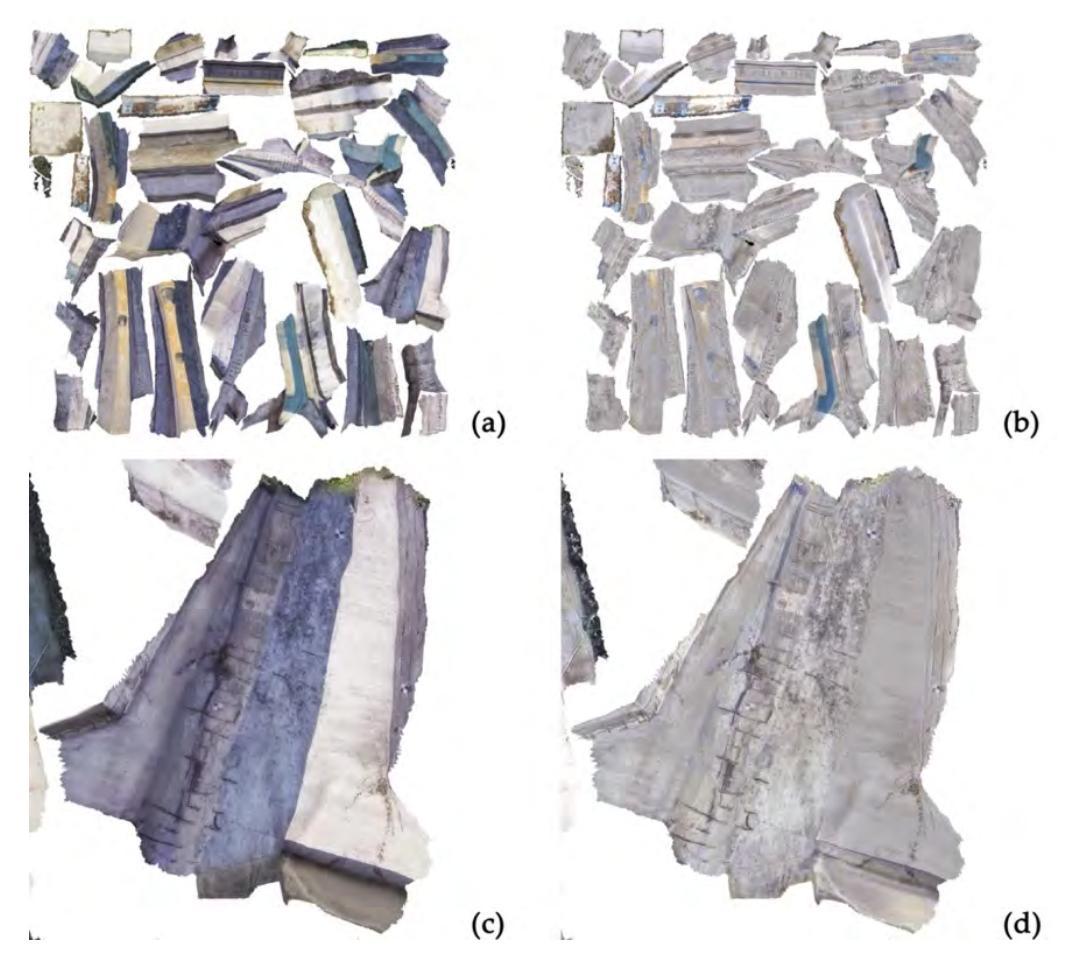
Figure 6. (a) Original UV map; (b) UV map after the editing process; (c) detail of the original UV map; (d) detail of the UV map after the editing process.

In order to facilitate the RGB reclassification for the semi-automatic decay detection procedure, the photogrammetric texture was edited with the aim of removing the shadows—due to the different sun exposures characterizing the different surveyed surfaces of the arch—and the radiometric discrepancies caused by the non-homogeneous illumination. As often happens when the data collection is performed in outdoor spaces, the impossibility of managing the lighting may cause the presence of areas characterized by significant differences in terms of radiometry. This can represent a problem for the reclassification task, where the RGB discrepancies are crucial for the proper detection of the analyzed degradation. For this reason, a 3D mesh was computed and a high-resolution UV map was generated (Figure 6). UV mapping is a texturing methodology that consists of projecting a 2D image—namely, the UV map—onto a 3D surface. The UV map is generated by processing oriented images of the photogrammetric block through orthorectifying and mosaicking procedures. Each point on the 2D textured surface corresponds to a vertex on the 3D mesh and is assigned a three-dimensional position, allowing for the texture to be projected onto the model. The UV space uses the Cartesian axes called U and V, while the 3D model is positioned in the XYZ reference system [28].

The generated UV map was processed with the aim of performing a radiometric equalization to homogenize the radiometry of composite elements of the same material but characterized by different solar exposures. This operation was carried out using the Agisoft Delighter platform, which allows for performing the equalization procedure by identifying different samples of underexposed and overexposed areas. The results of this operation can be observed in Figure 6d.

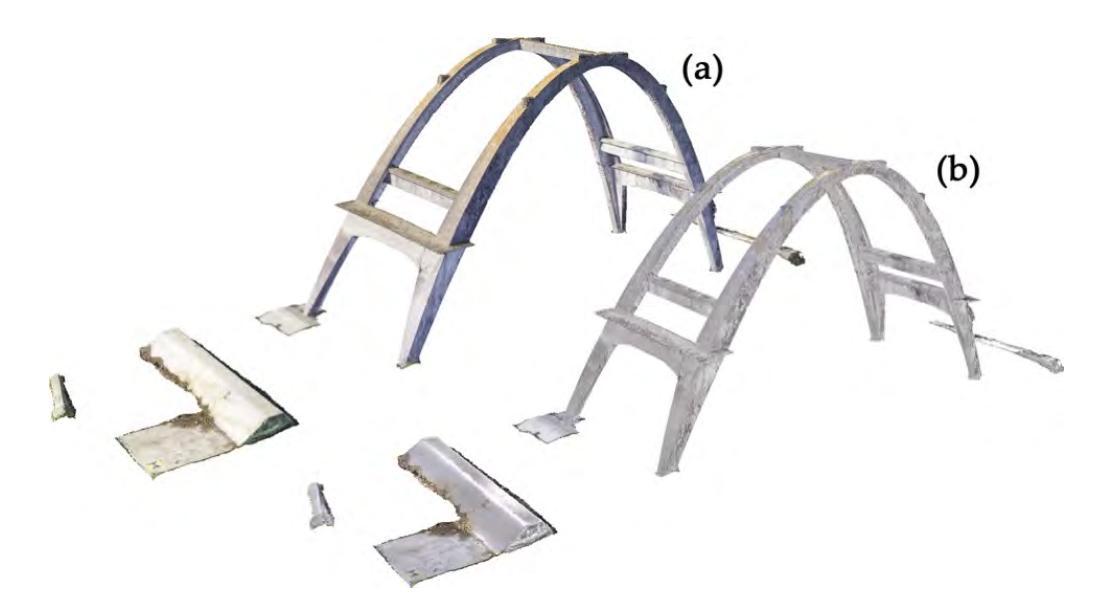
Figure 7. (a) Photogrammetric 3D mesh of the arch with the original texture; (b) reprojection of the edited texture on the original photogrammetric 3D mesh.

The edited texture was re-projected onto the computed 3D mesh (Figure 7) for the subsequent generation of the orthophotos that were used as primary data for the RGB-based reclassification for the identification of the analyzed types of decay. The reclassification of the exported raster images was carried out using the open-source software QGIS, which allowed—through the Raster Calculator tool—for grouping clusters of pixels with comparable digital number values and reclassifying them, exploiting the difference in terms of radiometry of the analyzed material (concrete) and decays (uncovered irons, efflorescence, and pollution blackening). After the reclassification processing, a degradation map was generated. In this case, the digital numbers embedded in each pixel of the classified orthophotos contained only four values: 0 for the concrete, 1 for the exposed irons, 2 for the areas affected by efflorescence, and 3 for the areas affected by the presence of pollution blackening (Figure 8).

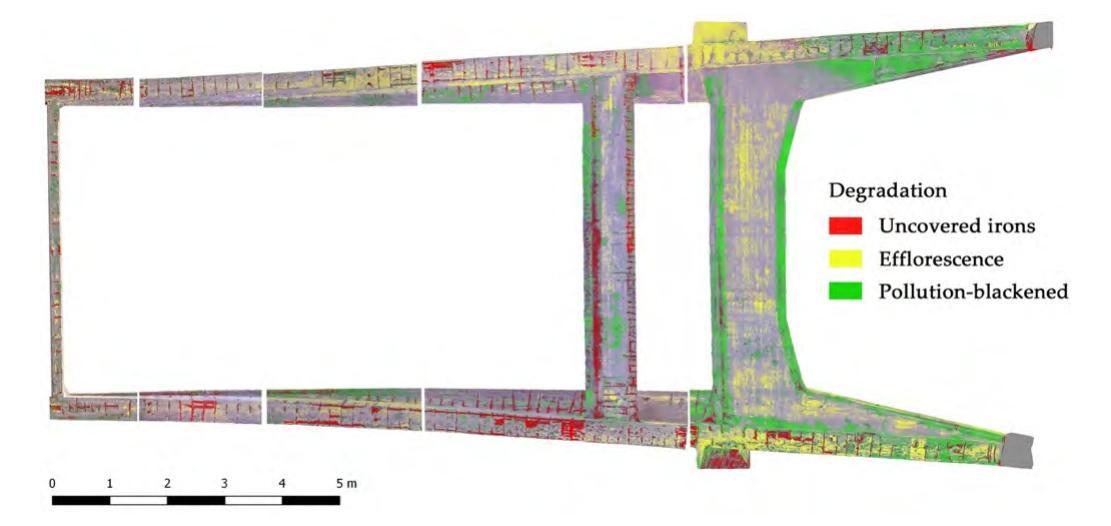
Figure 8. Example of the RGB-based reclassification of a portion of the intrados for the semi-automatic identification of different kinds of degradation.

In this case, an RGB-based semi-automatic classification was performed with the aim to identify the areas characterized by the following degradations:

- Uncovered irons;
- Efflorescence;
- Pollution blackening.

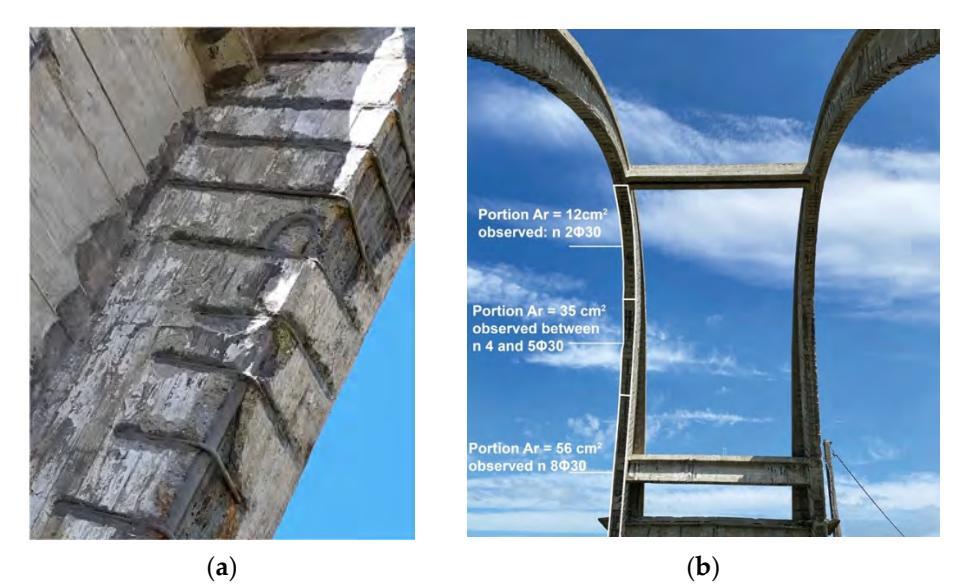
Figure 9. (a) Detail of the reinforcements of the arch; (b) measurements of surveyed reinforcements in the different portions of the arches.

Consistent with the design reported in the original drawings, it was observed that the percentage of longitudinal reinforcement decreased from the base toward the key of the arch (Figure 9b).

Pacometric tests allow for non-destructive verification of the presence and number of reinforcements in the structural elements of the work, as well as their orientation and arrangement, while also being able to estimate the thickness of the cover of the investigated elements. It was possible to directly measure the diameter of some of the outermost bars since the iron cover layer was absent in some places of the structure. Further comparison in terms of overall reinforcement area was possible from the design drawings (Figure 2b). The reinforcing bars were smooth with a diameter of 30 mm and had overlapping areas with hooked ends (Figure 9a). The stirrups, also smooth, had a pitch equal to 25 cm and a diameter of 12 mm. Pacometry made it possible to verify the presence of rebar even in areas where the cover was intact.

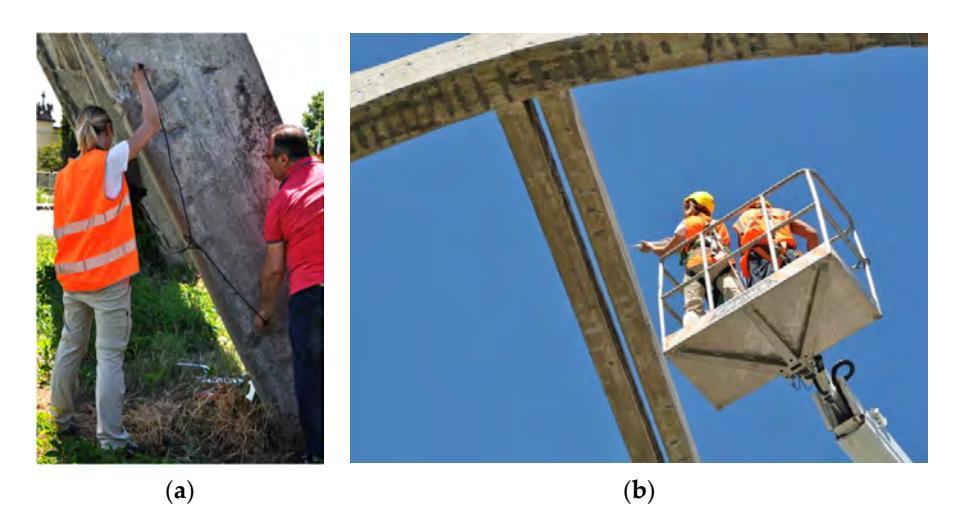
Figure 10. On-site testing of the various elements of the structure: (a) ultrasonic pulse velocity test; (b) rebound hammer test on one of the top beams connecting the arches.

Ultrasonic pulse velocity tests are well-known non-destructive tests that are used to evaluate the quality and homogeneity of concrete. Measurements were conducted in accordance with the standards [7,10]. The measurement of the propagation time of the ultrasonic pulses was carried out using two probes, namely, a transmitter and a receiver, each with a frequency of 54 kHz, and applied to the surface of the element involved in the test. Indirect, i.e., homeosurface, tests were performed by placing the probes on the same face of the structural element at varying distances (Figure 10a), and once the distance between the points under test was provided, the instrument returned the time and speed of the wave propagation.

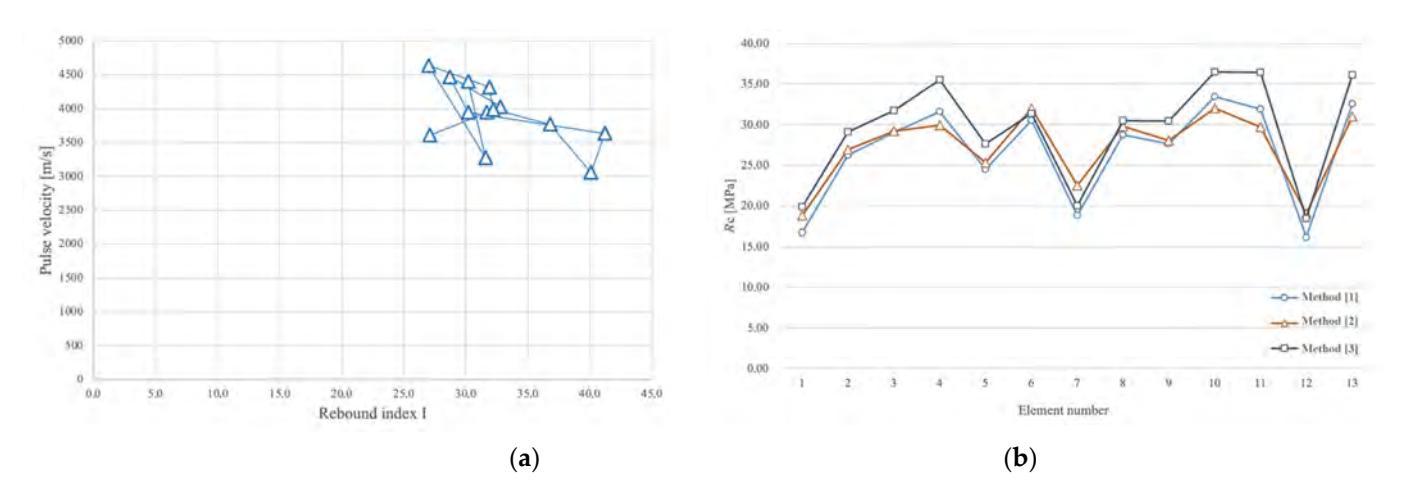
Figure 11a,b shows the results of the SONREB tests in graphical form. As can be seen, the values formed a rather definite cluster, which is generally an indication of a uniform material type.

Figure 11. (a) Diagram illustrating the values of the pulse velocities and rebound index; (b) SONREB results in terms of R_c .

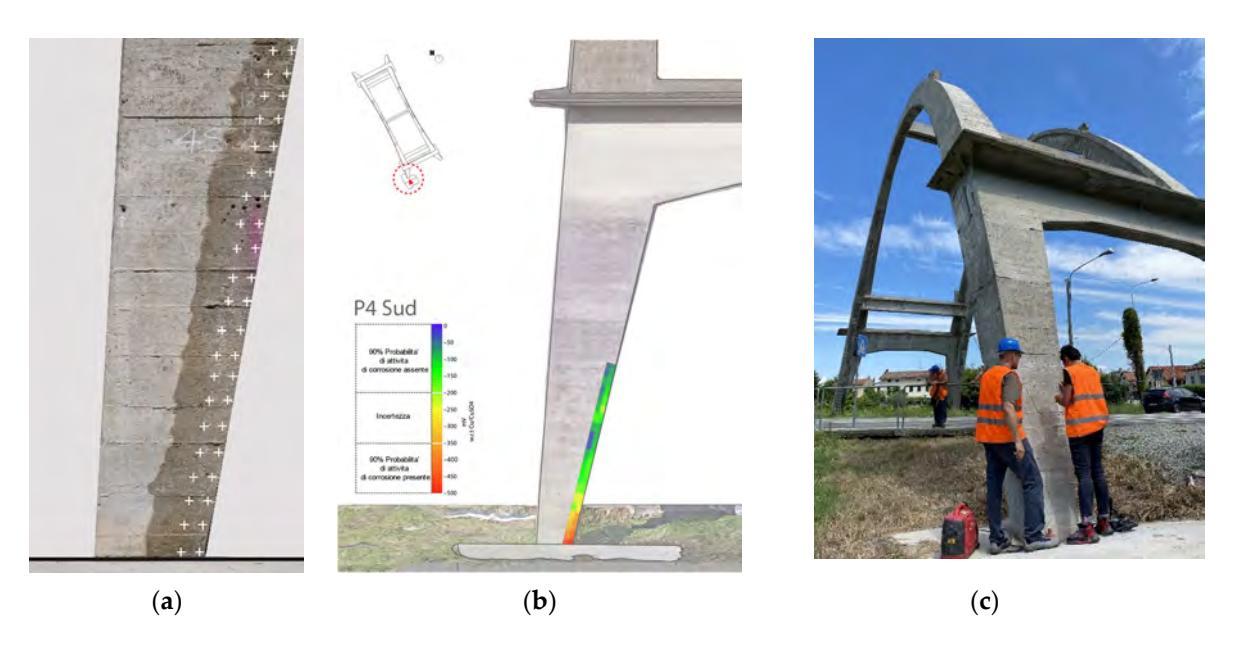
The data collected were translated into color contour maps to better illustrate the findings (Figure 12). Negligible corrosion levels were detected at the time of testing.

Figure 12. (a) Diagram illustrating the grid used to record the potential measurements ("+" indicate measuring locations); (b) an example of a half-cell potential map (the red circle specifies the arch pillar); (c) a photograph of the team during the fieldwork.

A half-cell potential survey was carried out in accordance with the ASTM C876-22b Standard Test Method for Corrosion Potentials of Uncoated Reinforcing Steel in Concrete [35]. The test was conducted by using a copper–copper sulfate reference electrode. Continuity testing was carried out before completing the corrosion testing to assess the presence of electrical continuity within the existing steel reinforcement. Due to limited continuity found between the existing steel reinforcement, testing was carried out in limited areas.

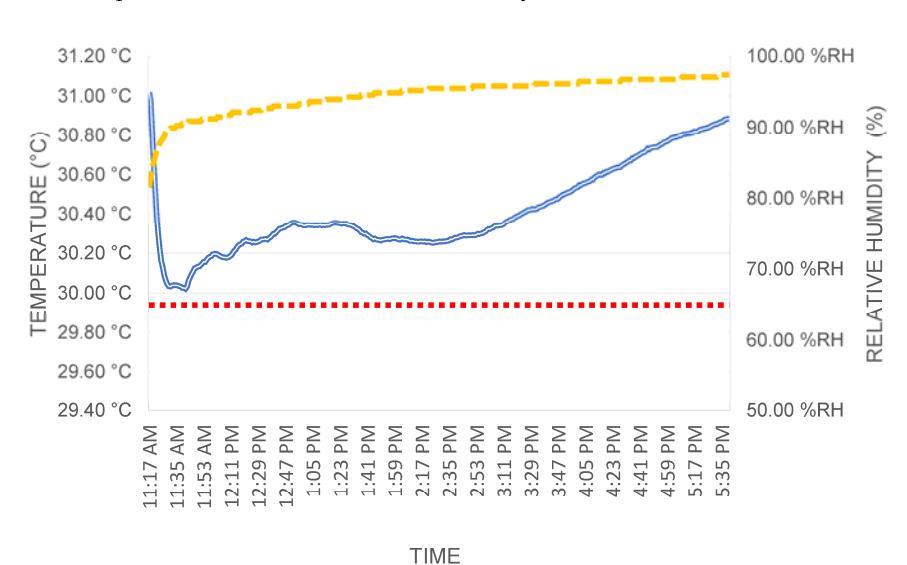
Environmental monitoring is an important factor to consider when assessing reinforced concrete structures. Several of the common deterioration mechanisms that affect reinforced concrete structures are initiated by a certain level of moisture present within the material. With corrosion, moisture is one of the two ingredients, together with oxygen, that needs to be present for the reaction to occur. Internal environmental monitoring was carried out at one location. A temporary sensor was installed inside the concrete to measure the internal temperature and humidity levels. Measurements were recorded every 20 min during the field workday (approximately 5 h). From the internal environmental monitoring, a high moisture content was detected from the data collected on site (Figure 13).

Figure 13. Graph illustrating the data collected of the internal temperature and humidity at the concrete column.

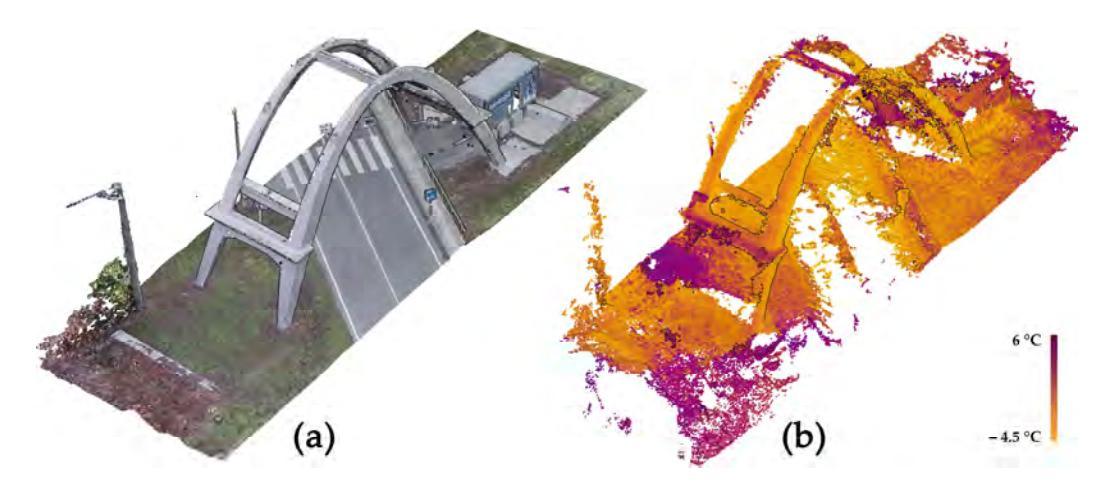
Figure 14. (a) Photogrammetric dense point cloud derived from the images acquired from the DJI Zenmuse XT2 visible sensor; (b) photogrammetric dense point cloud derived from the TIR images acquired from the DJI Zenmuse XT2 thermal sensor.

For these reasons, in many cases, the 3D reconstruction derived from the photogrammetric use of TIR images was characterized by a high level of noise and by the presence of numerous topological errors, gaps, or lack of information (Figure 14b). Often it is necessary to follow tailored strategies in order to optimize the results derived from the photogrammetric processing of the acquired thermal images. In most cases, a data fusion strategy is highly recommendable since it exploits the high spatial resolution of visible data (Figure 14a) in order to provide spatial referencing for the thermal information.

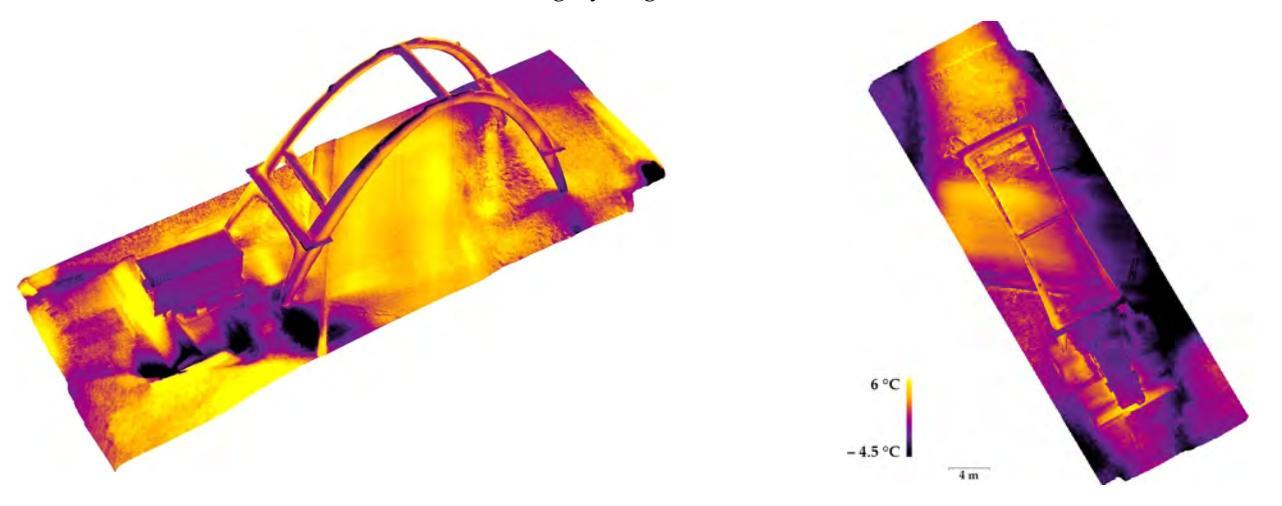
Figure 15. A 3D mesh derived from the integration between the visible data and the oriented TIR images.

- A high-resolution thermal-textured 3D mesh (Figure 15);
- Thermal orthoimagery (Figure 15).

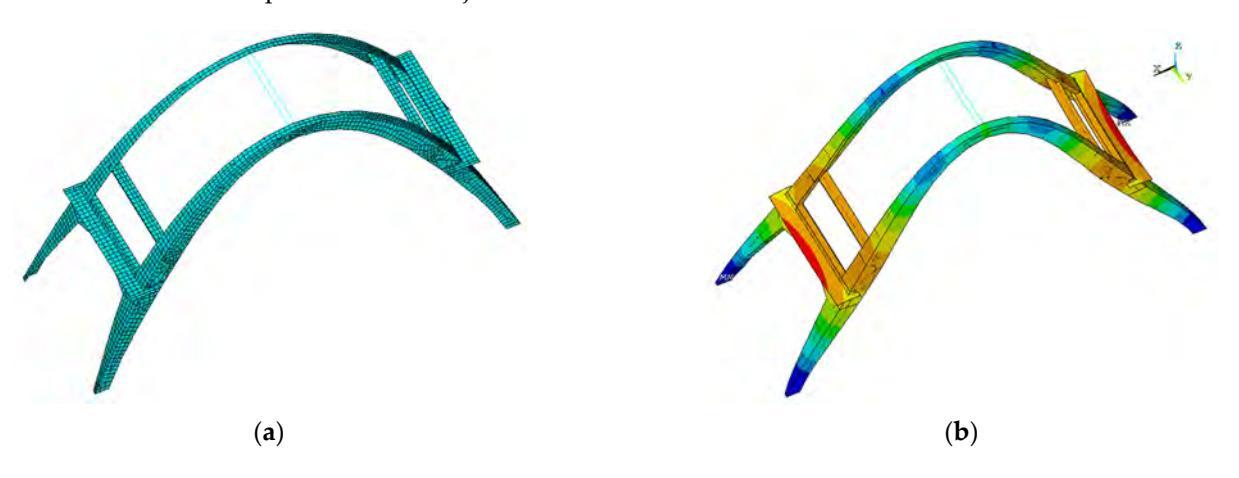
Figure 16a,b reports a view of the FE meshed model and the results of the static analysis, respectively. Overall, the distribution of deformations and stresses confirmed the substantial symmetry of the structure. The deformed shape of the structure indicated that the arch experienced its maximum deformation around the middle portion of the arches, in particular, at the joint with the beams.

Figure 16. (a) View of the 3D finite element modeling of the arch; (b) results of the static analysis that identified the static deformations of the structure (the scale goes to blue, deformations close to zero, to red, were the maximum deformations appear).

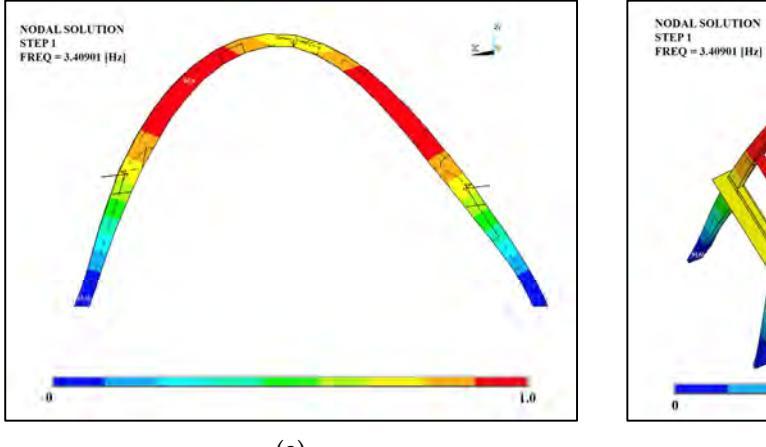
Figure 17. Mode 1: (a) lateral view; (b) perspective view.

In order to spot possible criticalities to be better analyzed, structural and eigenvalues analyses were also carried out. Based on an average of all six degrees of freedom, modes 1, 2, 4, 5, and 6 were the modes that excited the most mass; the mode that affected the largest percentage of mass was the first mode, which corresponded with the translational modal form along the x and y directions, with model 2 in second place (Figures 17 and 18). Overall,

it can be said that the behavior was governed by the interaction of the arches, which were modelled as being perfectly connected to each other by the presence of the beams. Further experimental tests could investigate the actual connection of these elements to the arches since they could affect both the global and local responses of the structure from a seismic point of view.

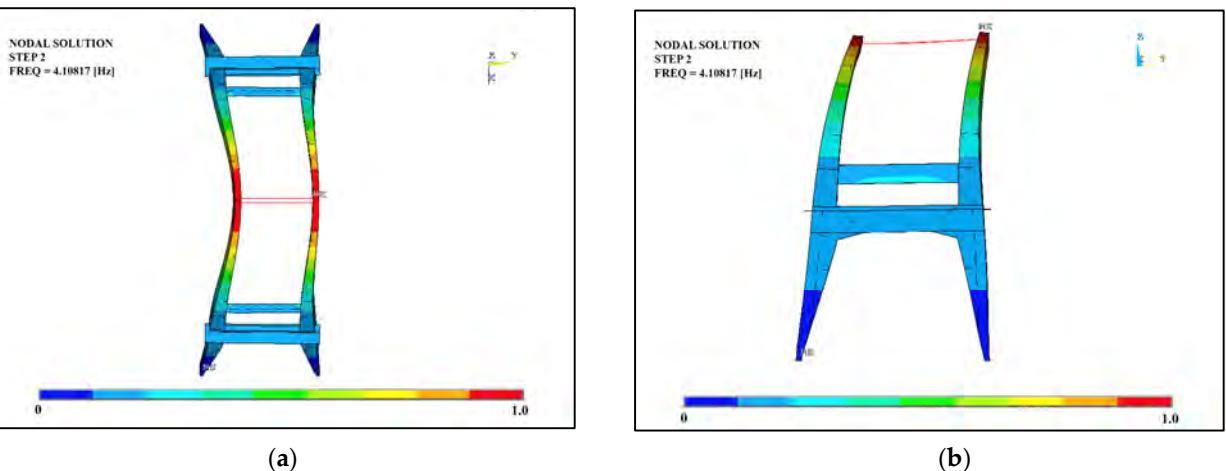
Figure 18. Mode 2: (a) top view; (b) lateral view.

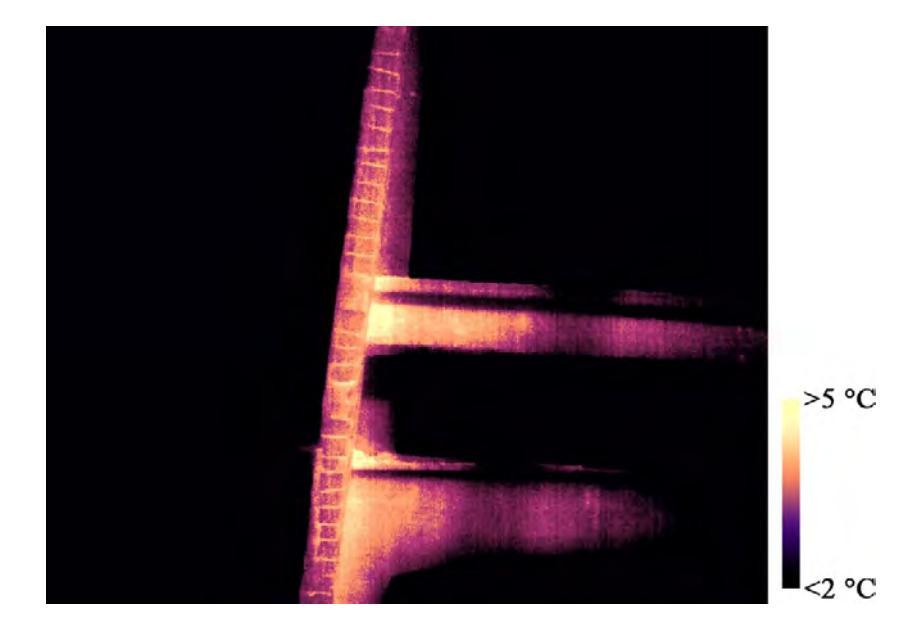
Moreover, the use of this type of imagery can represent a powerful alternative when the purpose is not only to identify but also to classify certain types of degradation. As an example, in Figure 19, it is possible to observe a portion of the intrados of the concrete arch of Morano. By exploiting the difference in terms of emissivity—leading to different temperature values—that characterizes the uncovered irons and the cement surface, it was possible to unambiguously identify, and consequently classify, the portion of the image occupied by the exposed steel bars by segmenting the pixels belonging to this class.

Figure 19. TIR image evidencing a thermal discrepancy between the uncovered irons and the concrete of the arch.
