ESREL 2024 Collection of Extended Abstracts

Defect Detection In Vehicle Painting: Case Study

Doaa Almhaithawi^a, Alessandro Bellini^b

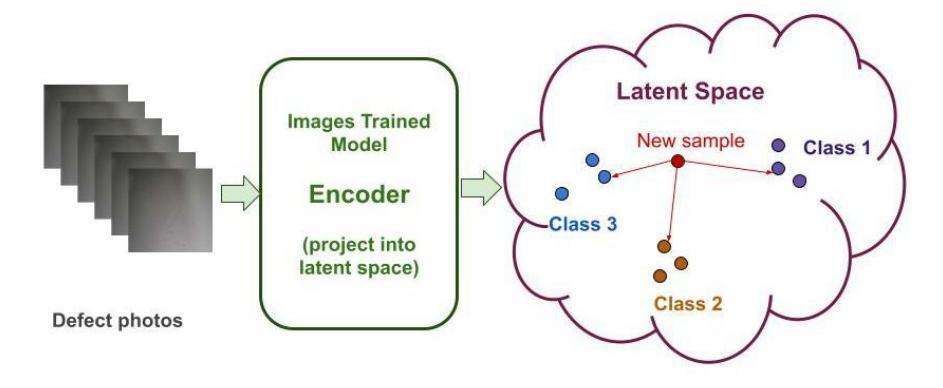
- 1) using the latent space of the images of an existing trained model;
- fitting the model to the defect dataset by projecting its samples into this latent space to obtain the casespecific new space;
- 3) investigating the similarities and differences in the latent representations of the samples;
- 4) using this new space for inferring new samples.

Fig. 1. Proposed solution methodology.

Proposed Solution. To train an effective AI system with relatively scarce amount of data, with respect to the usual datasets, our approach aims to reduce the dataset dimension for defect detection by moving from the image's pixels to more abstract representation, namely Latent Space, which many models use to embed real data into a numerical vectoral space. These latent spaces are built and modified through the training phase and the resulted space is used later for inference or to generate new samples. Our methodology will follow the steps shown in Figure 1:
