Procedia Structural Integrity 64 (2024) 1873-1879

# SMAR 2024 – 7th International Conference on Smart Monitoring, Assessment and Rehabilitation of Civil Structures

# Effect of Textile Architecture on the Durability of Flax Textile-Reinforced Mortars

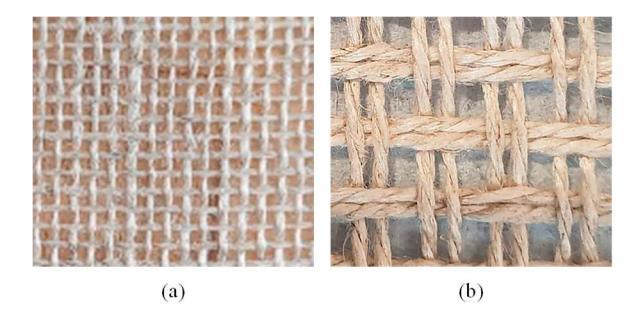
Fig. 1. Flax textile reinforcements adopted in the present study: (a) "K" and (b) "F" textiles.

Two types of flax textiles were used as structural reinforcement, including: 1) a flax textile comprising single twist yarns (denoted as "K") arranged in a 1.5-mm mesh with linear density equal to 100 TEX; 2) a flax textile comprising two-ply twist yarns arranged in pairs across a 4-mm mesh (denoted as "F") with linear density equal to 324 TEX (Fig. 1). Both textiles were woven (i.e. warp and weft yarns are interlaced at 90° to each other), balanced bi-directional, with a bulk density equal to  $1.5 \text{ g/cm}^3$ . The yarn's cross-sectional area was found equal to  $0.07 \text{ mm}^2$  and  $0.22 \text{ mm}^2$  for K and F textiles, respectively. It should be noted that the origin of the two types of flax fibres used in the textile production, and whether it was common to both textiles or not, is unknown.

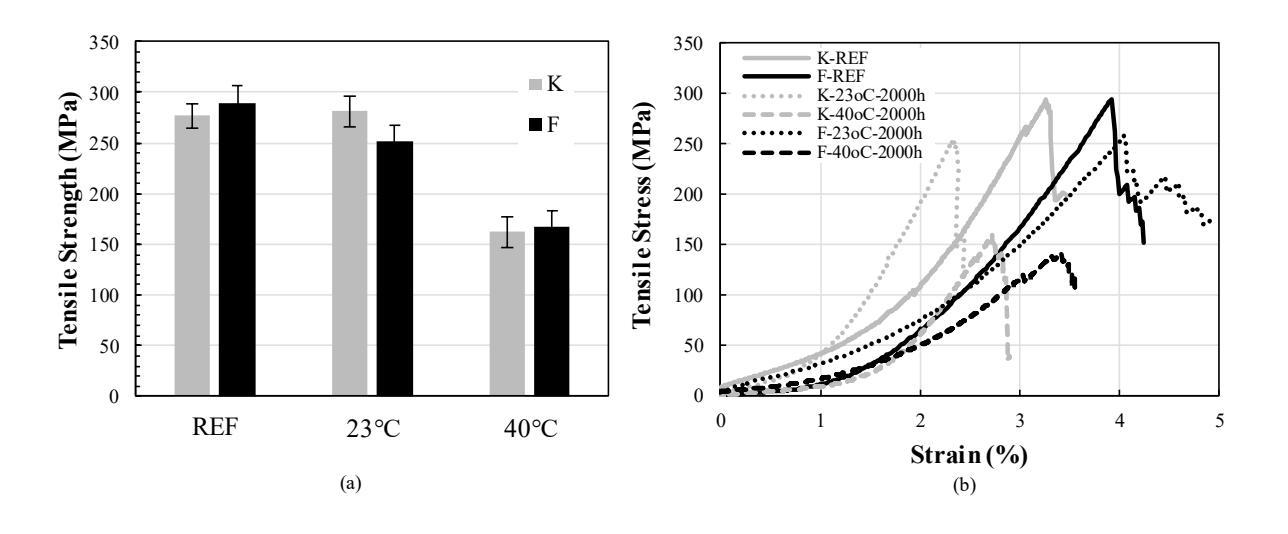
Fig. 2. (a) Tensile strength; (b) stress-strain curves of typical K and F bare textiles before and after exposure for 2000h.

Table 1 summarises the average mechanical properties of the bare "K" and "F" textiles before and after exposure to accelerated ageing. Fig. 2a illustrates the effect of the conditioning protocol on the tensile strength, while Fig. 2b presents the tensile stress–strain curves obtained from representative textiles from each conditioning protocol.

An initial inelastic behaviour followed by a linear elastic response up to the peak stress was consistently observed for both types of flax textiles. In all cases, failure occurred due to the progressive rupture of the individual yarns. Both types of unconditioned flax textiles attained similar values of strength (277 - 289 MPa) and ultimate strain (3.5-3.8%), in good agreement with those reported in previous studies (Ferrara et al., 2019).

Although exposure to 23°C for 2000h did not result in a significant change in the mechanical properties, given the observed variability, a decrease in tensile strength of up to 42% was recorded after exposure to 40°C, which accelerated the chemical reactions and the resulting degradation of the flax fibres.

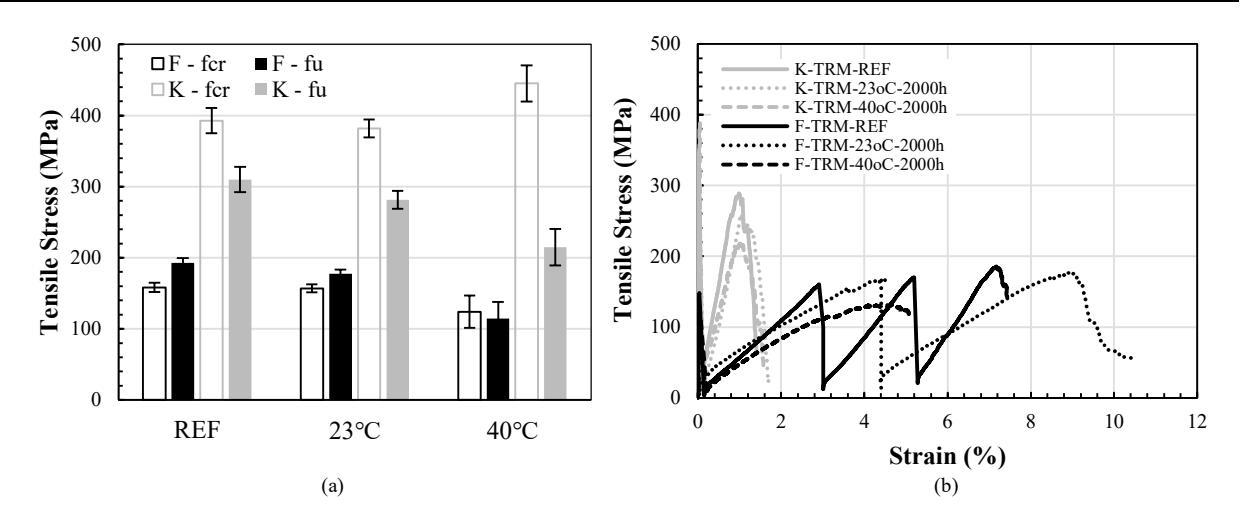
Fig. 3. (a) Cracking/ultimate strength; (b) stress-strain curves of typical K and F TRM composites textiles before and after exposure for 2000h.

Fig. 3a compares the average value of the tensile strength of TRM composites reinforced with two layers of "K" and "F" textiles, while Fig. 3b shows the tensile stress-strain response of representative TRM specimens from each system and ageing protocol. A summary of the average mechanical properties, their CoV, as well as the strength retention rate, calculated as the ratio of the ultimate strength of the TRM after exposure to that of the unconditioned TRM, are reported in Table 2.

The different ultimate strength attained by the two TRM systems can be explained upon the analysis of the associated stress-strain response (Fig. 3b). All "K"-TRM composites achieved a cracking load value higher than that of the maximum load attained during the cracked stage, with no strain hardening behaviour, exhibiting only one single crack during the test. This behaviour was observed in both unconditioned and aged composites, indicating that the reinforcement ratio in "K"-TRM composites (0,8%) was insufficient to enable stress redistribution. Failure occurred due to slippage of the yarns within the mortar in the proximity of the crack, followed by yarn rupture. For unconditioned coupons, the ultimate strength was similar to that attained by the corresponding bare "K" textiles. On the contrary, reference and conditioned "F"-TRM specimens at ambient temperature for 2000h presented the typical stages generally observed in TRM systems: i) stage I, where the stress increases linearly with the first crack formation, ii) stage II, crack development attributed to the degree of bond at the textile/mortar interface, iii) stage III, crack saturation and linear increase in stress until the peak load. The ultimate strength was immediately followed by the progressive failure of individual yarns, with unconditioned specimens showing typically more cracks than specimens conditioned at 20°C for 2000h. Stages II and III were not always distinguishable, with crack formation being accompanied by large energy release. This resulted in the limited contribution of the "F" reinforcement to the overall composite performance, and a lower exploitation of the textile strength (~67-70%) for both unconditioned and
