Durability of flax textile-reinforced mortar systems

Durability of flax textile-reinforced mortar systems / Trochoutsou, N.; Baldassari, M.; Monaco, A.; Cornetti, P.; Guadagnini, M. - ELETTRONICO. - (2024). (Intervento presentato al convegno Sixth International Conference on Sustainable Construction Materials and Technologies (SCMT6) tenutosi a Lyon (France) nel 9-14 June 2024) [10.18552/2024/SCMT/327].

# DURABILITY OF FLAX TEXTILE-REINFORCED MORTAR SYSTEMS

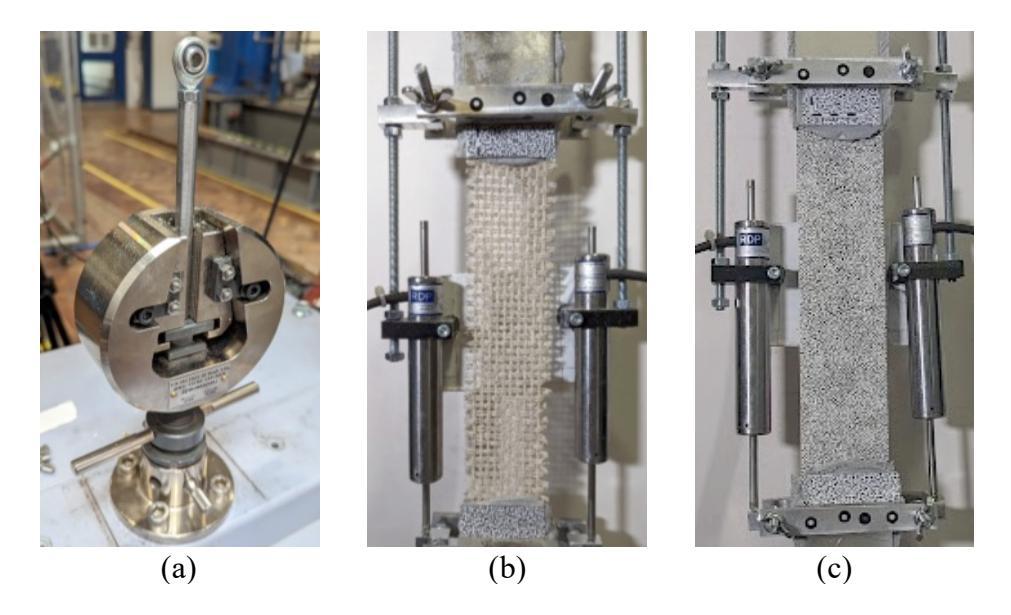
Figure 1. (a) Spherical joint of the clevis grips; (b) setup for textiles; (b) setup for FTRM composites.

Direct tensile tests were performed on bare textiles and FTRM composites following the EAD 340275-00-0104 (EOTA, 2020). The tests were carried out in displacement control in a universal testing machine of 10 kN capacity, at a displacement rate of 0.5 mm/min for the bare textile and 0.2 mm/min for the composites. The load was transferred through clevis-type grips, allowing for in- and out-of-plane rotation of the specimens while being loaded (Figure 1a).

An overview of the experimental setup is presented in Figure 1. Displacements were recorded by both contact and non-contact instrumentation. Two LVDTs were placed on opposite sides of the specimens and recorded uniaxial deformation. In addition, a bespoke 2D Digital Image Correlation (2D-DIC) setup was employed to obtain full-field displacement measurements of both textiles and FTRM composites. Detailed results from DIC analyses will be presented in future publications.

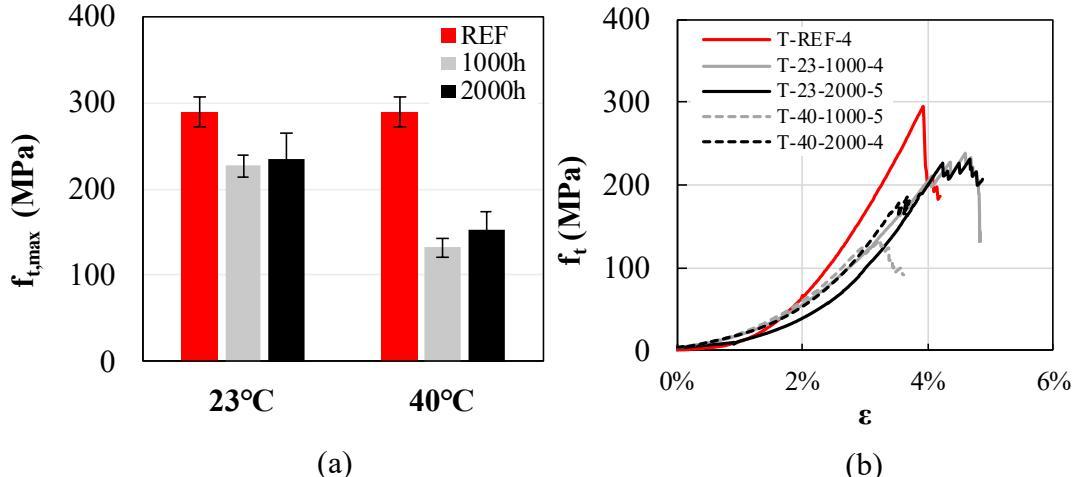
Figure 2. (a) Textile strength versus temperature and exposure duration; (b) typical tensile stress-strain of representative specimens from each conditioning protocol.

modulus was calculated as the secant modulus of the linear part in the stress–strain response curve to allow the characterisation of the largest stiffness that can be developed. The tensile strengths developed in the textiles after each conditioning protocol, along with the associated standard deviation values, are compared in Figure 2a, while the tensile stress-strain response of representative textiles from each conditioning protocol is shown in Figure 2b.

However, when subjected to 23°C and 40°C for 1000 h, flax textiles suffered a reduction in tensile strength and stiffness of about 22-24% and 50-54%, respectively. This is probably due to the combined effect of anisotropic swelling of the flax fibre multi-stack structure during immersion (Le Duigou *et al.* 2015), and the progressive alkaline hydrolysis of the chemical components of the fibre cell-walls (Wei and Meyer, 2015), which was accelerated under higher temperatures. Longer exposure durations did not seem to result in any further deterioration in the mechanical properties, taking into account the reported variability in Table 2 and illustrated in Figure 2a.

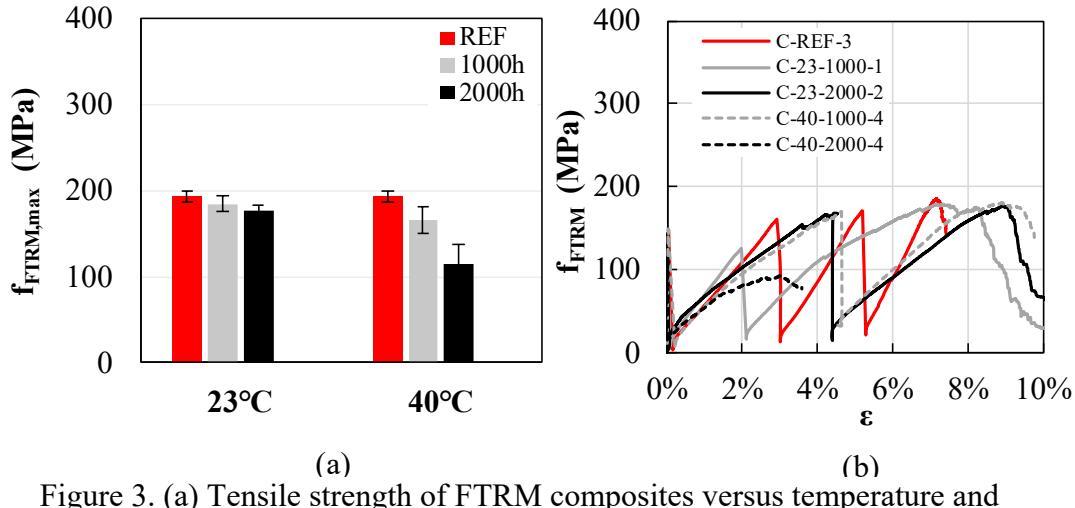
exposure duration; (b) typical tensile stress-strain of representative specimens from each conditioning protocol

The results of the tensile tests on the FTRM coupons are summarised in Table 3 in terms of average maximum strength at cracking,  $f_{cr}$ , and at failure,  $f_{FTRM,max}$ , corresponding strains,  $\varepsilon_{cr}$  and  $\varepsilon_{FTRM,max}$ , exploitation ratio of the textile,  $\eta = f_{FTRM,max}/f_{t,max}$ , and strength retention ( $f_{FTRM,max}/f_{FTRM,max}(REF)$ ). The stress was calculated by dividing the load by the cross-sectional area of the textile (accounting for two layers of reinforcement), while the exploitation ratio was calculated as the ratio of the maximum strength developed by the FTRM composite to that developed by the bare textile exposed to the same environment. Figure 3a compares the average values of  $f_{FTRM,max}$ , while Figure 3b shows the tensile stress-strain response of representative composites subjected to the examined conditioning protocols.

In general, accelerated ageing resulted in a loss of tensile strength, which was minimal after exposure to  $23^{\circ}$ C ( $\leq -10\%$  after 2000 h) and more significant after exposure to  $40^{\circ}$ C, (-40% after 2000 h). Regardless of the conditioning protocol, all specimens failed due to fibre rupture after distinct large cracks were formed in the composites. However, the different exposure conditions affected the crack development stage, with conditioned specimens being characterised by the development of two major cracks, typically close to the gripping tabs, which widened significantly during the test. Exposure to harsher environments (40°C, 2000 h) led to a composite performance with no strain hardening and absence of the crack development stage, indicating that the significant degradation occurring in the fibres, also evidenced by the reduction in the ultimate tensile strength of the composite, resulted in a further reduction of the actual reinforcement ratio.
