Reinforcement design and control of rock slopes above tunnel portals in Northern Italy

REINFORCEMENT DESIGN AND CONTROL OF ROCK SLOPES ABOVE TUNNEL PORTALS IN NORTHERN ITALY

Abstract: The stability features of slopes located above the portals of tunnels along important roads are here presented, together with two examples for reinforcement and protection works. The investigation phase and the reinforcement works have considered also the purpose of avoiding the interruption of the traffic when this would cause unacceptable consequences. The first case refers about the construction of a portal along a narrow and steep valley in a volcanick rock formation. The control of the vibration of the blasting action has been carried out for the period of the excavation in order to foresee the occurrence of potential dangerous situations. The second is the case of the portal of the East access to the Highway n.10. Even though the adits are protected by two portals, the occurrence of rock and debris falls from the upper part of the mountain could create a dangerous situation. Above the portals the morphology of the slope is characterized by two subvertical rock slopes, which are separated by an

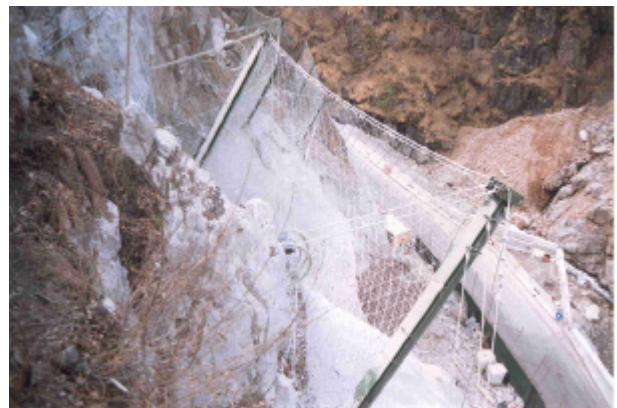
Figure 1. *View from the upper part of the rock slope: some net fences are visible and in the right side the existing road.*

One of the adits was arranged with limited excavation at the external part of the steep and high rock slope, with heavy reinforcement of the rock mass and with the installation of passive protection; the rock reinforcement has been made by means of rock bolting and wire mesh, sometime coupled with shotcrete, while the passive protection has been made of net fences.

In the area surrounding the adit also some detritic surface formation occurred and for this reason the remedial works were made of wire mesh and bolting (for the fractured rock mass) and net fences (for the debris protection).

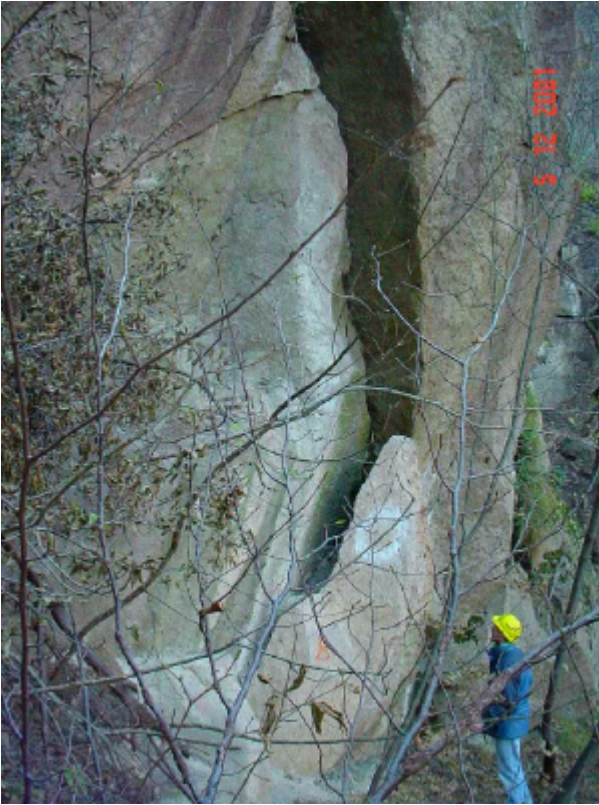
Figure 2. Detail of the rock mass structure 30 m above the tunnel portal.
