Influence of the microstructure on fatigue and fracture toughness properties of large heat-treated mold steels

D. Firrao<sup>1</sup>, P. Matteis<sup>1</sup>, P. Russo Spena<sup>2</sup>, R. Gerosa<sup>3</sup>

This is the author post-print version of an article published on *Materials Science and Engineering: A*, Vol. 559, pp. 371-383, 2013 (ISSN 0921-5093).

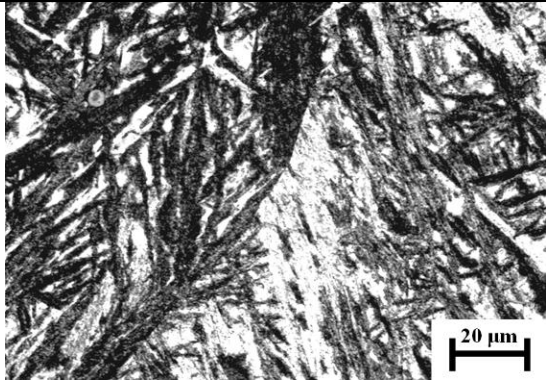
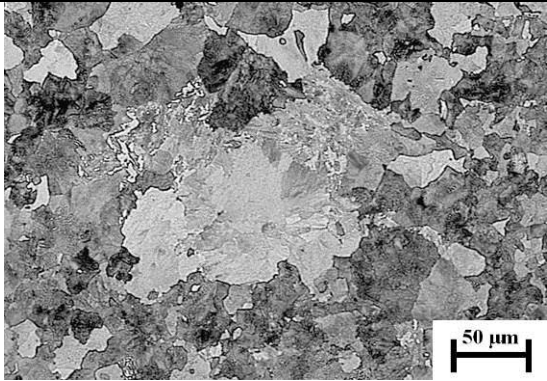
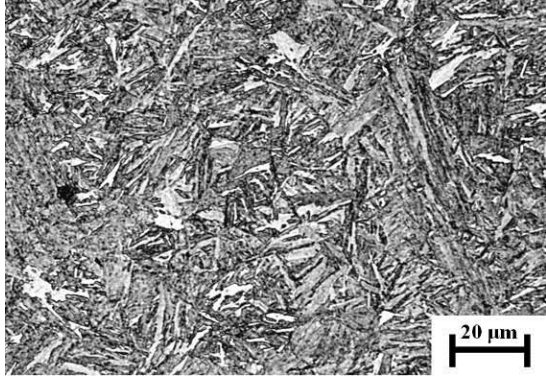
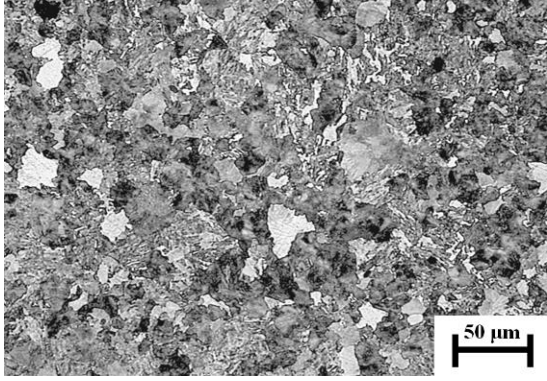
<p>~25 mm depth, tempered martensite</p>

<p>~460 mm depth, pearlite</p>
B

<p>~55 mm depth, tempered martensite</p>

<p>~650 mm depth, pearlite and bainite</p>

Fig. 3. Surface and core microstructures of the A, B, and C blooms. Optical microscopy.

The varying microstructures of the blooms were examined at increasing depth along either the S direction (C bloom) or T direction (A and B blooms), from surface to core, the large bloom size implying local cooling rates, during the quenching, sensibly different as a function of the depth. The microstructure of the ISO 1.2738 steel blooms, Fig. 3, consists mainly of tempered martensite close to the surface, of lower and upper bainite (affected by tempering) in most of the bloom volume, and of fine and ultra-fine pearlite at core (the lamellar morphology was resolved by SEM, as for instance shown in Fig. 4); rare islands of retained austenite are also detected in the bloom section. The tempered martensite and the lower bainite have a needle-like appearance, whereas, going towards the bloom core, the microstructural constituents become less acicular and pearlite colonies appear and become increasingly common at larger depth. It can be noted that the microstructures are generally finer in the B bloom than in the A one, probably due to smaller PAGs.

In A bloom, pearlite first appears at a smaller depth than in B bloom, 155 mm and 285 mm respectively, and with a less homogeneous distribution (i.e. mainly at PAG boundaries). Close to the core, fine pearlite, is the main constituent in all examined blooms; nevertheless a significant fraction of bainite is still detected in B bloom, Fig. 4, whereas the same constituent is almost absent in A bloom.

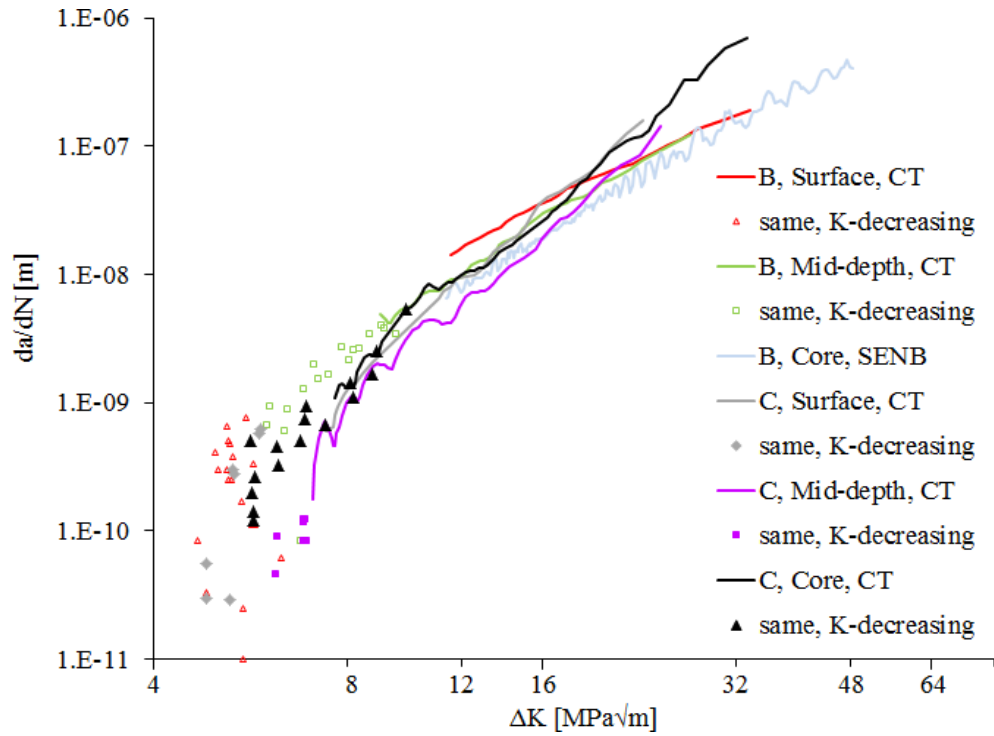
Fig. 11. FCG behavior of steel B and C bloom specimens at different bloom depth. Plot of K-increasing (lines) or K-decreasing (isolated points) tests. SENB or CT samples.

The fatigue crack growth rates (regardless of the measurement techniques) of B and C steels at different bloom depth, with the former both in the original and in the RHT condition, are herein stated. Results are expressed in terms of crack tip stress intensity factor range ( $\Delta K$ ), from the fatigue threshold to the  $K_{max}$  controlled instability (i.e. fracture). The  $\Delta K$  threshold value was determined by the decreasing method down to crack growth rates of about  $10^{-10}$  m/cycle. The overall FCG behavior of the as-received B and C bloom samples are shown in Fig. 11. The Paris slope of B bloom sample ranges from 2.4 to 3.2, whereas that of the C one is slightly steeper. In this way, even if the C bloom samples exhibit a lower FCG rates at stress intensity factor ranging up to about  $15 \text{ MPa}\sqrt{\text{m}}$ , their FCG rates exceed those of the B bloom samples at  $\Delta K$  values higher than  $20 \text{ MPa}\sqrt{\text{m}}$ . The  $\Delta K$  threshold of all samples were estimated between  $5$  and  $6 \text{ MPa}\sqrt{\text{m}}$ , even though the data dispersion could hide possible differences in the FCG threshold region.

From the fatigue crack growth test results, it is understood that almost all as-received bloom specimens exhibit similar fatigue crack growth resistance and fatigue thresholds, despite the different microstructures (Figs. 11 and 12). The overall FCG rate of the B bloom specimens generally decreases (for a fixed SIF cycle, or  $\Delta K$ ) from surface to core. This result can be compared to the fatigue strength at  $4.2 \cdot 10^6$  cycles of smooth rotating bending specimens cut from the same bloom, that generally decreases from surface to core. In the Paris law region, the FCG behavior of the B bloom surface material, that consists mainly of tempered martensite, is very similar to that of the RHT tempered martensite sample, despite the much lower fracture toughness ( $K_{Ic} = 35$  vs.  $\sim 80 \text{ MPa}\sqrt{\text{m}}$ ) of the former. In the bloom core, the pearlitic microstructure has a FCG rate higher than the RHT pearlite samples. By comparing the FCG results of the as-received and ISO 1.2738 RHT bloom samples, it is apparent that, at  $\Delta K$  values larger than  $20 \text{ MPa}\sqrt{\text{m}}$  the tempered martensite and the pearlite can be regarded as an upper and a lower boundary, respectively, for the FCG rate of the varying microstructures inside a pre-hardened bloom.
