A new experimental snow avalanche test site at Seehore peak in Aosta Valley (NW Italian Alps) – Part II: engineering aspects

Keywords Avalanche dynamics; small and medium avalanches; experimental site; NW Italian Alps

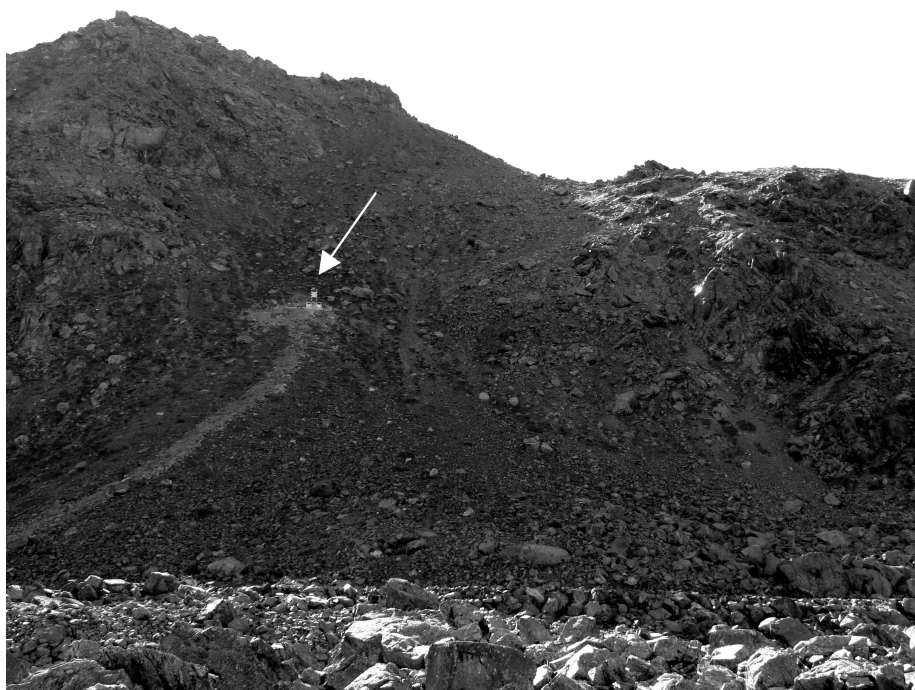
Figure 2: Frontal view of the test site in summer. The arrow marks the obstacle position.

Close to the location of the instrumented obstacle the following types of coverage were observed (see Figure 2):

The obstacle and the measurement systems rest on a concrete slab 3 m long by 3 m wide and 0.6 m thick, placed approximately in the position shown in Figure 2. They were designed to resist the impact of avalanches running along the path and to measure velocity and impact forces. The foundation was embedded so that it emerges only 0.6 m from the natural slope. Gabions filled with material readily available on site were used to support the excavation; this choice helped to minimize the environmental impact, also reducing the amount of concrete to be cast in place (Figure 3).

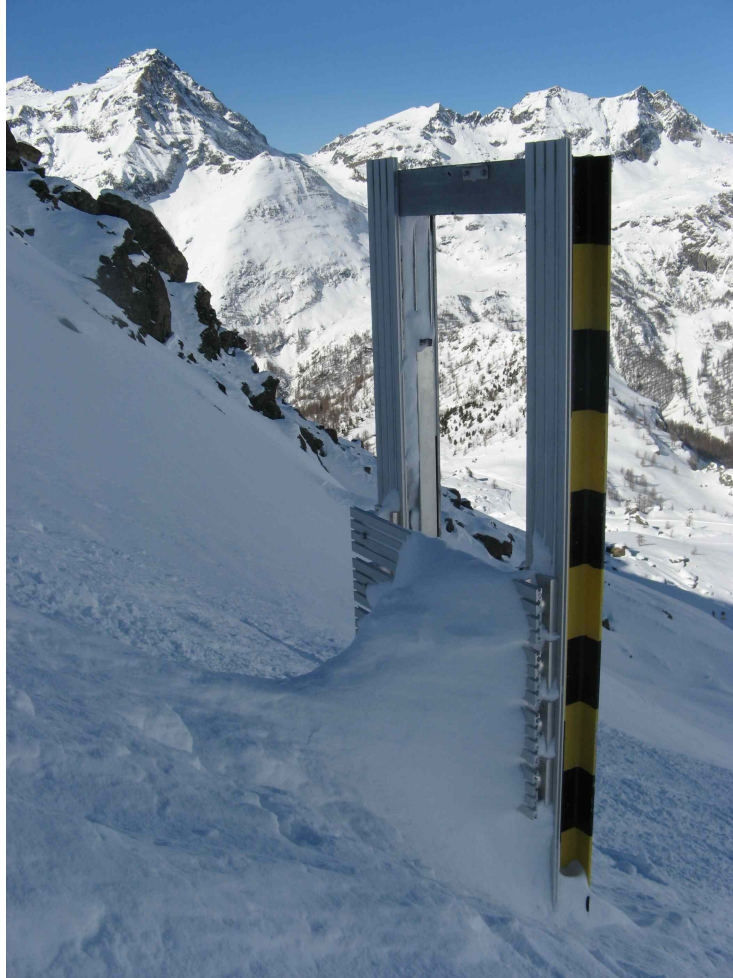
Figure 4: View of the obstacle after an avalanche event. Only the upper part of the steel structure emerges from the snowpack.

The following main parts were assembled (Figure 4):

The impact surface is made of an array of 5 aluminum grooved plates placed at different heights, each one supported by two load transducers, which are connected to the structure. The load transducers are, in turn, mounted on slides that can be easily moved along vertical guides: this design permits their positioning at the desired height above the ground level. The total area of the impact plates is 1 m² (Figure 4).

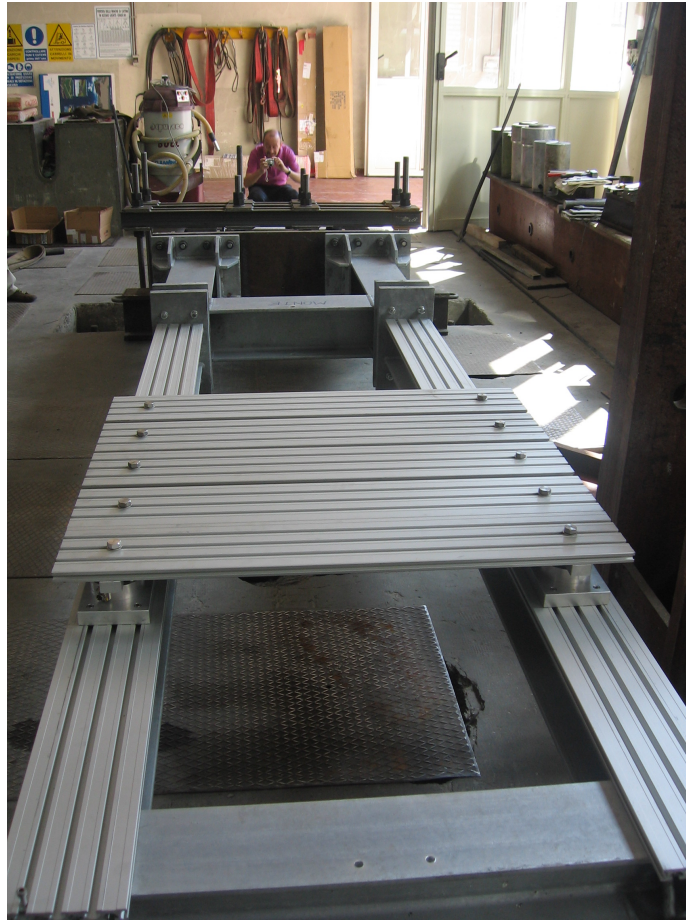
Figure 6: The obstacle mounted in horizontal position as tested in the laboratory.

In order to validate the design assumptions, a number of tests have been carried out at the laboratory of structural mechanics of the Department of Structural, Geotechnical and Building Engineering of the Politecnico di Torino. The complete structure had been assembled within a specially built testing frame in order to place the obstacle in a horizontal position (Figure 6).
