2015 J. Phys.: Conf. Ser. 628 012102

## Non-destructive testing on aramid fibres for the long-term assessment of interventions on heritage structures.

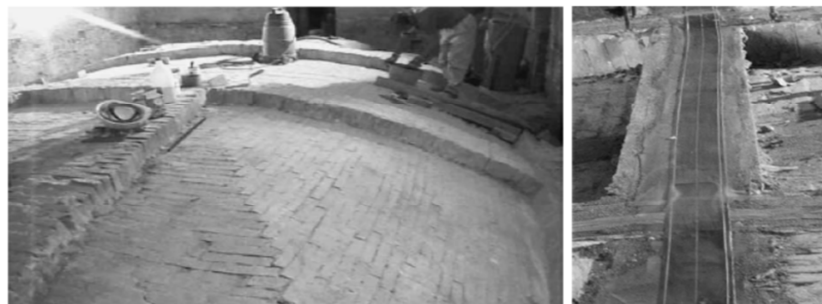
**Figure 1.** (a) The masonry vault and reinforcement arches dated 1600 during surface preparation for CFRP application. (b) Smart CFRP sheet placed on vault [3].

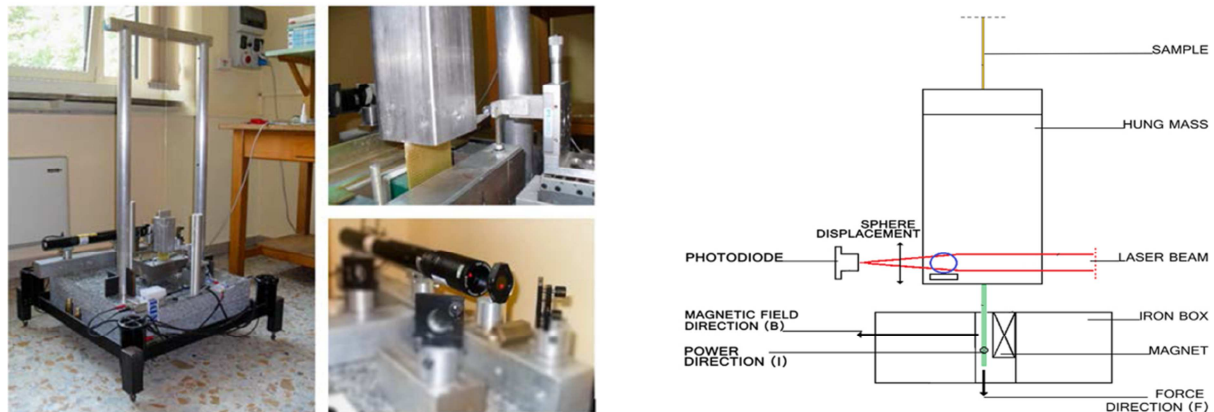
**Figure 2.** (a) The testing setup. (b) Micrometer slides, magnet for forced oscillation testing and hung mass. (c) He-Ne laser beam generator, attenuator and mirrors. (d) Schematic representation.

The testing machine frame (Figure 2.a) is composed of a rectangular crossbeam ( $L=45$  cm, cross section:  $4 \times 4$  cm) made of aluminium, transversely bounded at two cylindrical aluminium holed columns ( $h=95.4$  cm; diameter: 5 cm, thickness: 0.5 cm) on a massive square basement ( $60 \times 60$  cm) made of marble with a thickness of 14.5 cm. An isolation steel table supports the marble mass, this allowing to neutralize most of environment vibrations. The materials used for the testing system were selected in order to minimise the effect of the temperature excursion in the laboratory.

The specimen, consisting of parallel fibres, were mounted vertically, with the top fixed at the horizontal crossbeam and at an aluminium block at the lower part; a special device was inserted at the bottom in order to measure the specimen displacement during the test (Figure 2.b).

A helium-neon generator was used for the experiment (Figure 2.c) in order to produce the laser beam. The device is able to emit a coherent, monochromatic and concentrated light beam in a highly collimated beam straight, through the process of stimulated emission. The laser generator is mounted on a suitable support, so that the laser beam was emitted in the horizontal direction with respect to the anti-vibration table.

An attenuator is an electronic device that reduces the power of a signal without appreciably distorting its waveform. The attenuator was used to prevent saturation of the photodiode, attenuating the beam light (Figure 2.c).

Metal mirrors were used to adjust the direction of the laser beam. They were mounted on supports in order to be adjusted for different inclinations. The combined movement of rotation about the horizontal and vertical axes of the two mirrors allows to determine completely the direction of the light beam (Figure 2.c).

A photodiode, which converts an optical signal to an electric signal, was mounted on three precision micrometre slides. Two of these were assembled together in reference to the X-direction (parallel axis to the plane formed by the optical bench and orthogonal to the laser beam) and Z-direction (orthogonal axis to the plane formed by the optical bench and orthogonal to the laser beam direction). The third slide is positioned in a parallel direction to the bench and the laser beam (Figure 2.b).

In Figure 2.b it is also possible to notice the hung mass of 1.375 kg which was used to form a 1-DoF system with the specimen acting as spring. A copper wire coil was placed inside a magnet and aligned so that an electromagnetic force in the vertical direction could be produced and applied to the hung mass and, consequently, to the fibres (Figure 2.b).

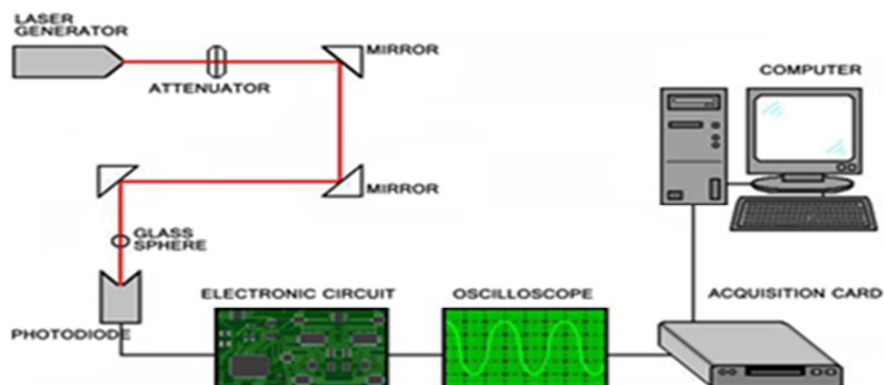
**Figure 3.** Principle of operation - schematic representation.

The principle of operation of the instrumental apparatus used in the tests (Figure 3) can be summarized in the following stages. The light source produced by the laser generator was forced to follow a predetermined path by means of a prism and two lenses. These lenses, if properly set, deflected the laser beam causing it to converge towards the instrument test, where the sample was allocated. In order to allow the photodiode to read the optical signal and, consequently, the possible displacement of the fiber, a glass sphere (connected to the hung mass) with a diameter of 8 mm was used, which, working as a convex lens, focuses the beam to a very precise point of the marker located inside the photodiode (Figure 2.b). The marker was divided into four sectors, generally square. The sensor read the movement of the glass sphere and indirectly the elongation of the fiber, in relation to the quadrant where the laser beam was focused. Therefore, it was important to make a correct positioning of the

photodiode using the micrometer slides. Indeed, for the system in a quiescent state, the read signal was set equal to zero. An electronic circuit was used to link the photodiode to an oscilloscope. An acquisition card and a Lab View application were used to record the collected data on csv files.

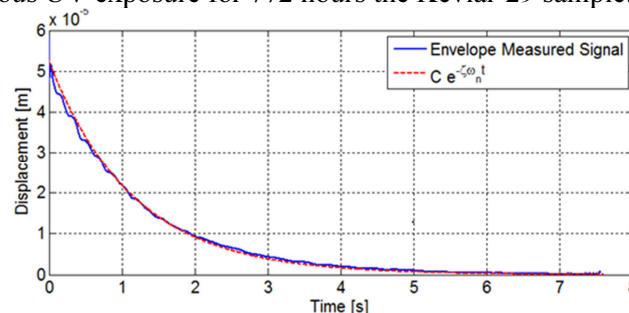
**Figure 4.** Kevlar-29 pristine sample: fitting of the envelope of the acquired signal.

In order to characterise the dynamic behaviour of the fibres, free-decay tests were performed. The tests allowed for the identification of natural frequencies and damping ratios of both specimens. The system identification was achieved with time domain fitting techniques applied to the Hilbert transform envelopes of the acquired signals (Figures 4 and Figure 5). Results were also validated by using standard ERA techniques [8].

The application of curve fitting techniques over free-decay signals sampled at 2500 Hz gave for the Kevlar-29 pristine samples, a resonance frequency of  $(20.30 \pm 0.03)$  Hz and an experimental damping ratio of  $(0.7 \pm 0.1) \%$ ; whilst for the Kevlar-29 damaged samples, a value for natural frequency of  $(19.80 \pm 0.02)$  Hz and experimental damping ratio equal to  $(0.6 \pm 0.1) \%$  were evaluated. The spread of the results was computed using 7 free-decay measurements for both samples. The high sensitivity of the measurement device allows to quantify low damping ratio and frequencies with a high level of accuracy. These damping ratios can be directly linked to the intrinsic material dissipation factor, because all other dissipation phenomena can be actually neglected. The mean value of the natural frequency was used to estimate the elastic dynamic modulus of the fibres.

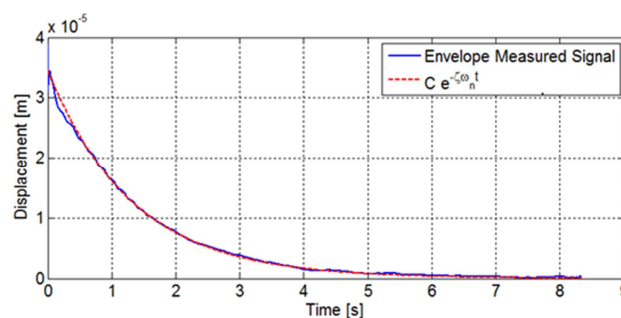
**Figure 5.** Kevlar-29 damaged sample: fitting of the envelope of the acquired signal.

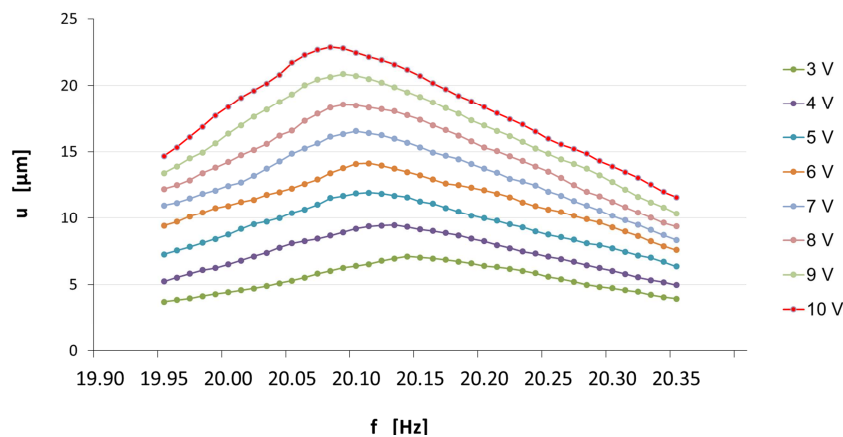
**Figure 6.** Response spectra for increasing values of the input force – pristine sample.

Once the input voltage interval has been defined, changing the frequency of the driving force (via the function generator) it is possible to record the values of the output voltage, from which the displacement can be determined by using a conversion factor established during the photodiode calibration. The results are reported in Figure 6 and Figure 7.

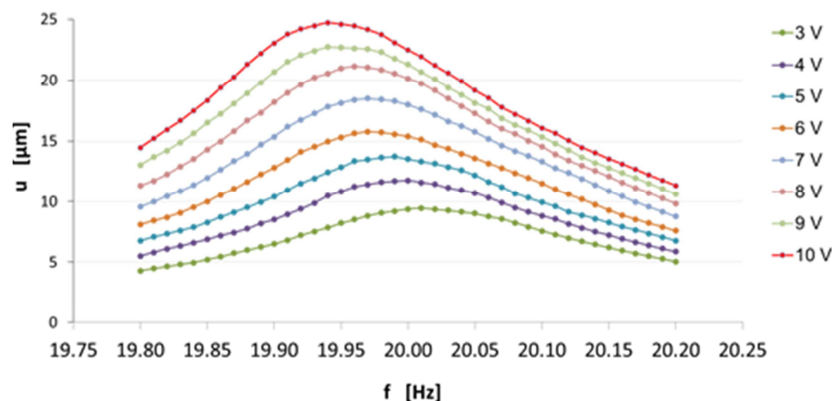
**Figure 7.** Response spectra for increasing values of the input force – damaged sample

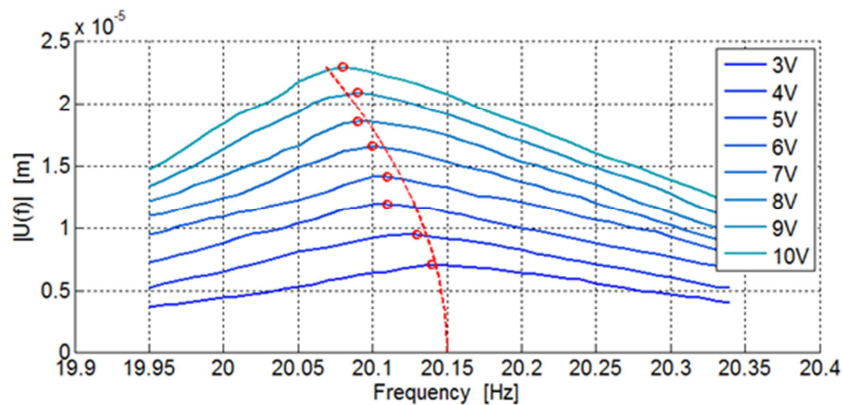
**Figure 8.** Back-bone nonlinear curve identification - undamaged Kevlar-29 sample.

Equation (1) was used to identify the so-called back-bone non-linear curve of the response, as it is highlighted by a red line in Figure 8 and Figure 9.

For the first Kevlar-29 (not damaged sample) the non-linear stiffness  $\chi$  was identified at  $-3.23 \cdot 10^{11}$  N/m<sup>3</sup>, whilst for the second Kevlar-29 sample (after damage) it was ca  $-3.04 \cdot 10^{11}$  N/m<sup>3</sup>.

From Figures 8 and 9, where the backbone non-linear curves were represented, no significant differences can be appreciated between the pristine and damaged samples, as regards the inclination of the back-bone curve and the value of the index of non-linearity.

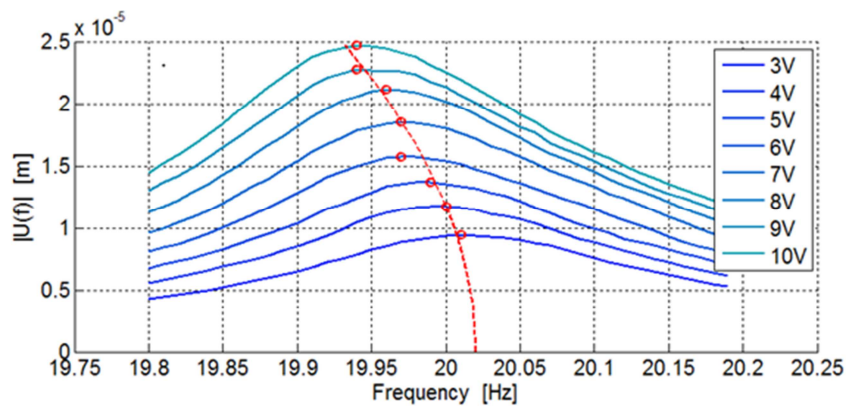
**Figure 9.** Back-bone nonlinear curve identification - damaged Kevlar-29 sample.
