A Power and Energy Procedure in Operating Photovoltaic Systems to Quantify the Losses According to the Causes

Abstract: Recently, after high feed-in tariffs in Italy, retroactive cuts in the energy payments have generated economic concern about several grid-connected photovoltaic (PV) systems with poor performance. In this paper the proposed procedure suggests some rules for determining the sources

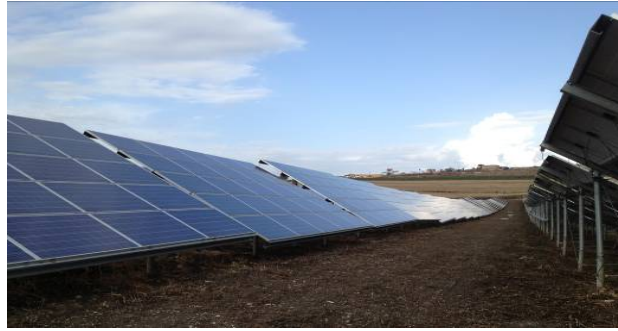
The *GMPV* system includes both PV modules in poly-crystalline silicon (p-Si), accounting for 3 MWp, and the remainder (0.3 MWp) in mono-crystalline silicon (m-Si). Fig. 1 shows two successive rows of PV modules mounted on open structures close to the terrain. They are arranged in PV arrays which supply MPPT racks with 55 kW rated power. Nine 330 kVA inverters with six MPPT racks each convert DC energy into AC energy delivered to the medium voltage grid.

Fig. 1. Photo of two successive rows of PV modules in the *GMPV* system.

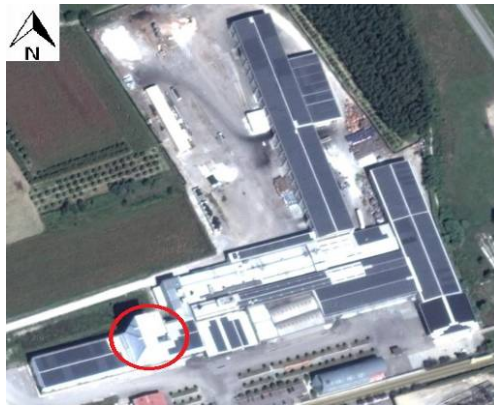
During the inspection of the *BIPV* plant, it was observed that a remarkable obstacle (Fig. 2 inside the red circle) can put into shade a part of the PV modules. The 3D model of the obstacle (a tower in the factory) in SketchUp with the near roofs, subject to lateral shades of tower, was created to estimate the resulting power losses on the PV modules. In details, the tower is 25-m higher than the roofs, where these PV modules are placed. The tilt of the roof is 6° , whereas the azimuths are -17° (southeastern) and $+163^\circ$ (northwestern). The decrease of productivity is different for each individual string and depends on the position in which it is installed. To carry out daily simulations representative of the yearly behavior, spring, summer and autumn days are chosen: the winter impact is negligible. The Sun-beam evolution is analyzed with respect to the projected shades on the PV modules: 109 strings in different colors in Fig. 3 at right and left sides of the tower. The irradiance profiles, only for 10 strings with SE (left side) and NW (right side) orientations, are shown in Fig. 4, in which the steep increments and decrements represent the end of shadows in the morning and their beginning in the afternoon on the involved strings. PVGIS [12] provides data on global irradiance and diffuse contribution in monthly mean conditions. The diffuse irradiance is considered, if the shadow of the tower covers at least one of the string modules, neglecting the action of the bypass diodes inside the modules with a pessimistic estimation. As main findings of the simulation on a 272-kWp portion of *BIPV* system, the energy losses are $\approx 6\%$ in spring, $\approx 9\%$ in summer and $\approx 3\%$ in autumn (negligible in winter) with respect to the calculation without the shade effect. However, these losses have an impact $< 1\%$ on yearly basis (0.7%, 1.1% and 0.3% in the three seasons, respectively), taking into account the relative weight (12% of 2.3 MWp) of the PV system portion in the energy production. In addition, other obstacles, as e.g. balustrades and chimneys, provide losses concentrated in winter (it accounts for 9% of the yearly production) with noticeable deviations with respect to energy calculated without shades. Even if the shades have an impact month by month, the energy reduction per year can be estimated within 1—2%.

Fig. 2. Satellite image of the 2.5 MWp *BIPV* system.

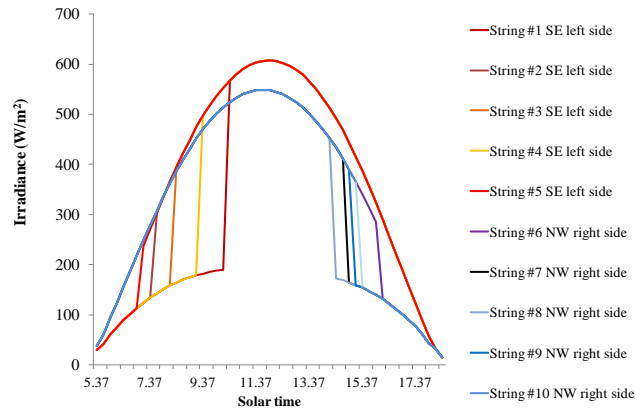
Fig. 4. Global irradiance and diffuse contribution in spring on 10 strings.

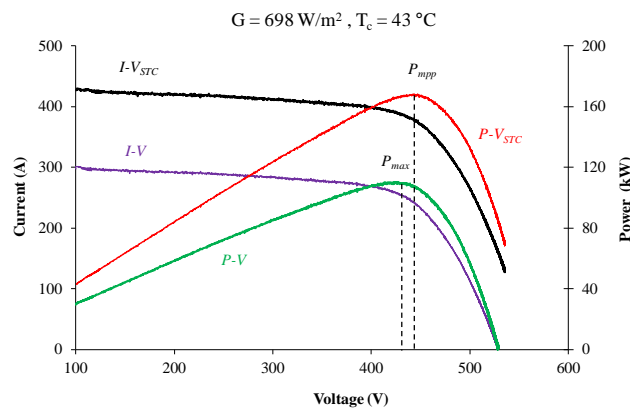
the PV modules. Then, organic waste remains long time near the buildings attracting birds with their dropping. To assess the impact of resulting dirt, a mechanical cleaning on two BIPV arrays (225 and 222.5 kWp) was carried out and proper tests were performed before and after the cleaning. Before the cleaning, the power loss was 25% (on one array in Table III and Fig. 5); after the cleaning, the loss was 21%, with a power recovery of 4%. This loss takes into account the power reduction due to the accumulation of dirt, but not the presence of bird dropping which is continuous but non-homogeneous (included into η_{array}). Further tests were performed on 12 arrays to estimate, in average, the other losses: the negative deviations of the measured P_{mpp} , vs. the nameplate data, were $>20\%$ in average. It is interesting the inverse relationship of fill factor with power deviations vs. datasheet: low values of FF (63—67%) correspond to high deviations vs. datasheet [6].

Fig. 5. The I-V and P-V curves of a dirt array at real and STC conditions.

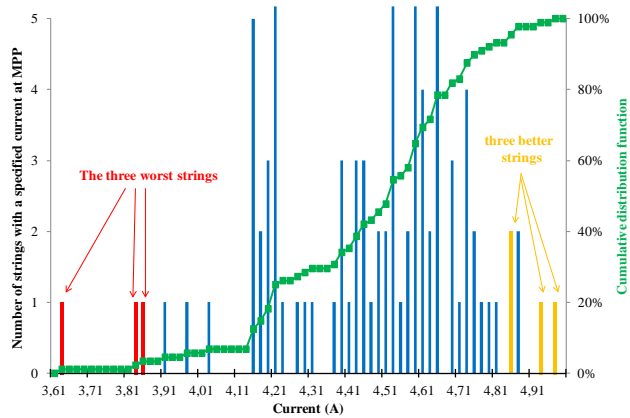
Considering one of the greatest PV arrays with 225 kWp, Fig. 6 shows the frequency distribution of 90 string currents at $G \approx 950 \text{ W/m}^2$ from the on-site monitoring system of the *BIPV* plant during its MPPT operation. It is clear that the current deviations are very wide, putting into evidence the importance of *I-V* mismatch. For the experimental tests, six PV strings were selected, with 50% being the worst strings and 50% being among the better strings in terms of current. Powers P_{mpp} , corrected at STC, were in the range 1.9—2.2 kW (in average 2.1 kW) and their summation (six strings) was 12.2 kW. The results were very interesting, because the voltages at P_{mpp} of the 6 strings are enough different each other (403 V to 457 V), whereas the voltage at maximum power of the PV array is located in intermediate position (443 V).

Fig. 6. Current distribution of the 90 strings in operating conditions.

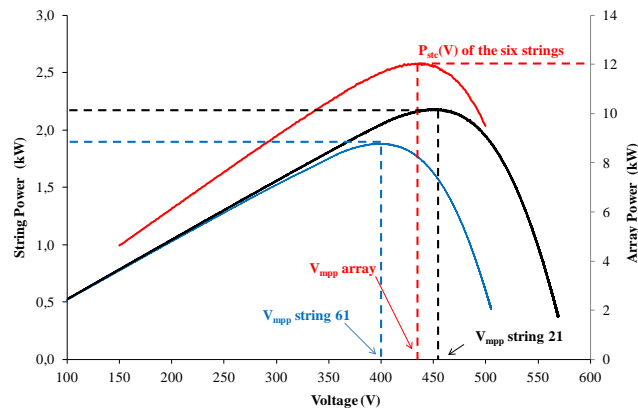
Then, the I - V mismatch increases when the strings are connected in parallel, because the strings operate at a global voltage (of the array) different from their voltage at P_M (Fig. 7). These additional losses, caused by interaction of series and parallel connections, and the deviations vs. datasheet (i.e., a power derating) provide 3.5—4% losses. All these mismatch losses contribute a total of 10—11% losses for the *BIPV* system.

Fig. 7. P-V curves of the best string, the worst string (as current production) and the whole array.

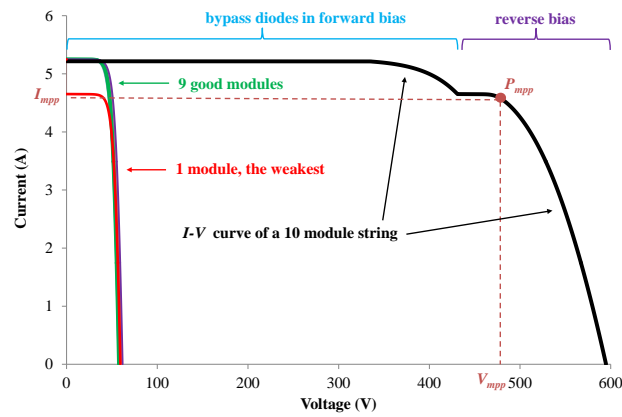
The deviations of the four parameters in (5) are in the ranges $I_{ph} = [4.65—5.25 \text{ A}]$; $m = [1.45—1.55]$; $I_0 = [0.5—1 \text{ } \mu\text{A}]$; $R_s = [7—14 \text{ m}\Omega]$. Thus, the I - V curve of the modules is characterized by $\Delta I_{mpp} = [-2\%; -13\%]$, as found in the module testing. The action of bypass diodes was taken into account as a voltage drop of -2.4 V in reverse voltage: 4 diodes per each module. In fact, they are parallel connected across the terminals of 24-cells groups in the *BIPV* system. The connection of one to four weakest modules, i.e., $\Delta I_{mpp} \approx -13\%$, generates a range of $\ell_{mis} = 2 - 2.5\%$. The current at P_M of the resulting string is lower than the short circuit current of the weakest modules and thus their bypass diodes are not activated (Fig. 8).

Fig. 8. Simulation of string I-V curve with current deviation at maximum power due to mismatch.

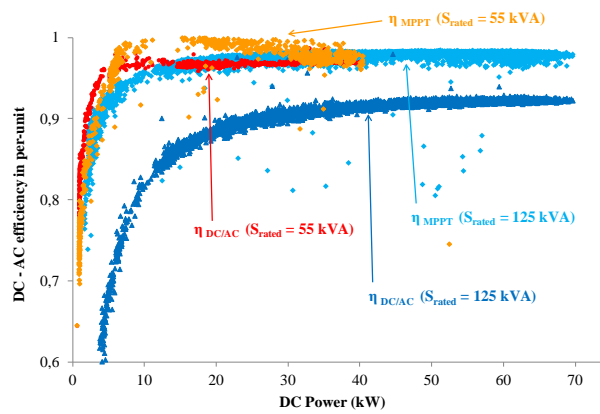
Fig. 18. MPPT and DC-AC efficiencies of *GMPV* and *BIPV* inverters.

As a further finding, the dirt has a sensible impact in the case of PV system located in a food/pharmaceutical factory. Then, the power losses in *MPPT* and DC-AC conversions were higher than those declared by the manufacturer of PCUs with 50-Hz transformer. Finally, as a solution or mitigation of the underperformance, it is possible the replacement of PV modules and inverters at their current prices ($< 1 \text{ €/Wp}$). This is true taking into account the generous rates (0.3—0.45 €/kWh) of the old feed-in tariffs in Italy.

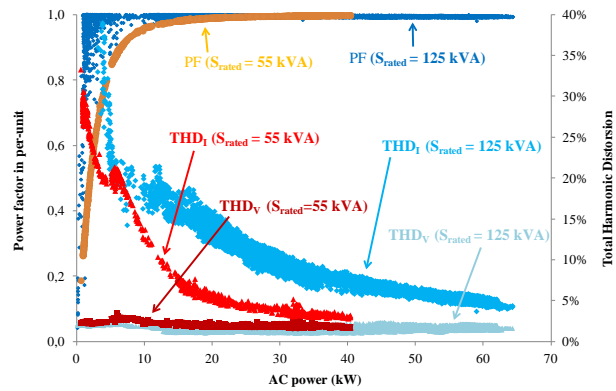
Fig. 19. Power factor and total harmonic distortion of current/voltage in *GMPV* and *BIPV* inverters.
