Damage identification on spline coupling teeth by means of roughness parameters

Damage identification on spline coupling teeth by means of roughness parameters / Cuffaro, Vincenzo; Cura', Francesca Maria; Mura, Andrea. - In: THEORETICAL AND APPLIED FRACTURE MECHANICS. - ISSN 0167-8442. - STAMPA. - 82:(2016), pp. 9-16. [10.1016/j.tafmec.2015.09.008]

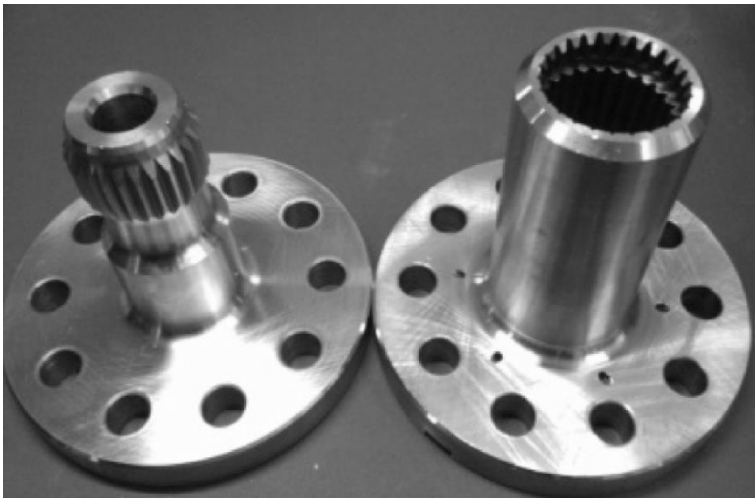
Experimental tests presented in this work have been carried on by means of a mechanical power recirculation spline couplings test rig [12]. Splined couplings specimens are steel made (42CrMo4) nitrogen-hardened (Figure 1); they have crowned tooth profile and the main characteristics are: 26 teeth, 1.27mm modulus, 30° pressure angle, 200 mm crowing radius and 12 mm face width.

Here: Figure 1 Spline coupling specimen

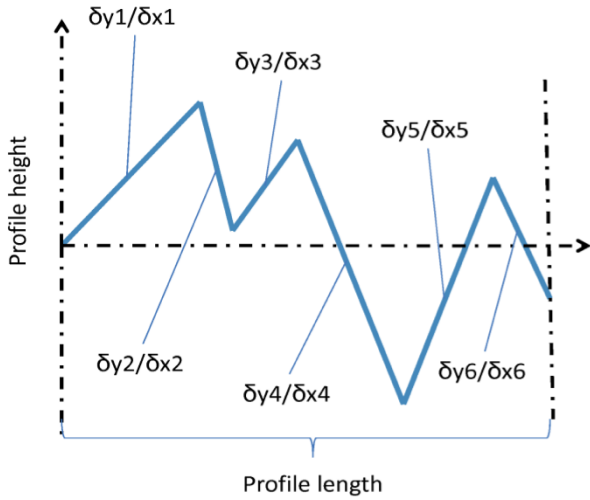
where $\frac{\delta_{y_i}}{\delta_{x_i}}$ is the slope between each two successive points of the profile (see Figure 2).

Here: Figure 2 Representation of the profile slope trend for Δa calculation

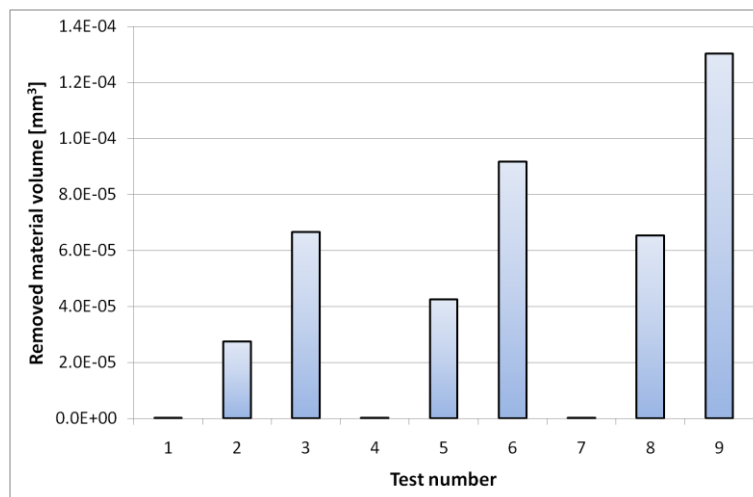
Here: Figure 3 Amount of removed material during the wear tests

It is possible to observe that the volume of removed material increase by increasing both the torque and the misalignment angle.

Figure 2 shows the trend of removed material obtained for the wear test presented in this work.

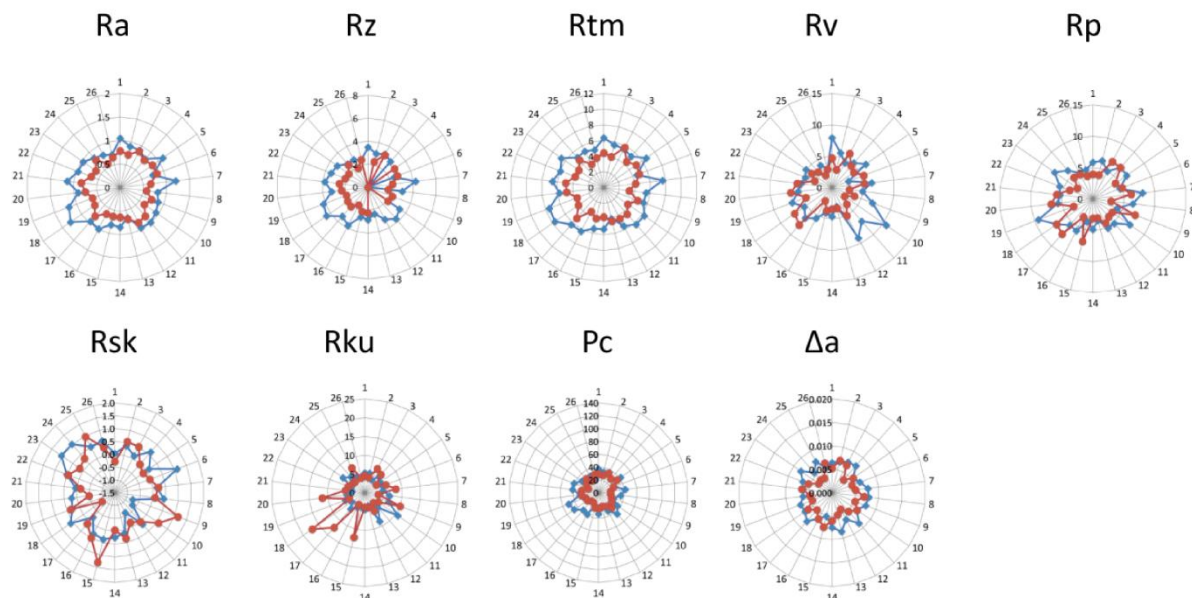
Roughness parameters have been compared before and after tests. As an example Figure 4 shows the polar graphs obtained for each roughness parameter (respectively R_a , R_z , R_{tm} , R_v , R_p , R_{sk} , R_{ku} , P_c , Δa) before and after test MB3. The quadrant of the polar graph has been divided into 26 parts corresponding to each tooth of the specimen; the roughness parameter values before (pre test) and after (post test) wear tests may be seen on the corresponding radius.

Here: Figure 4 Behavior of roughness parameters (R_a , R_z (ISO), R_{tm} , R_v , R_p , R_{sk} , R_{ku} , P_c , Δa) for test MB3

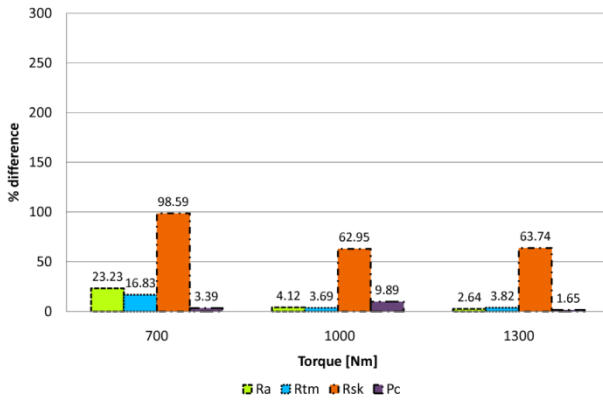
applied torque on the difference of the sub-area of the roughness curve respectively for tests performed aligned ($\alpha = 0^\circ$, Figure 5), and misaligned conditions, as $\alpha = 5'$, (Figure 6) and $\alpha = 10'$, (Figure 7).

Here: Figure 5. effect of the applied torque on mean roughness area variation ($\alpha = 0'$).

Firstly, as already observed in previous studies [6], test conditions related to aligned spline couplings do not emphasize wear damage traces on teeth surfaces and also any appreciable difference in roughness parameters.

Moreover, it may be observed that all percent differences of roughness parameters refer to global damage phenomenon, being related to averaged data obtained from measurements performed on all specimen teeth. In addition, diagrams shown in Figures 5 to 10 are influenced by this way of processing.

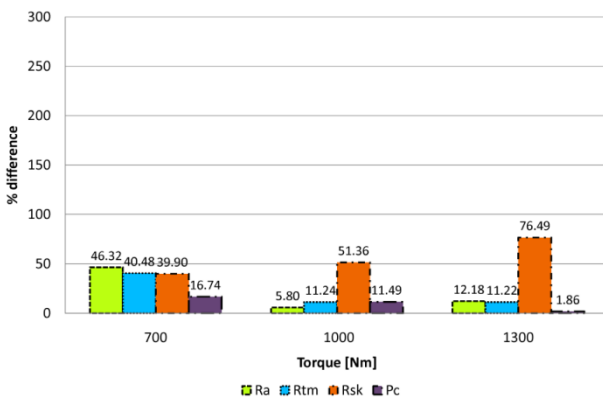
Here: Figure 6. effect of the applied torque on mean roughness area variation ($\alpha = 5'$).

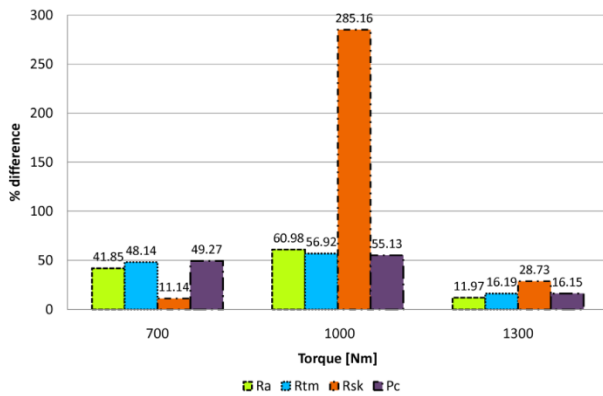
Here: Figure 7. effect of the applied torque on mean roughness area variation ($\alpha = 10^\circ$).

The test conditions involving the most important variation in roughness parameters, above all emphasized by R_{sk} parameter, is that related to test MB6 (Figure 7 and 9).

On the basis of this result, it may be concluded that test MB6 corresponds to the most severe working conditions related to fretting wear damage, being strongly influenced by the angular misalignment.

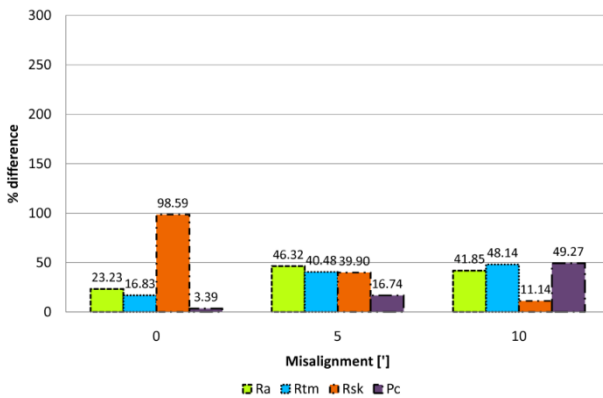
Figures 8, 9 and 10 represent the effect of the angular misalignment on the difference of the sub-area of the roughness curve, respectively for tests performed with 700Nm torque (Figure 8), 1000Nm (Figure 9), and 1300Nm (Figure 10).

Here: Figure 8. effect of angular misalignment on mean roughness area variation (Torque = 700Nm).

R_a and R_{tm} parameters provide results difficult to be interpreted; on the contrary, P_c parameter increases by increasing the angular misalignment emphasizing an appreciable sensitivity to the damage phenomenon.

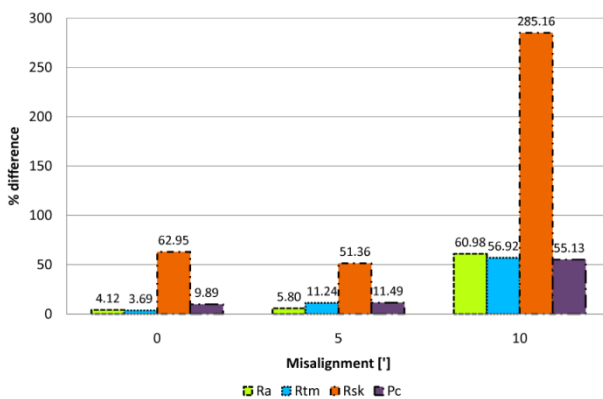
Here: Figure 9. effect of angular misalignment on mean roughness area variation (Torque = 1000Nm).

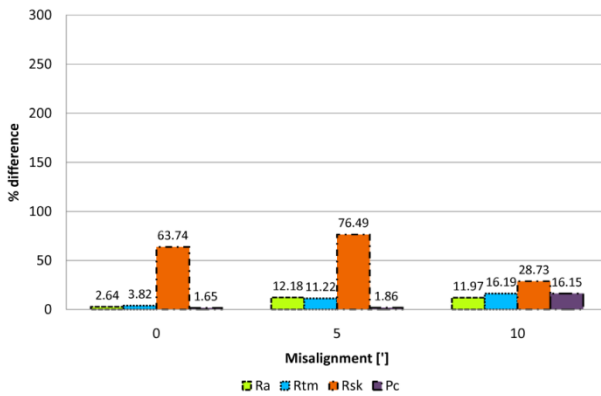
Here: Figure 10. effect of angular misalignment on mean roughness area variation (Torque = 1300Nm).

Finally, from the torque values point of view, it may be observed that the cases related to 1300Nm (tests MB7, MB8 and MB9) are misrepresented by the roughness parameters variation, due to surfaces plasticity phenomena causing a strong asperities smoothing.

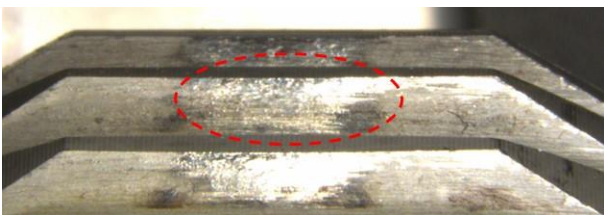
In this section, the surface topology of the worn surfaces is analysed. Teeth surfaces have been acquired by an optical microscope with 115x magnification. The images represent the area near the middle of the tooth face width, where the wear damage is higher. Figure 11 shows the area where the pictures have been captured.

Here: Figure 11 wear area.

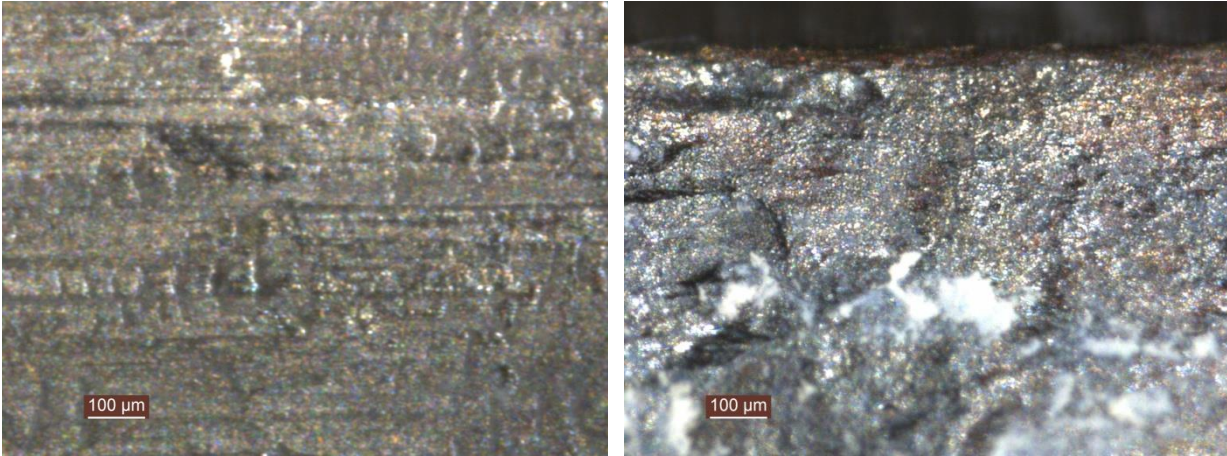
In particular, Figure 12 shows an example of the effect of misalignment angle: the picture on left is relative of the test MB5 performed with 1000Nm torque and 5' misalignment angle and the picture on the right is relative of test MB6 performed with the same torque, but with higher misalignment angle ($\alpha = 10'$). it is possible to observe as the higher misalignment angle brings to a different aspect of the worn surface: the case with $\alpha = 5'$

has little scars and scratches while the case with $\alpha = 10'$ shows big craters and the surface is very irregular. In both cases the nitrogen hardened layer is completely removed.

Here: Figure 12 worn surfaces 115x magnification: Test MB5: torque 1000Nm, $\alpha = 5'$ (left), Test MB5: torque 1000Nm, $\alpha = 10'$ (right)

Magnified images of the worn surfaces shows different kind of surface topology, in particular the surface damage increases by increasing both torque and misalignment angle. Tests performed with higher levels of torque and misalignment angle show not uniform surfaces with big craters and scars, moreover the nitrogen hardened layer is completely removed; on the other hand, surfaces of specimens working with lower torque and misalignment angle show little scars and scratches, the nitrogen hardened surface is not completely removed.

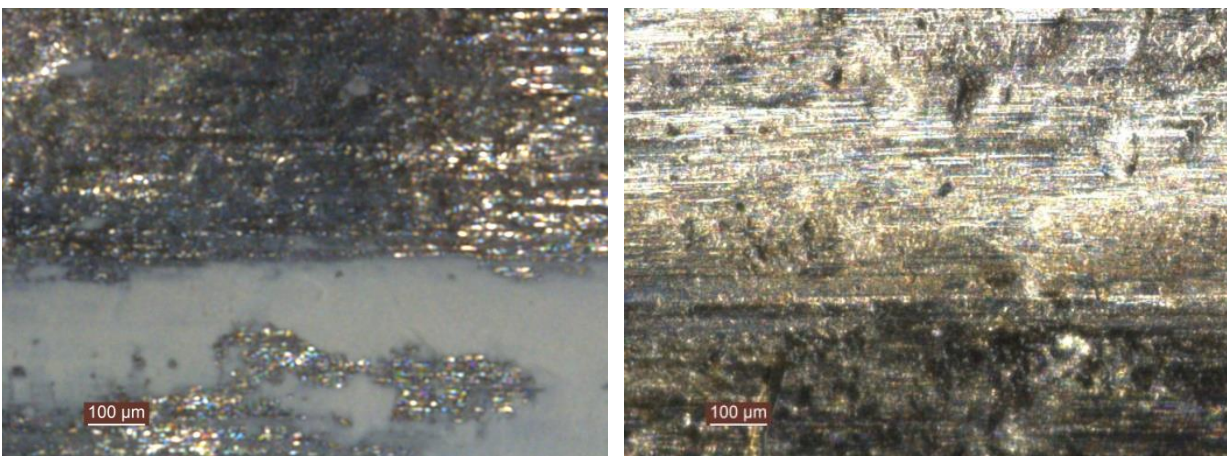
Figure 13 compares the surfaces of test performed with the same misalignment angle ($\alpha = 5'$), but different torque levels: 700Nm (test MB2) on left, and 1300Nm (test MB8) on right. It is possible to observe that in the test performed with lower torque some traces of the nitrogen hardened layer are present (the gray traces in Figure 13 left), while with higher torque there is no traces of nitrogen hardened layer, moreover little craters (seems to be as vaiolature) may be observed.

Here: Figure 13 worn surfaces 115x magnification: Test MB2: torque 700Nm, $\alpha = 5'$ (left), Test MB8: torque 1300Nm, $\alpha = 5'$ (right)
