Microstructure and preliminary fatigue analysis on AlSi10Mg samples manufactured by SLM

Microstructure and preliminary fatigue analysis on AlSi10Mg samples manufactured by SLM / Biffi, C. A.; Fiocchi, J.; Bassani, P.; Paolino, D. S.; Tridello, A.; Chiandussi, G.; Rossetto, M.; Tuissi, A.. - In: PROCEDIA STRUCTURAL INTEGRITY. - ISSN 2452-3216. - ELETTRONICO. - 7:(2017), pp. 50-57. [10.1016/j.prostr.2017.11.060]

3rd International Symposium on Fatigue Design and Material Defects, FDMD 2017, 19-22  
September 2017, Lecco, Italy

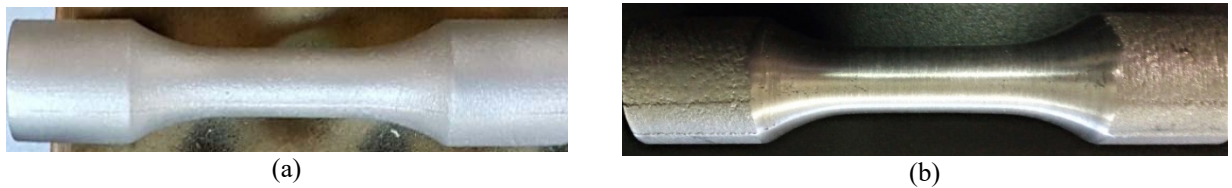
The specimen was finally manufactured with a uniform allowance of 0.1 mm and finely polished by using sandpapers with increasing grit (from 240# to 1200#) in order to remove the residual parts of the support structures and macroscopic surface defect. Fig. 2 shows the Gaussian specimen in the as built condition (Fig. 2a) and after the polishing process (Fig. 2b).

Fig. 2: Gaussian specimen for the VHCF test: (a) specimen in the as-built condition; (b) specimen after polishing.
