VHCF response of as-built SLM AlSi10Mg specimens with large loaded volume

Abstract:

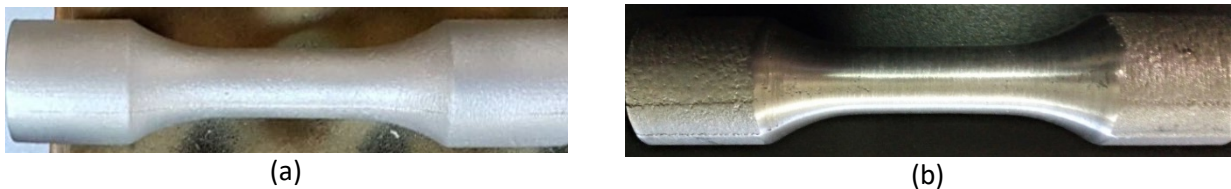
Before the experimental tests, specimens were finely polished by using sandpapers with increasing grit (from 240# to 1200#) in order to remove macroscopic surface defects and residual parts of the support structures. The surface roughness R_a of the tested specimens, equal to $1.41 \pm 0,26 \mu\text{m}$, was measured on five specimens by using a Mitutoyo Surftest SV-500 instrument.. Fig. 3 shows a Gaussian specimen before (Fig. 3 (a)) and after the polishing process (Fig. 3 (b)).

Figure 3: Gaussian specimen used for the ultrasonic VHCF tests: (a) specimen before the polishing process; specimen after the polishing process.

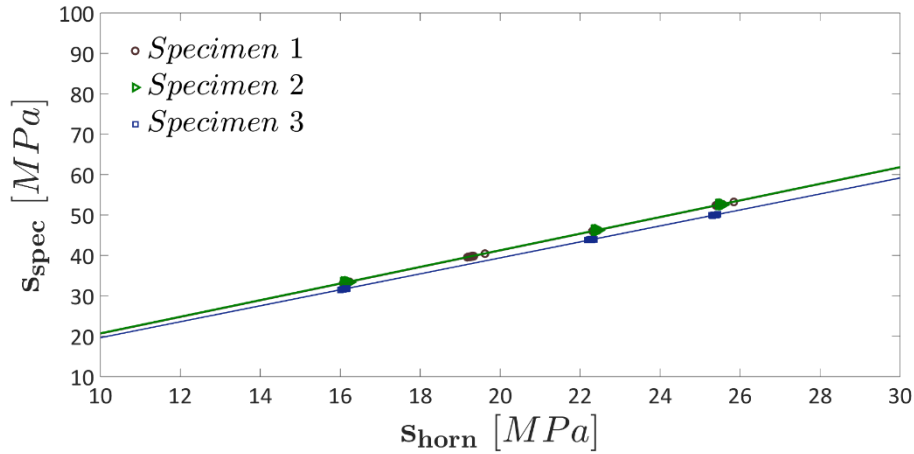
Fig. 4 shows the stress amplitude measured by Gage B, s_{spec} , with respect to the stress amplitude measured by Gage A, s_{horn} . The two stresses, s_{spec} and s_{horn} , were obtained from the measured strain amplitude and by considering the average Dynamic Young modulus (Section 2.2). The calibration procedure was performed on three specimens at four increasing voltage amplitudes imposed by the piezoelectric transducer.

Figure 4: Stress amplitude measured by Gage B, s_{spec} , with respect to the stress amplitude measured by Gage A, s_{horn} .

According to Fig. 4, the difference between the stress amplitude measured at the specimen center in the three tested specimens is smaller than 1 MPa, confirming that Gaussian specimens produced through AM can be tested and that the stress amplitude variation among the specimens is limited notwithstanding the large manufacturing tolerances typical of AM processes.

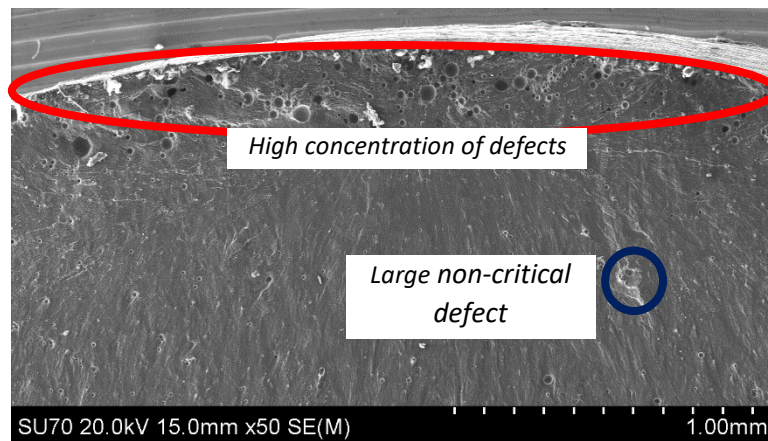
Fig. 7 shows an example of fracture surface characterized by a large concentration of defects close to the surface and by one large non-critical internal defect.

Figure 7: Example of a fracture surface showing a large concentration of defects close to the surface and one non-critical internal defect.

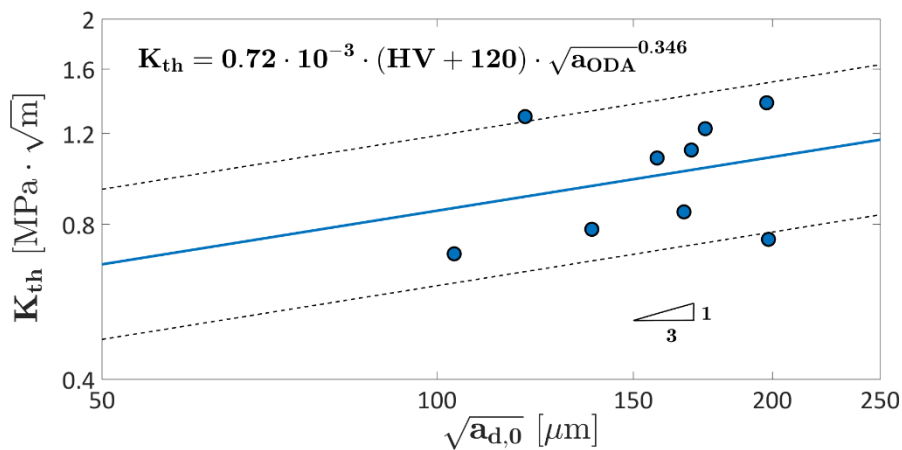
The SIF threshold, K_{th} , was estimated by considering the defect size or the equivalent defect size measured on fracture surface. A linear model in a log-log plot is considered for K_{th} , according to Ref.^{10,37}. Fig. 10 shows the K_{th} values with respect to $\sqrt{a_{d,0}}$ in a log-log scale, together with the estimated linear model. The median, the 0.1-th and the 0.9-th quantiles of the K_{th} function are also depicted in Fig. 10.

Figure 10: SIF threshold, K_{th} , with respect to the defect size $\sqrt{a_{d,0}}$.

According to Fig. 10, the linear model is in agreement with the experimental data¹⁰. The slope of the interpolating function, equal to 0.346 (in the log-log scale) is close to the values reported in Ref.¹⁰ (1/2 for defects smaller than 800 μm and 1/3 for a defect range of [200 – 800] μm).

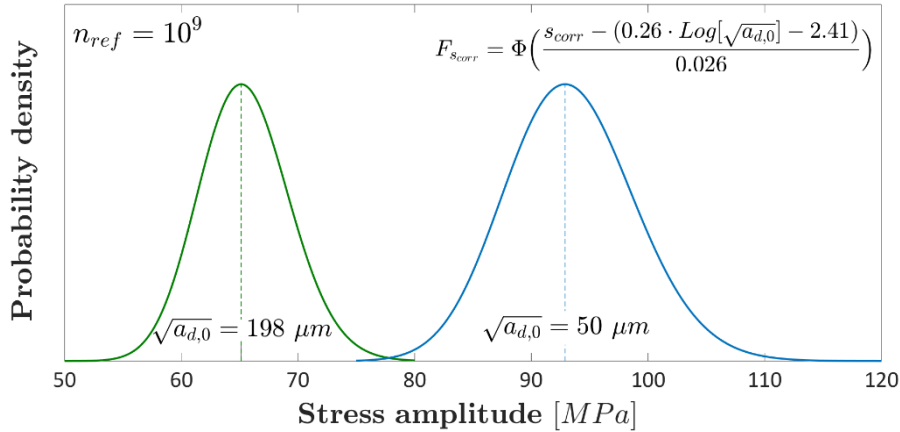
Therefore, by substituting $F_{S_{corr}}$ with α and solving Eq. 2 with respect to s_{corr} , the α quantile of the fatigue strength at n_{ref} for an initial defect size equal to $\sqrt{a_{d,0}}$ can be estimated. Fig. 13 shows the probability density functions of S_{corr} at $n_{ref} = 10^9$ for an initial defect size equal to 50 μm and to 198 μm .

Figure 13: Probability density function of S_{corr} at $n_{ref} = 10^9$.

According to Fig. 13, the mean fatigue strength significantly decreases with $\sqrt{a_{d,0}}$ (about 30% reduction). The proposed methodology of gathering all the experimental failures can also be effectively employed for evaluating and quantifying the influence of the defect size on the VHCF strength of AM parts.
