Icelandic Concrete Surfaces: Guðjón Samúelsson's *Steining* (1930–50)

Sofia Nannini

Politecnico di Torino, Italy

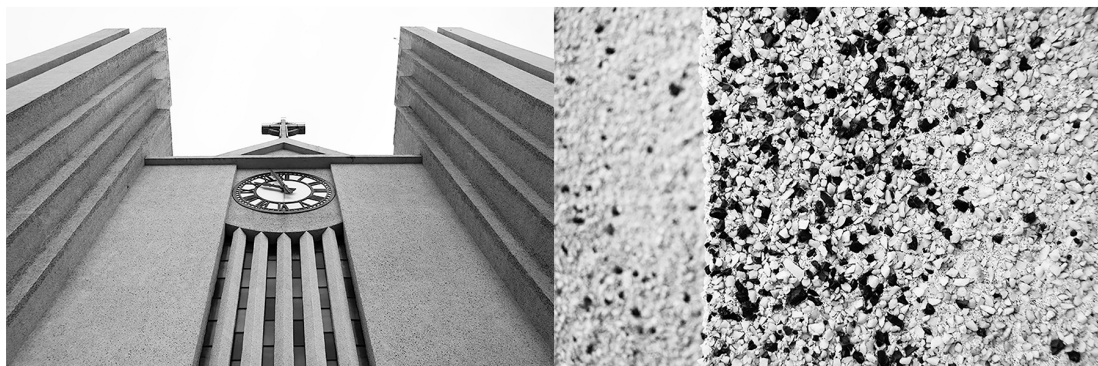
Figure 7. *Steining* on the church of Akureyri. Detail on the right. Photos by Sofia Nannini.

Quartz (*kvars*) was mined in the Mosfellsbær area, near Reykjavík. Its presence was discovered mostly in the vicinity of some gold mines which had been active since 1909 [31]. An interesting application of both obsidian and quartz can be seen on the façade of the church in Akureyri, northern Iceland, designed and built by Guðjón Samúelsson in 1934–40. Dark obsidian splinters were used to mark the edges of the structure, while pale quartz pieces covered the rest of the surface (Fig.7).

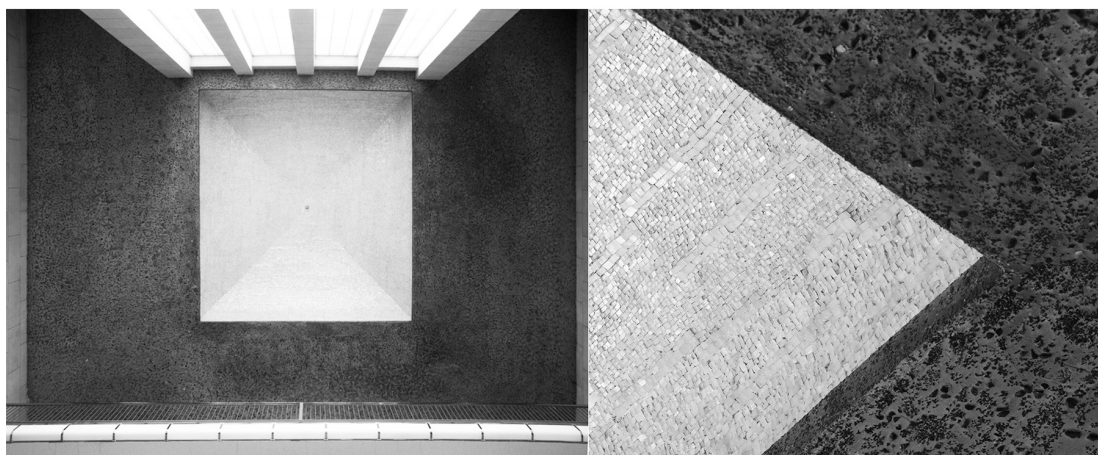
Figure 10. *Steining* on the ceiling of the main entrance of the University of Iceland. The central vault is rendered with calcite fragments, the surrounding portion with obsidian on a blue-cement field. Photos by Sofia Nannini.

The vestibule’s walls were covered with seashell-rendered slabs, and the ceiling coated with ground, shiny Iceland spar. The main doorway was rendered with a mixture of ground obsidian together with greenish rhyolite. The floor was covered with dolerite, whereas the main hall’s vestibule was clad with red rhyolite slabs. The altar of the University’s chapel was decorated with clear Iceland crystals. The whole outer façade was rendered with a quartz-based *Steining* blend, for which approximately 7 tons of quartz were imported [39] (Figs.9-10).
