Integrated BIM-based Framework for Actual and Post-earthquake Structural Assessment of Existing Buildings

Keywords: BIM model; schools building; seismic vulnerability; non-destructive test

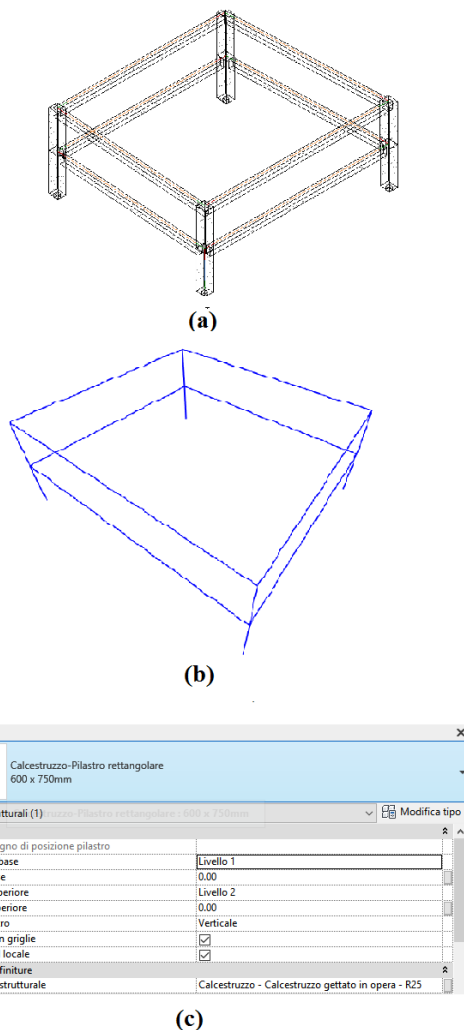
Figure 1. An example of extrapolation from Revit to SAP: (a) Revit 3D model; (b) SAP model; (c) Revit material sheet.

Figure 1 shows the extrapolation of a building specimen from Revit to SAP, while Figure 2 shows the application to the case study of a real school building.

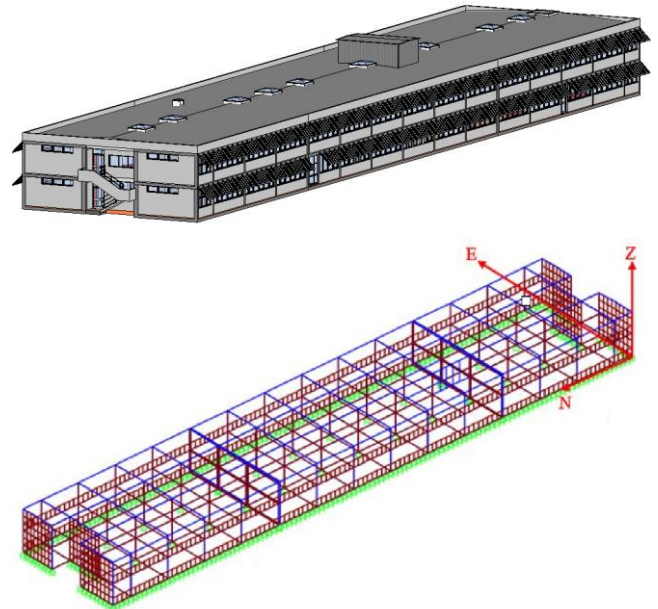
Figure 2. Mascagni school model in Revit and SAP2000

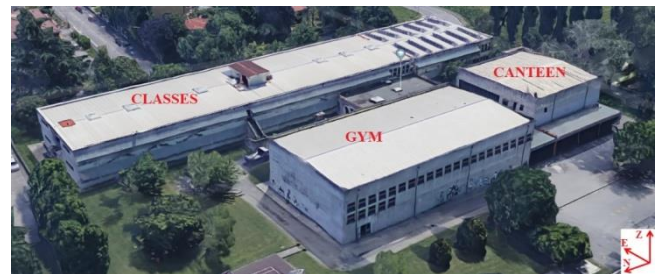
Figure 3. Building overall view

The “Mascagni School” is a reinforced concrete building located in Melzo (MI) built in 1976. The school consists of three separated structures including classes, gym and canteen. Figure 3 shows the overall view of the school. Only the main building including the classes is analyzed in this research.

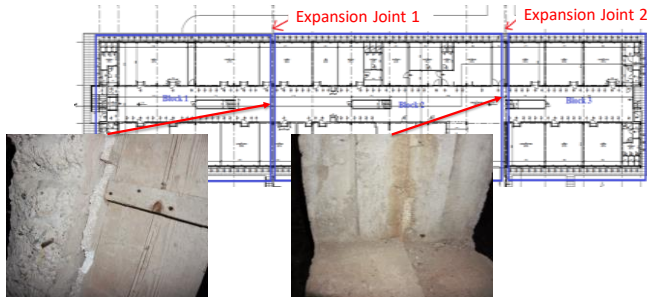
Figure 4. Expansion Joints filled with polystyrene material

The main structure (Classes) is a two storey building with a rectangular plan about 98.5 m x 20 m and the height of 6.8 m. This building is composed of three different blocks separated by two expansion joints. During the inspection, it was observed that the space in expansion joints is about 3cm filled with polystyrene material (Figure 4).

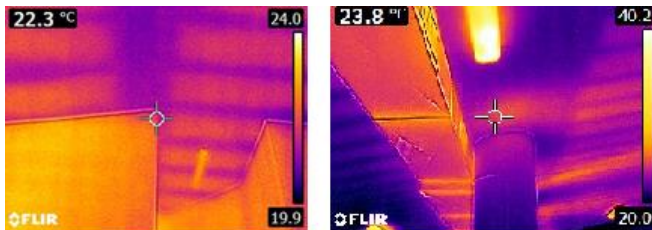
Figure 5. Constructional element identification using thermal camera

Thermal camera was used to detect the hidden structural elements such as columns and beams. The device is an infrared camera able to detect the different degrees of irradiation emitted by the different surface materials. Figure 5 shows an example of the test performed in canteen building identifying beams and column. The concrete elements (blue areas) have a lower temperature with respect to the masonry elements, lighting systems and aluminum ventilation elements (orange and yellow areas).

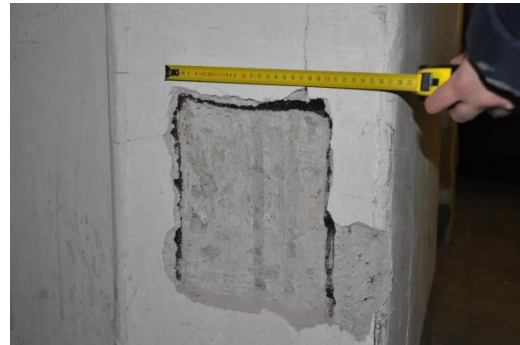
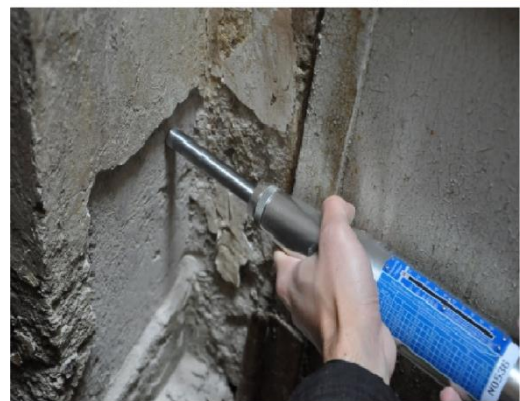
Figure 6. Constructional element identification using concrete hammer test

To have some indications on the materials strength, non-destructive tests have been performed with sclerometer (concrete hammer test). This device measures the rebound value R. Using the conversion tables, it is possible to determine the value of the compressive strength based on the magnitude of the measured rebound. The concrete to be examined must be free from any coatings (such as a column) to show the surface of the elements. The test was performed directly on the beams and columns surfaces since they were not covered fully with any material (Figure 6). E.g., the test was performed to determine the

strength of two columns located at the ground floor. They have two different dimensions (25x50 cm and 30x50 cm) as representative of the typical columns of the building. The results show that the average concrete strength of the columns is equal to 31.5 MPa. Therefore, the concrete class C25/30 can be used to integrate the BIM.

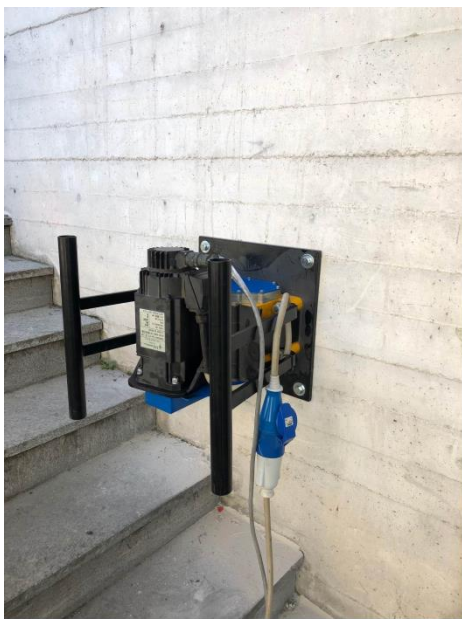
Figure 7. Application of the vibrodyne on the shear wall

the different type of accelerometers both ambient vibration tests and forced dynamic tests have been performed. In the last case a vibrodyne facility able to apply harmonic forces on the structure has been employed. It has been applied to a reinforced concrete element, the elevator containment (Figure 7).

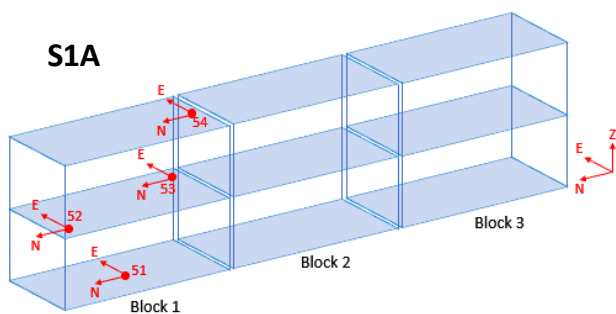
Figure 8. Accelerometers configuration for 1st block

Different accelerometers configurations were considered during the test to analyze the building dynamic response assuming that the main building is separated in three blocks. The accelerometers registered the ambient noise for a duration of 15 minutes. Figure 8 shows as an example the accelerometers configuration used to identify the dynamic response for the first block.

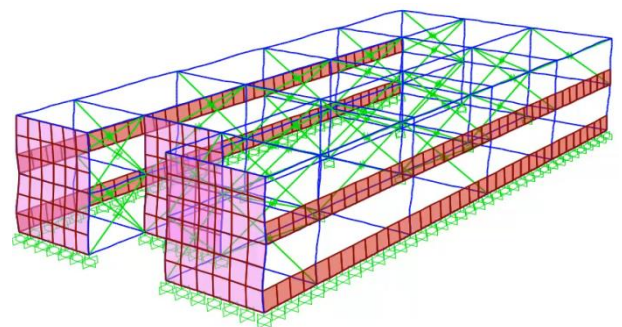
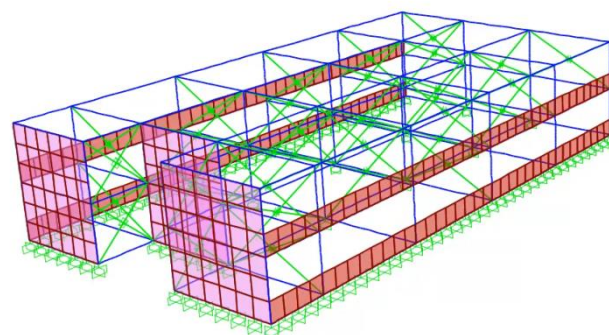
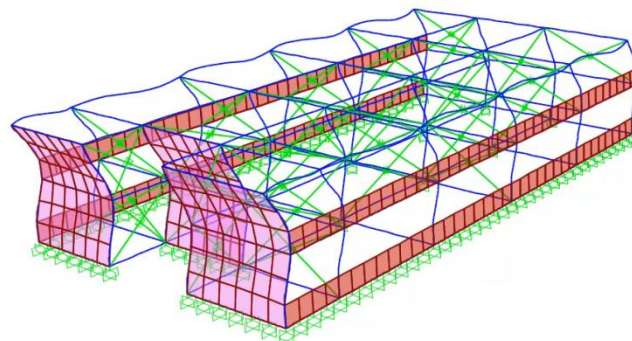
Modes	FDD [Hz]	RDT [Hz]	FEM [Hz]	Participating mass ratio
S1A (1st block)	1 st mode	5,33	5,30	5,40	0,91
	2 nd mode	6,38	6,50	6,40	0,52
	3 rd mode	13,40	13,34	13,20	0,97

Figure 9. First block 1st mode (a), 2nd mode (b), 3rd mode (c), and comparison between FDD, RTD and FEM frequencies (d)

vibrodyne test, the data was processed by using Frequency Response Function (FRF) to verify the results obtained through the ambient test. Figure 9 depicts as an example the frequencies comparison for the first block of the school building at the north direction.

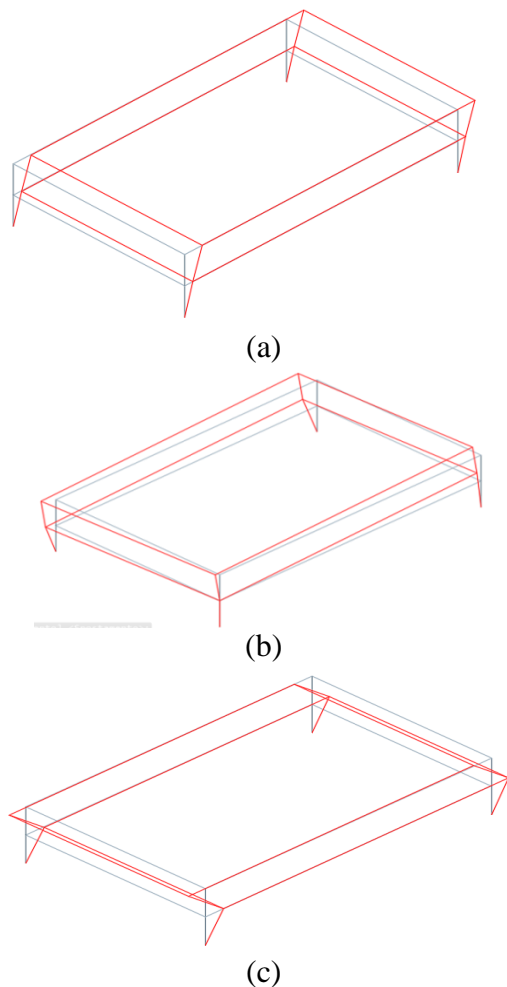
Modes	FDD [Hz]	RTD [Hz]
S1A (1st block)	1 st mode	5,33	5,30
	2 nd mode	6,38	6,50
	3 rd mode	13,40	13,34

Figure 10. First block 1st modal shape (a), 2nd modal shape (b), 3rd modal shape (c), and comparison between FDD, RTD and MAC

In addition, the mode shapes deriving from the analysis of the two methods were compared: the Modal Assurance Criterion (MAC) was used to determine the similarity of two mode shapes. If the mode shapes are identical the MAC will have

a value of 1, if the mode shapes are very different, the MAC value will be close to zero.

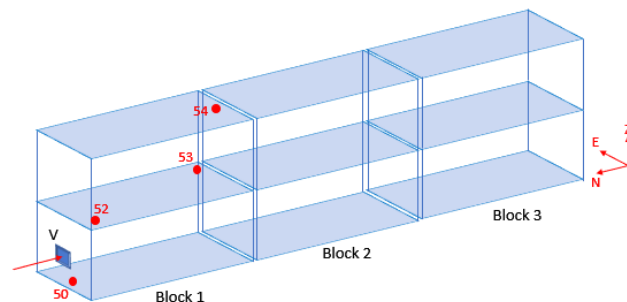
Figure 11. Accelerometers configuration for 1st block during the vibrodyne test

To verify the results of the ambient vibration, the frequencies were also calculated by using a different approach (FDD and FRF) induced by vibrodyne. A vibrodyne was fixed on the shear wall of the first block applying the force only in north direction. Figure 11 shows the position of vibrodyne and the configuration of the accelerometers within the first block. The results of FRF method have been transformed from amplitude and phase to real and imaginary parts. The real part is equal to zero at natural/resonant frequencies while the imaginary part with the peaks indicates resonant frequencies. The direction of the peak can be used to determine the

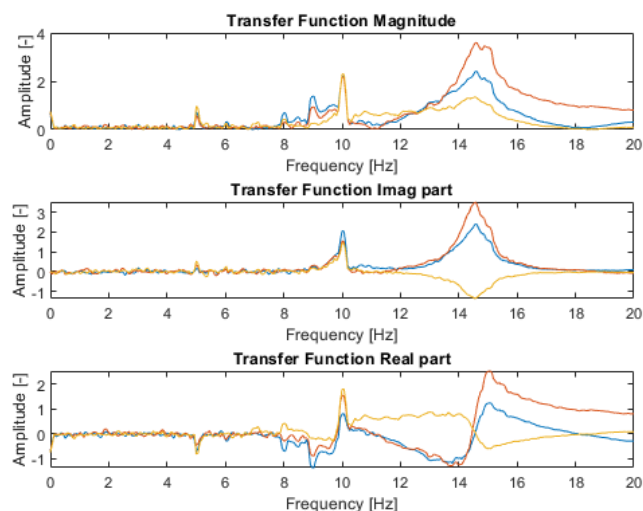
Figure 12 FRF results of the first block for the vibrodyne test in north direction

mode shape associated with the natural or resonant frequencies. Figure 12 shows the result of FRF analysis.
