Experimental Characterization of Piezoelectric Transducers for Automotive Composite Structural Health Monitoring

Massimiliana Carello, Alessandro Ferraris, Andrea Giancarlo Airale, Alessandro Messina, Lorenzo Sisca, Henrique de Carvalho Pinheiro, and Simone Reitano

Politecnico di Torino

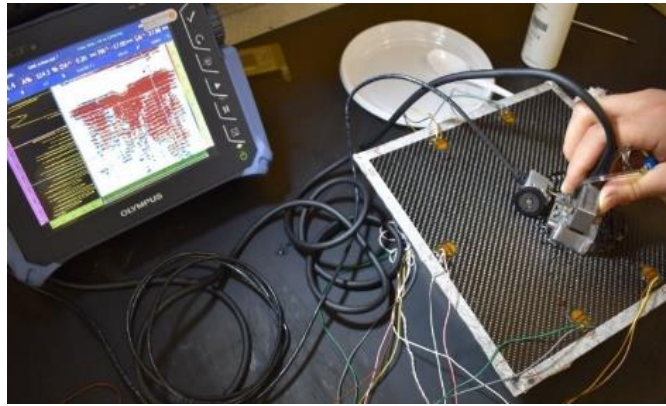
Figure 12: Experimental setup for the C-Scan investigation with Olympus OmniScan SX device.

To evaluate the entity of the damage generated with the drop-dart impact machine, a C-Scan Analysis has been conducted on composite plate using an Olympus OmniScan SX, a device based on phased array technique and equipped with a near-wall probe of 64 piezo elements. The experimental setup is shown in Figure 12.

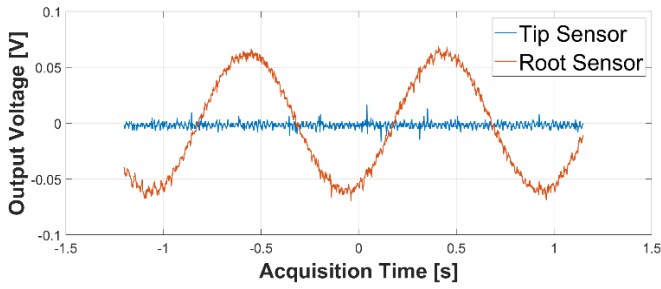
Figure 19: Output Voltage vs. Time for the piezo sensors at root and tip at the exciting frequency of 1 Hz.

At frequency of 1 Hz, the signal sensed at the tip cannot be distinguished because of noise interference; at the root, the acquisition is sufficiently

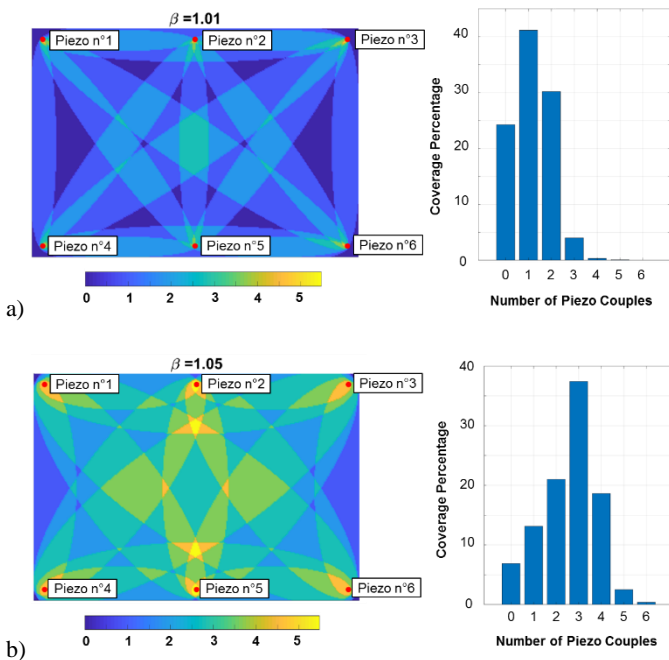
Figure 25: Covered area for the piezo couples at values of β equal to 1.01 (a), 1.05 (b) and 1.1 (c).

The area covered by each data transmission between two couples of transducers depends on the value of β . Three different configurations with β equal to 1.01, 1.05 and 1.1 are shown in Figure 25.

The increasing of the influence area for each couple generates a larger area covered by the damage inspection. On the other hand, the accuracy for damage localization decreases, because the damage index is spread on an area instead to be localized on a single point. The β value of 1.05 is the trade-off between accuracy and a large covered area, as reported in the literature [15].

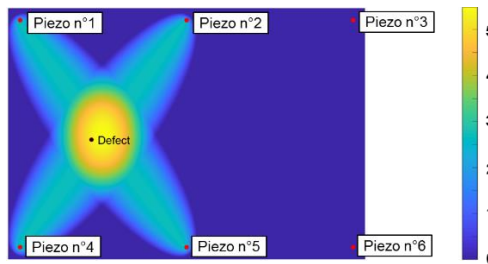
Figure 27: Damage map with high probability of defect presence between piezo couples 1-5 and 2-4.

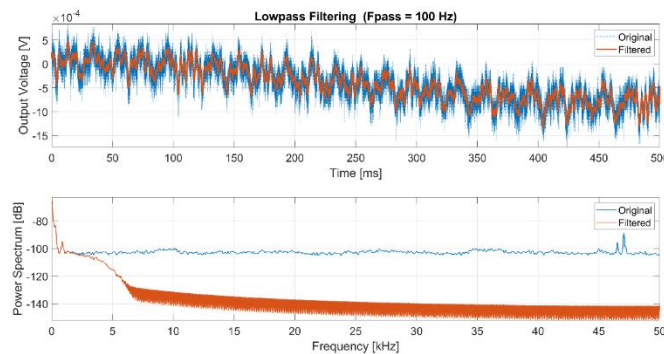
Figure 42: Low-pass filter at exciting frequency applied to an example of the acquisition data sets at 100 Hz.

Despite the structural conditions are the same, different data sets have been acquired. Consequently, each configuration needs its proper baseline acquisition. Then, the comparison between reference and actual signals for each defect has been analyzed. The actuation signal is a sinusoidal burst. For the right excitation signal definition, the test frequency changed in the range 100 Hz to 125 kHz. For low frequency of 100 Hz, a low amplitude mechanical vibration is induced and the sinusoidal signal transmitted cannot be distinguished, as plotted in Figure 42.
