# THE CONSERVATION OF GIOVANNI LABUS'S SCULPTURE OF BONAVENTURA BAVALLIERI (1844) AND ANTONIO GALLI'S SCULPTURE OF CARLO OTTAVIO CASTIGLIONE (1855)

In this project a cleaning intervention of the neoclassical statues in the Brera Academy courtyard was performed with the use of living microbial cells. These living organisms, belonging to the species *Desulfovibrio vulgaris*, were able to remove chemical alterations, mainly caused by sulfates, from the stone surface of the statues. The method has been chosen because it is highly efficient, respectful to the original material, the environment and the restorer operating it. Thanks to the microorganism's selectiveness, it was possible to remove only the harmful alteration of the stones, respecting the so-called "noble patina" a key element in art pieces. Considering the precarious state of conservation of the hands belonging to the statue of Carlo Ottavio Castiglione, a 3D (Rilievo 3D) survey was taken.

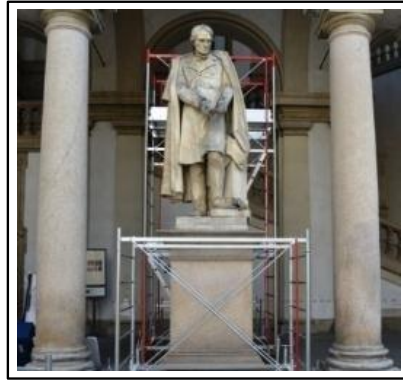
*Fig. 2: Initial phases of the conservation of Antonio Galli's sculpture of Carlo Ottavio Castiglione (1855). Height of statue plus the pedestal 503 cm (198 inches), Just the statue 305 cm (120 inches). The original surface appears hidden by a layer of aged protective varnish.*

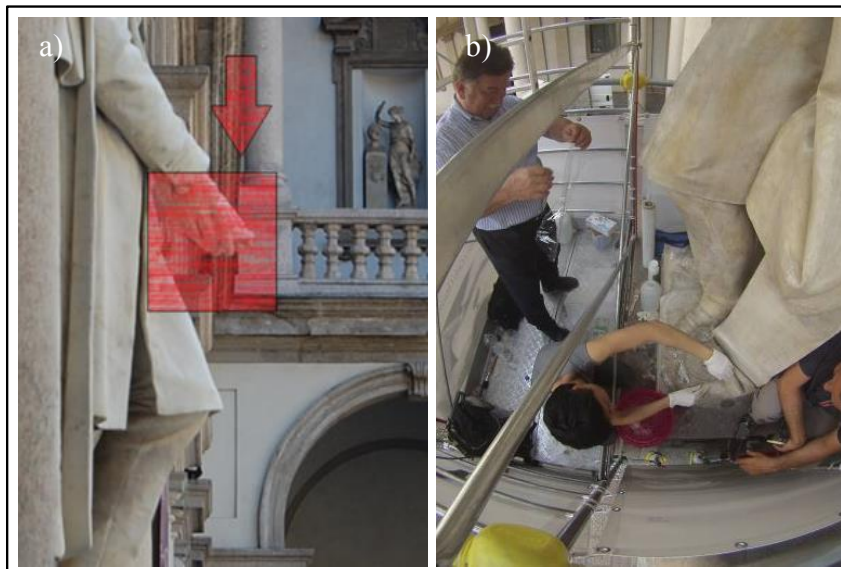
*Fig. 7: a) Scheme of the consolidation system adopted (dip coating); b) Dr. Annalisa Balloi during the application of sulfate-reducing bacteria through a gelatinous medium on the areas that were altered and covered by sulfates.*

Since the statue hands had reached such a critical state it was opted for consolidation by submerging them in a low viscos acrylic dispersion with either Primal<sup>™</sup> B60 or Primal<sup>™</sup> WS-24 (by Rohm & Haas) and water (dip coating, Fig. 7). The web of acrylic dispersion which is generated inside the pores increases the mechanical properties of the treated

With the help of Dr. Annalisa Balloi sulfate-reducing bacteria through a gelatinous medium were applied on sulfated areas that appeared altered. The gelatinous medium was left overnight on the stone surface until the desired result where obtained. The bacteria contained in the gel attack and eliminate the sulfate. Local interventions of traditional cleaning were limited to the removal of varnish drops that had fallen from above. These interventions have been performed by swabbing soluble non-polar solvents. The conservation intervention was then concluded with a mild application (4% micro-dispersed acrylic in water) with a protective patina on all the surfaces, to reduce the absorption of meteoric and condensation water (albeit for a limited time).

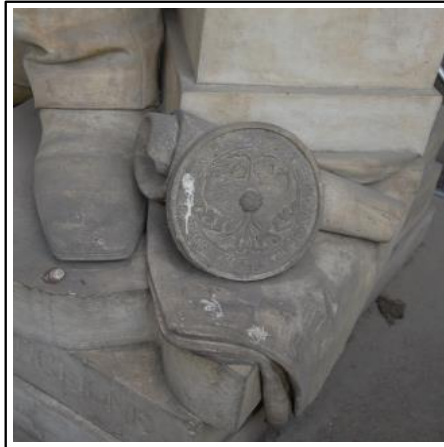
*Fig. 8: Signature of Antonio Galli on the statue of Carlo Ottavio Castiglione (1855) before the application of sulfate-reducing bacteria by a gelatinous medium.*

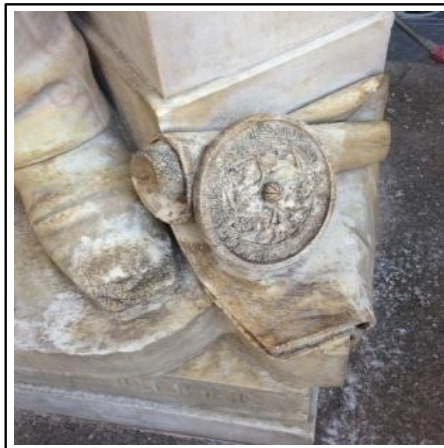
*Fig. 9: Signature of Carlo Ottavio Castiglione's statue (1855) during the cleaning using sulfate-reducing bacteria applied to the surface with the aid of a gelatinous medium. The cleaning has brought to light (for example in the right area of the cartouche) some punctual spots along the surface. FTIR analysis carried out by Palladio Analisi s.r.l. laboratories identified calcium carbonate, gypsum, silicates, and very feeble traces fluorosilicate absorptions, which are most probably left by residues of protective and polishing products used in the past.*
