Finite Element Modeling Application in Forensic Practice: A Periprosthetic Femoral Fracture Case Study

# Finite Element Modeling Application in Forensic Practice: A Periprosthetic Femoral Fracture Case Study

This study aims to quantitatively analyse, by means of a FE analysis, the possible causes of a real case of femoral plate break, implanted following a PFF. Different load conditions acting on the femur during daily and incidental activities were simulated, in order to validate the correct behavior of the plate, according to the intended use recommended by the manufacturer.

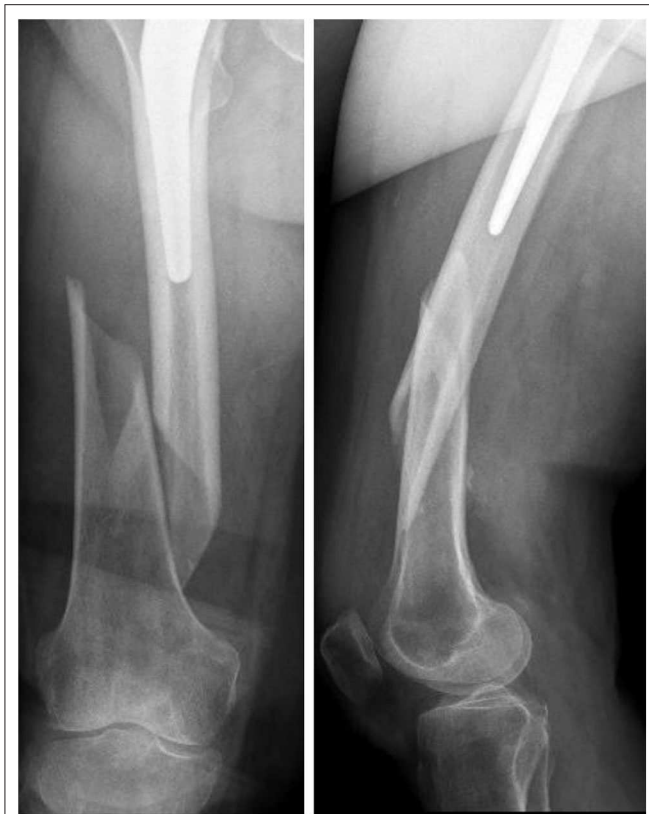
**FIGURE 1 |** Anteroposterior (**Left**) and lateral (**Right**) x-ray images of the periprosthetic fracture.

The x-ray images of the femoral fracture are shown in **Figure 1**, while **Figure 2** shows the x-ray images after the plate implant. After 3 months the plate suffered of catastrophic break in the area where the healing bone was present, accompanied by a further femoral fracture characterized by a profile similar to the previous one (**Figure 3**). The context and reason of the break are unknown.

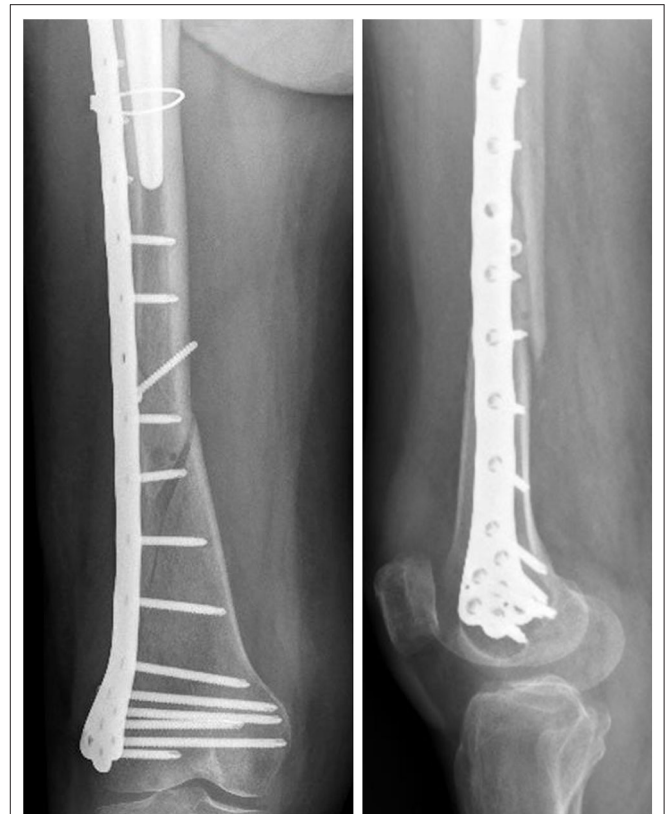
**FIGURE 2 |** Anteroposterior (**Left**) and lateral (**Right**) x-ray images of the reduced periprosthetic fracture after the plate implant.

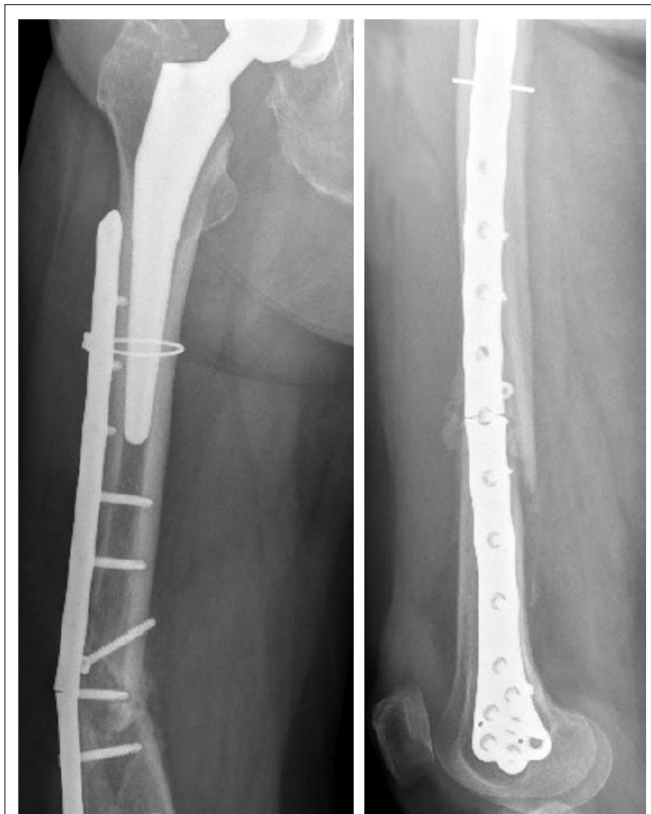
**FIGURE 3** | Anteroposterior (**Left**) and lateral (**Right**) x-ray images of the plate break.

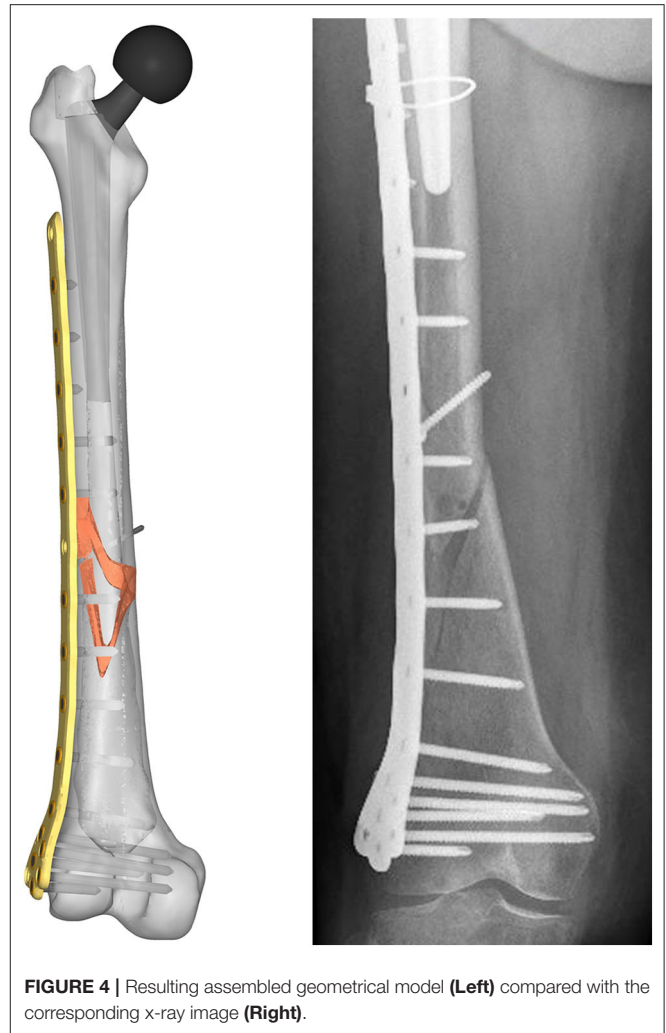
**FIGURE 4** | Resulting assembled geometrical model (**Left**) compared with the corresponding x-ray image (**Right**).

the main object of investigation of the present study (Papini et al., 2007). Using the software ImageJ (National Institutes of Health, USA) some reference measures were taken on the x-ray images in order to scale the standard femur model and adapt it to the real anatomical case. To recreate the fracture profile, reference points were identified on the x-ray images and reported on the bone surface, so that the fracture shape could be reproduced. The result is a fracture volume characterized by an average thickness of 1 cm (**Figure 5**).

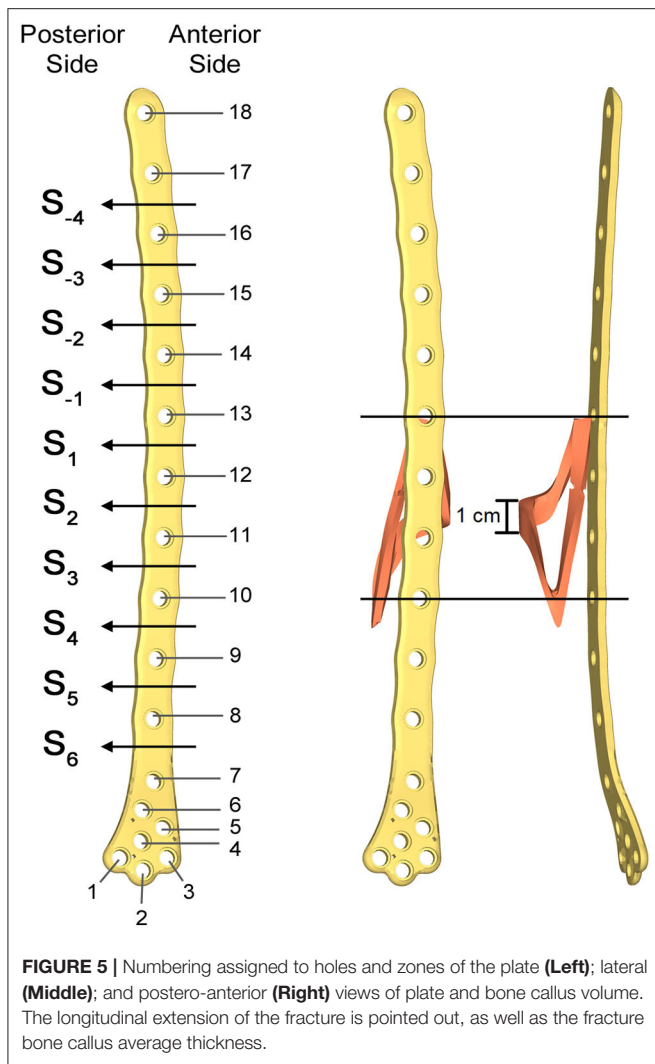
**FIGURE 5 |** Numbering assigned to holes and zones of the plate (Left); lateral (Middle); and postero-anterior (Right) views of plate and bone callus volume. The longitudinal extension of the fracture is pointed out, as well as the fracture bone callus average thickness.

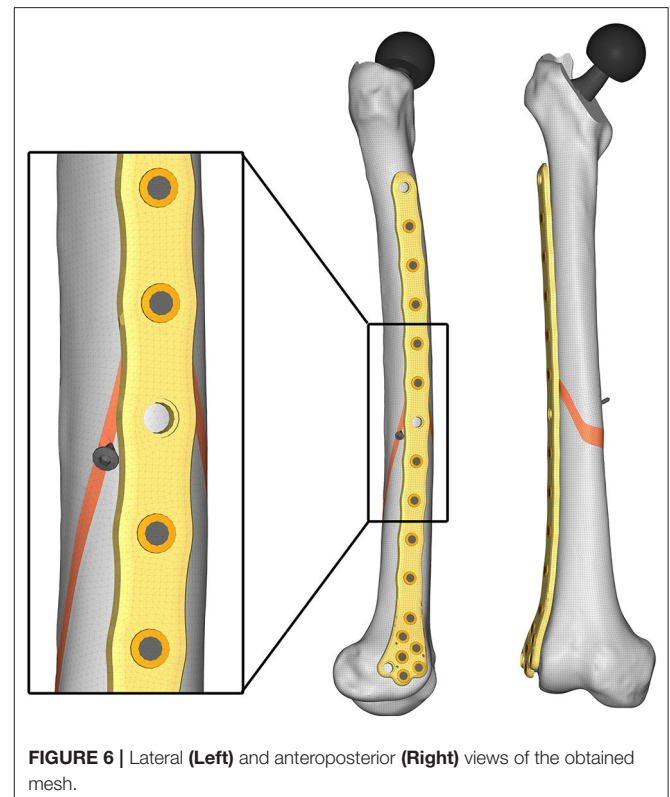
**FIGURE 6 |** Lateral (Left) and anteroposterior (Right) views of the obtained mesh.

According to Viceconti et al. (1998), Polgar et al. (2001), and Ramos and Simões (2006), a tetrahedral mesh of 388652 elements with a 2 mm average edge length was created (Figure 6).

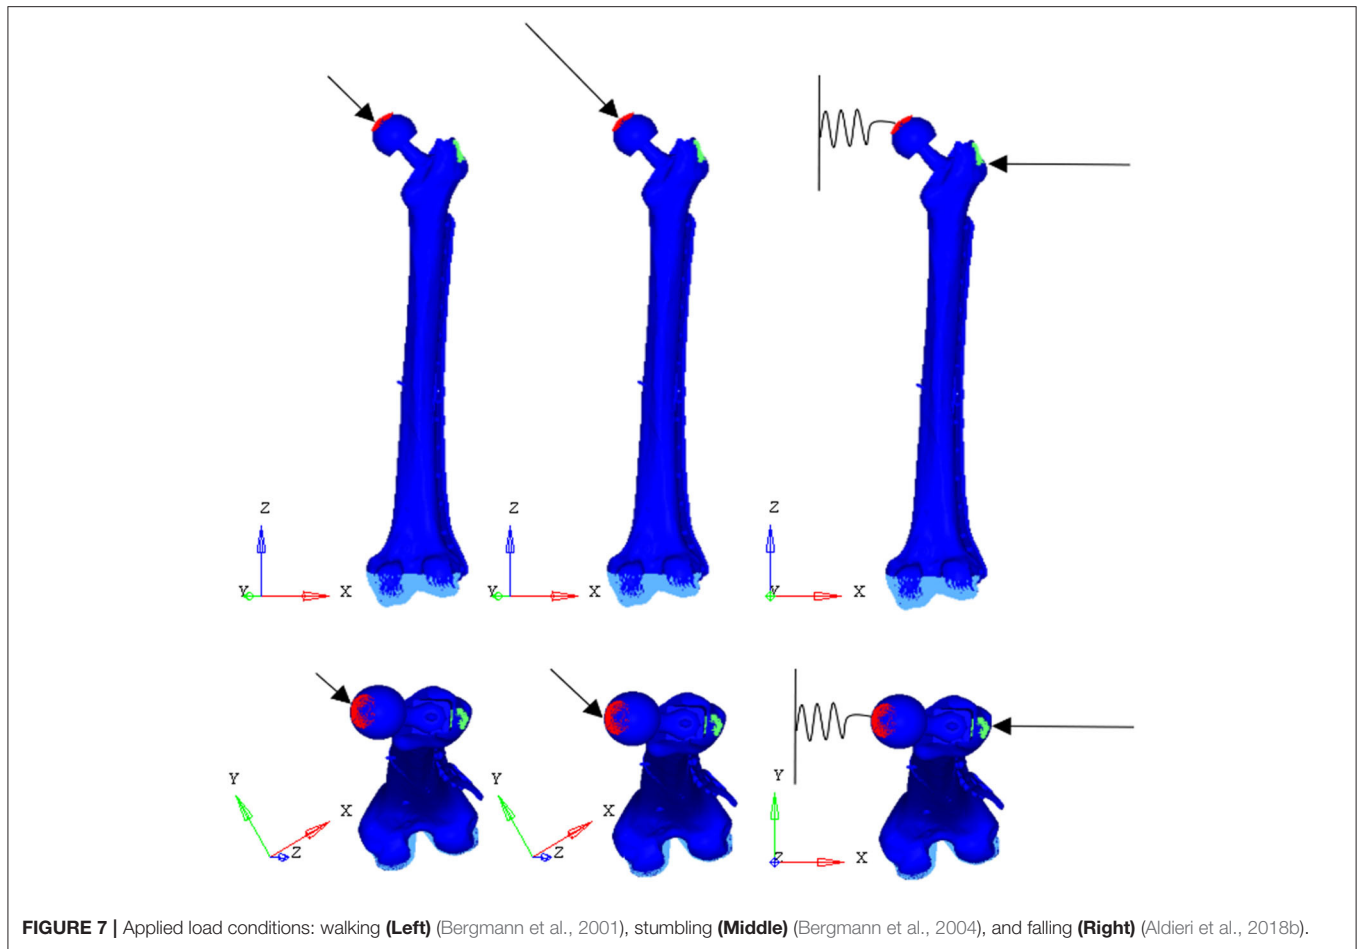
**FIGURE 7 |** Applied load conditions: walking (Left) (Bergmann et al., 2001), stumbling (Middle) (Bergmann et al., 2004), and falling (Right) (Aldieri et al., 2018b).

Loads applied in the three simulated conditions are listed in Table 3. It should be noted that loads directions were implanted according with the examined literature, and the used coordinate systems are shown in Figure 7.

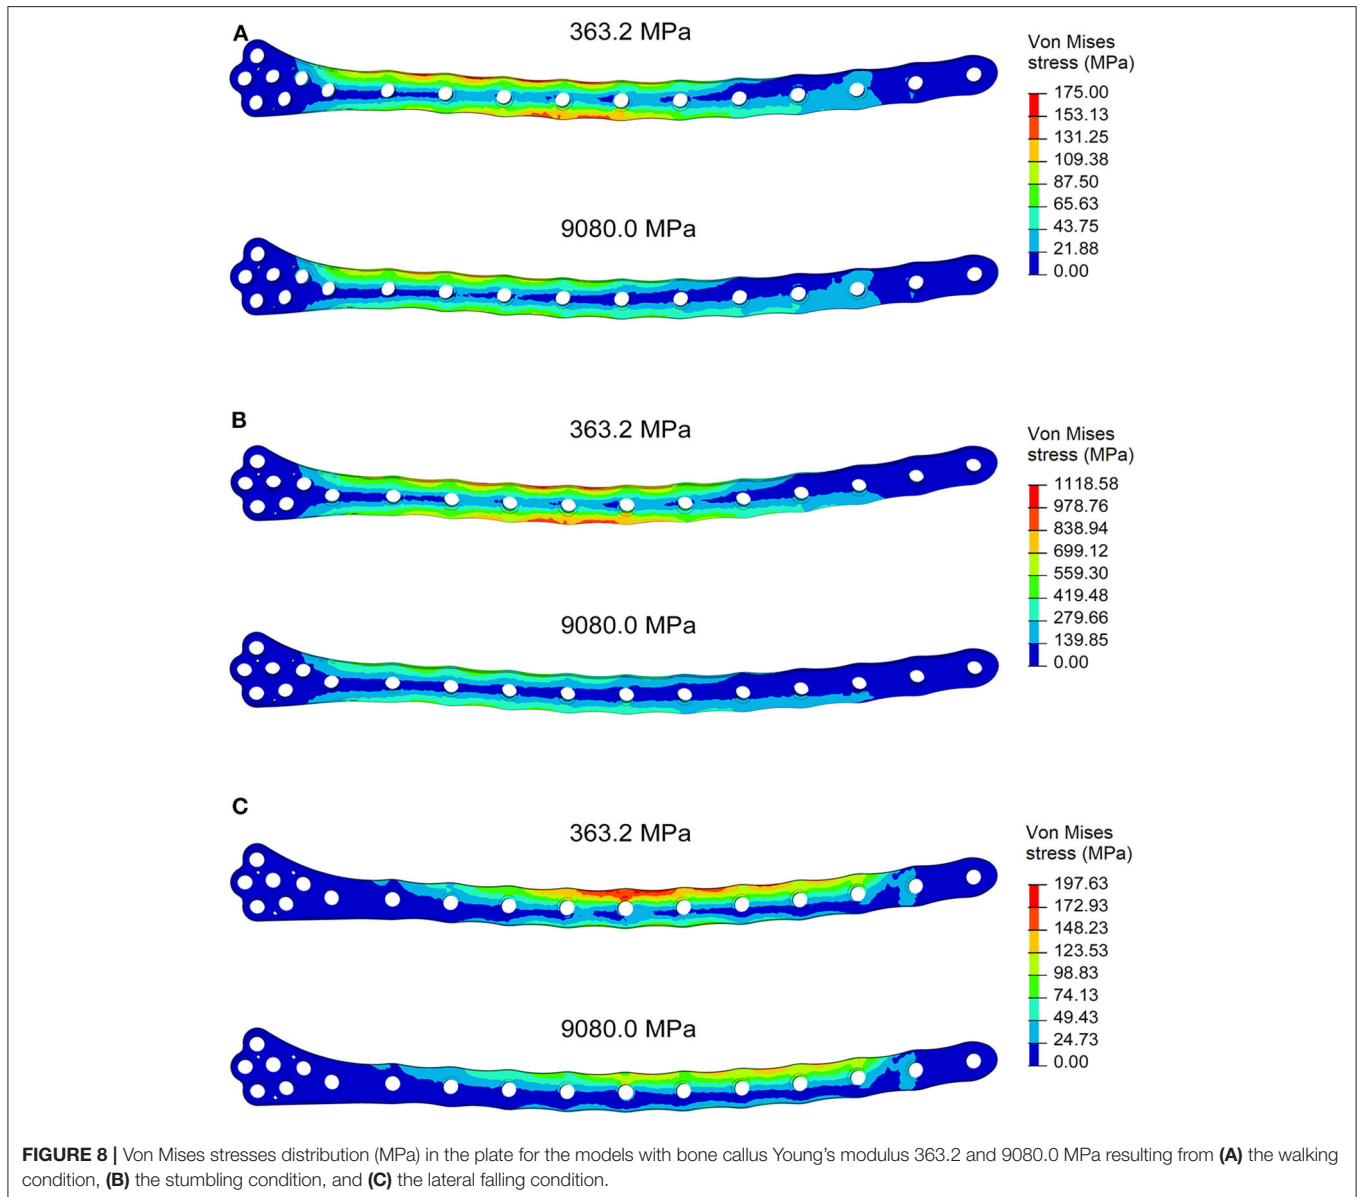
**FIGURE 8 |** Von Mises stresses distribution (MPa) in the plate for the models with bone callus Young's modulus 363.2 and 9080.0 MPa resulting from (A) the walking condition, (B) the stumbling condition, and (C) the lateral falling condition.

For each of the load configurations considered, Von Mises stress in the femur plate and its peak value were analyzed. As regards the walking load configuration Von Mises stresses distribution within the plate varies according to the level of

healing achieved. For lower Young's modulus values of the fracture bone callus, the lateral surfaces belonging to the S2 zone are more stressed. As the bone callus stiffness increases, the highest stresses move downwards, affecting the lateral surfaces of the S4 and S5 zones (Figure 8A), while the Von Mises stress values on the femur plate surface in the S2 zone reduce, with initially precipitous progression as visible in Figure 9A. In the S2 zone, the plate stress is distributed evenly between the anterior and the posterior portions, with a slight prevalence of the posterior area in the presence of lowest bone callus stiffness. Conversely, the S5 zone is characterized by a slightly decreasing trend both posteriorly and anteriorly, but with a clear predominance of the posterior values compared to the anterior ones.

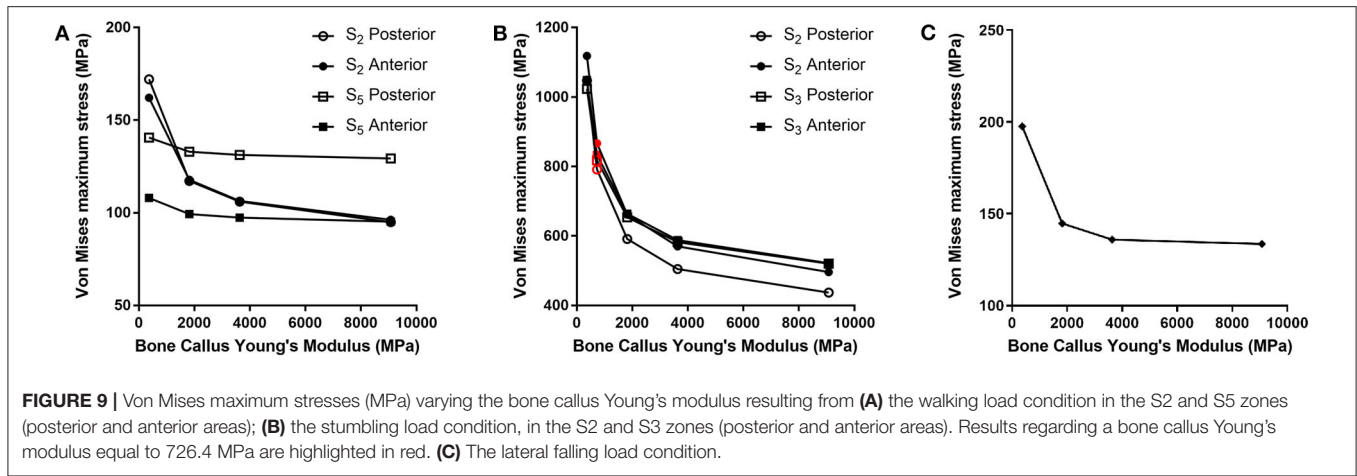
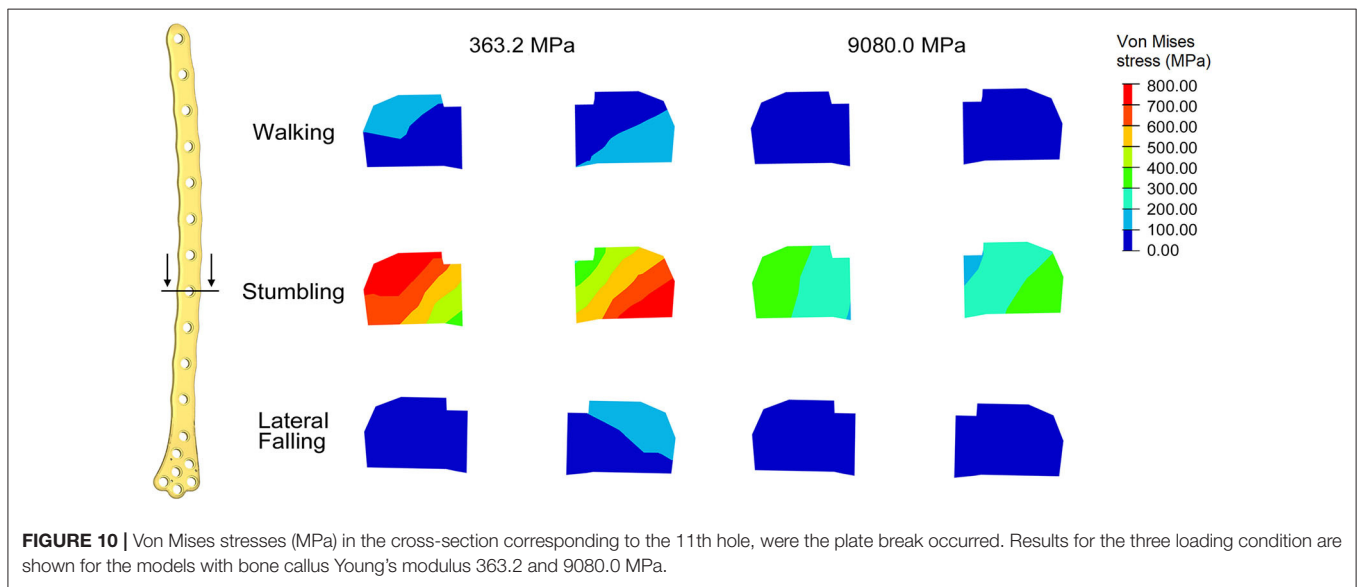
The force acting on the femur during stumbling from standing position have the same direction as that during walking, but its module is amplified. In this case the zones where Von Mises stress is higher are S2 and S3, and in these zones the femur plate yield point is exceeded for lower values of the fracture bone callus Young's modulus (Figures 8B, 9B). This is interesting because, as previously stated, the real plate break occurred at the 11th hole between S2 and S3 zones. For this reason, an additional model was considered to better understand which level of bone healing would correspond to the plate break. Here, the bone callus Young's modulus was set equal to 726.4 MPa after few trials, corresponding to a bone reduction factor of 4%, and Von Mises stress results are represented in red in Figure 9B. The two stress distributions around the hole section where the actual break occurred show how the fracture bone callus Young's modulus influences the femur plate stress state (Figure 8B): indeed, as the fracture bone callus Young's modulus decreases, the higher stress

zone moves closer to the 11th hole. The consequent yield causes the reduction of the plate section and the subsequent break. Being the most representative or the real break event, for the stumbling load condition a further model was considered in which a body mass equal to 75 kg, representative with high probability of the real situation, was addressed and the applied load was reduced accordingly. The obtained Von Mises stresses distribution was similar to the previous one, but as expected the stress peaks were lower and reached the yield stress value for a fracture bone callus Young's modulus equal to 300.0 MPa.

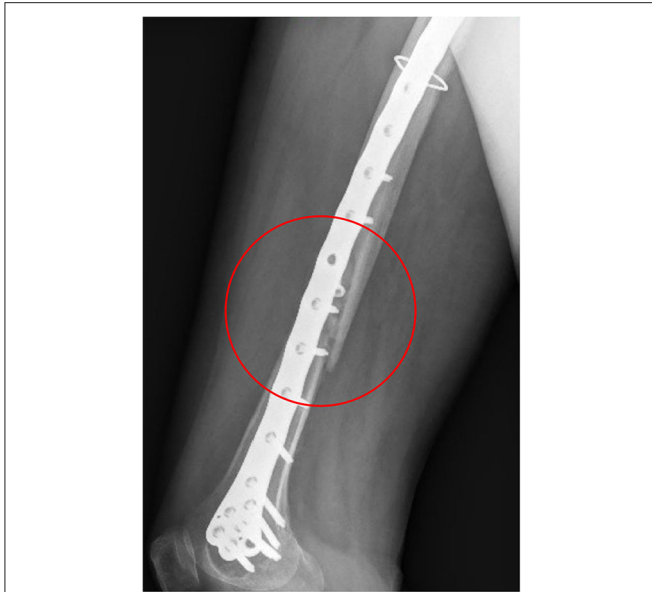
**FIGURE 11** | X-ray image taken after 2 months from the surgery. The non-consolidation of the bone fracture is pointed out.
