Finite Element Modeling Application in Forensic Practice: A Periprosthetic Femoral Fracture Case Study

Finite Element Modeling Application in Forensic Practice: A Periprosthetic Femoral Fracture Case Study / Terzini, M., Aldieri, A., Nurisso, S., De Nisco, G., Bignardi, C.. - In: FRONTIERS IN BIOENGINEERING AND BIOTECHNOLOGY. - ISSN 2296-4185. - 8:(2020), pp. 1-11. [10.3389/fbioe.2020.00619]

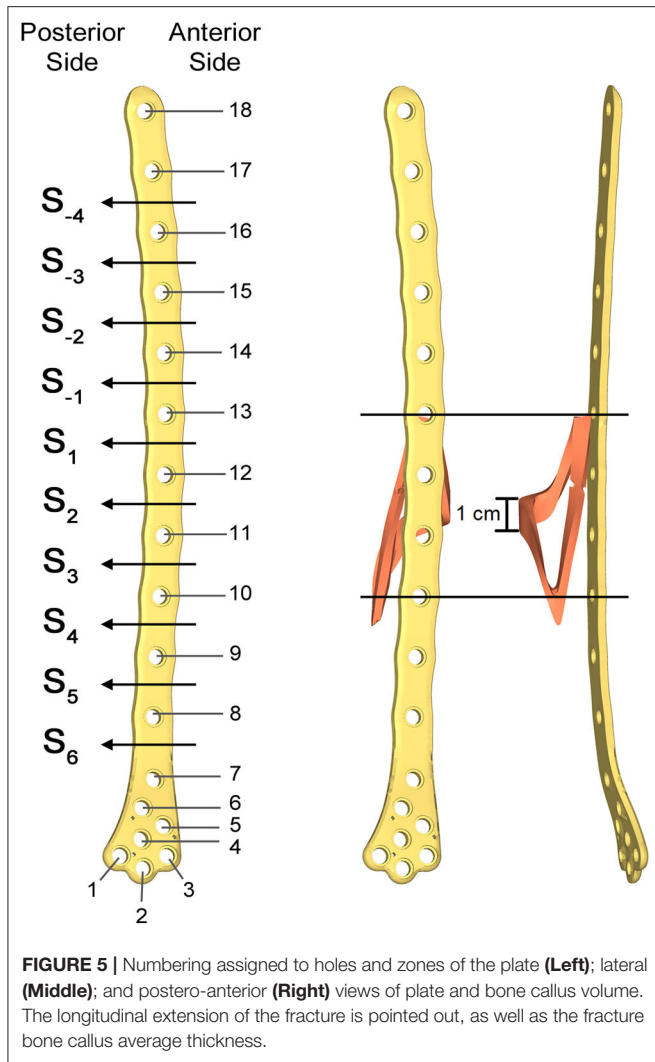
FIGURE 5 | Numbering assigned to holes and zones of the plate (Left); lateral (Middle); and postero-anterior (Right) views of plate and bone callus volume. The longitudinal extension of the fracture is pointed out, as well as the fracture bone callus average thickness.

the main object of investigation of the present study (Papini et al., 2007). Using the software ImageJ (National Institutes of Health, USA) some reference measures were taken on the x-ray images in order to scale the standard femur model and adapt it to the real anatomical case. To recreate the fracture profile, reference points were identified on the x-ray images and reported on the bone surface, so that the fracture shape could be reproduced. The result is a fracture volume characterized by an average thickness of 1 cm (**Figure 5**).

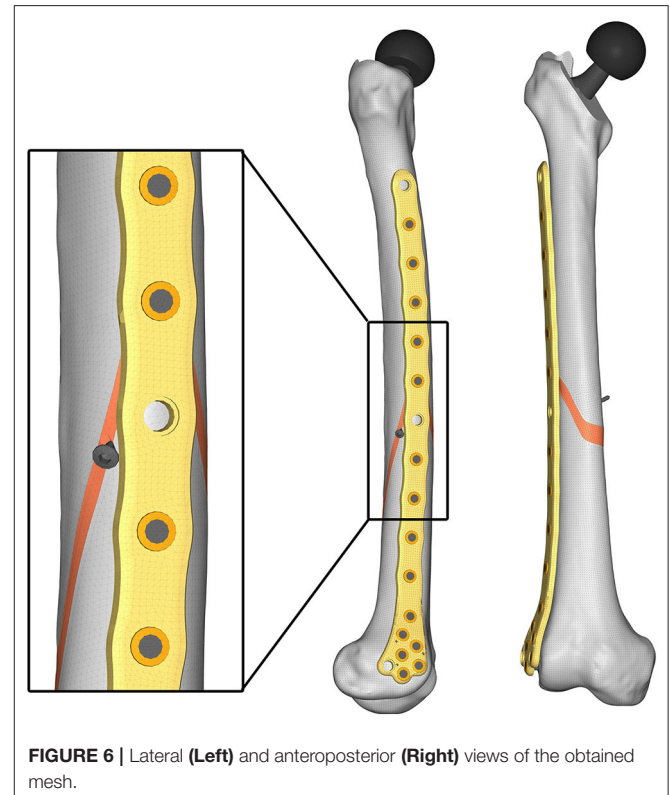
FIGURE 6 | Lateral (Left) and anteroposterior (Right) views of the obtained mesh.

According to Viceconti et al. (1998), Polgar et al. (2001), and Ramos and Simões (2006), a tetrahedral mesh of 388652 elements with a 2 mm average edge length was created (Figure 6).

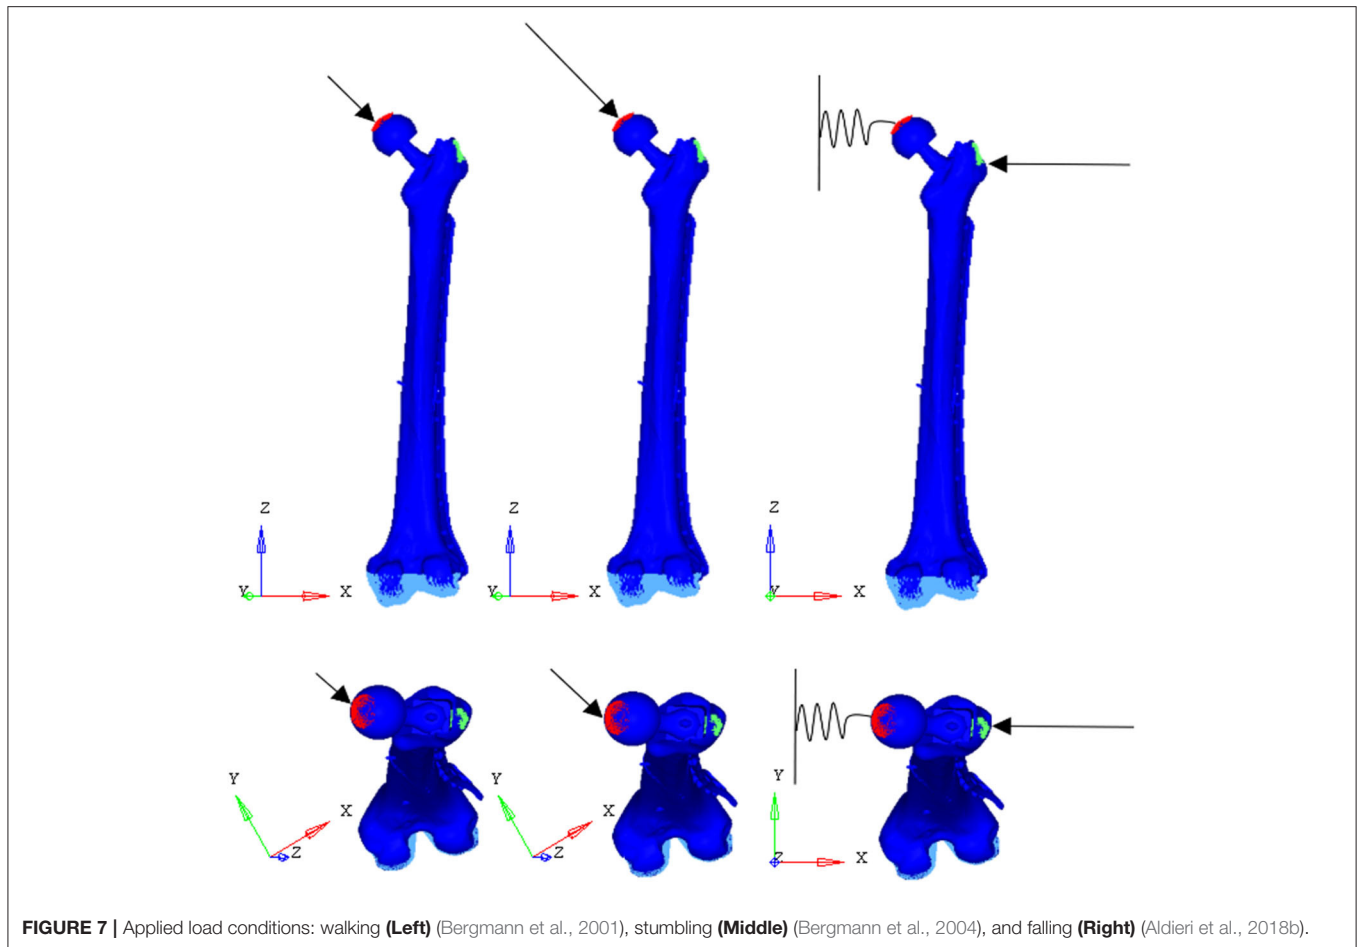
FIGURE 7 | Applied load conditions: walking (Left) (Bergmann et al., 2001), stumbling (Middle) (Bergmann et al., 2004), and falling (Right) (Aldieri et al., 2018b).

Loads applied in the three simulated conditions are listed in Table 3. It should be noted that loads directions were implanted according with the examined literature, and the used coordinate systems are shown in Figure 7.
