Deteriorated seismic capacity assessment of reinforced concrete bridge piers in corrosive environment / Domaneschi, Marco; De Gaetano, Antonino; Casas, Joan R; Cimellaro, Gian Paolo. - In: STRUCTURAL CONCRETE. - ISSN 1464-4177. - 21:5(2020), pp. 1823-1838. [10.1002/suco.202000106]

# Deteriorated seismic capacity assessment of RC bridge piers in corrosive environment

**ABSTRACT:** The coupled effects of corrosion and earthquake action on bridges piers are investigated in this study. Starting from a literature review to collect existing corrosion models, a bridge overpass is selected to perform seismic analyses. It allows to assess the degrading seismic capacity of the bridge pier at different periods due to general and pitting corrosion. The selected bridge structure belongs to the class of motorway overpass, that is a frequently used structural system all around the world. Consequently, the development of a suitable and effective tool for an in-depth degradation analysis of this type of system, with the identification of the most appropriate time for restoration, is of paramount importance to guarantee continuous serviceability and safety.

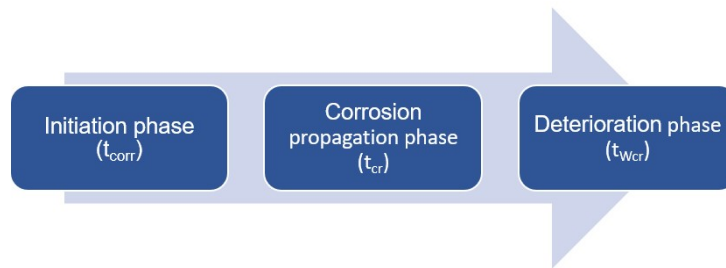
Figure 2: Phases of corrosion process of reinforcing steel

The chloride-induced reinforcement corrosion process could be summarized into three main phases as Figure 2 illustrates [26, 27]:

In the *initiation phase*, the access of chloride ions occurs in the steel reinforcement. This phase lasts when the concentration of chloride ions at the reinforcement surface becomes major than a threshold value. Once the corrosion initiation time,  $t_{corr}$ , has been reached, the *corrosion propagation phase* begins. Subsequently, the deterioration process can occur in two possible corrosion forms: pitting and general. Finally, at the initial cracking time,  $t_{cr}$ , i.e. the time in which the concrete cover cracks, the *deterioration phase* starts and proceeds up to the severe cracking time,  $t_{Wcr}$ , when eventually the bridge service life ends. Once the values of  $t_{cr}$  and  $t_{Wcr}$  are found, the whole corrosion rate model can be obtained by applying the following analytical method.

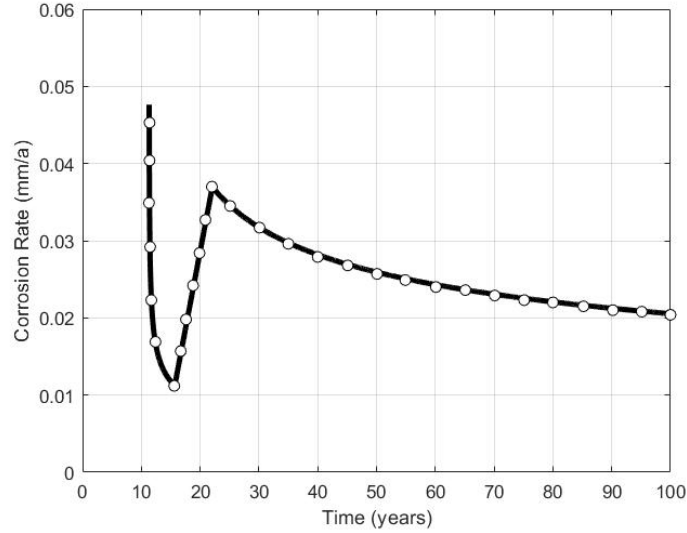
Figure 3: Comparison between corrosion rate obtained by *Matlab* and points in the paper by Cui et al.

The corrosion rate function, described in Figure 3, starts sharply at the corrosion time and then decreases during the first few years. Subsequently, the corrosion rate varies more slowly and reaches a nearly uniform value until the initial cracking time,  $t_{cr}$ .

In the present paper, the corrosion rate model of the paper by [17] for the splash zone has been implemented. Subsequently, a comparison has been performed in order to check if the herein developed *Matlab* model corresponds to the one implemented in [17]. As shown in Figure 3, a satisfactory comparison can be noted, i.e. the continuous black curve obtained by the developed *Matlab* code and the white points from the literature [17] case study. The curve refers to the splash zone only. This outcome allows to develop the same corrosion rate model to the bridge pier discussed in Section 3.

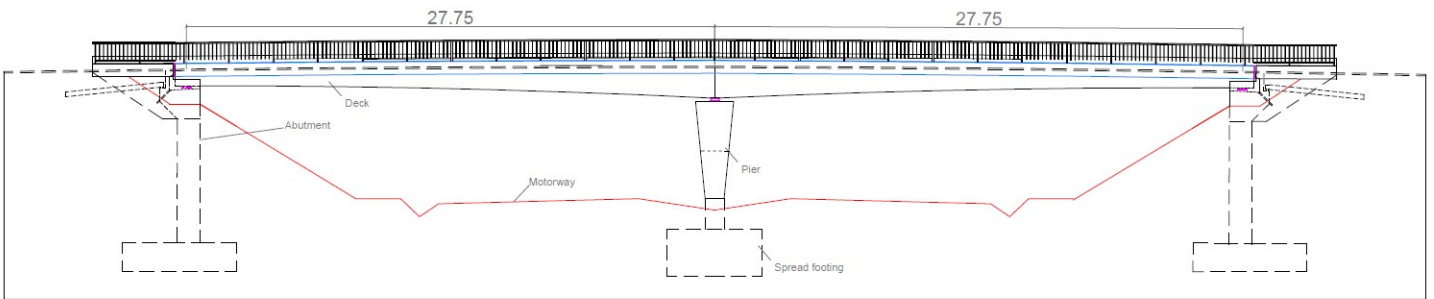
Figure 4: Representation of the bridge front view

The selected application is a frequently used structural system with several existing examples in critical infrastructures. The bridge case study accounts for a motorway overpass. The platform is made up of a 7.5 m

carriageway, 1.5 m docks and 2.5 m wide pedestrian sidewalks. Thus, the total width of the bridge is 15.5 m. The representation of the front view is shown in Figure 4.

The typology of the abutments is open to be more aesthetic and safer. Therefore, the total length of the bridge is 55.5 m, with a 27.75 m span.

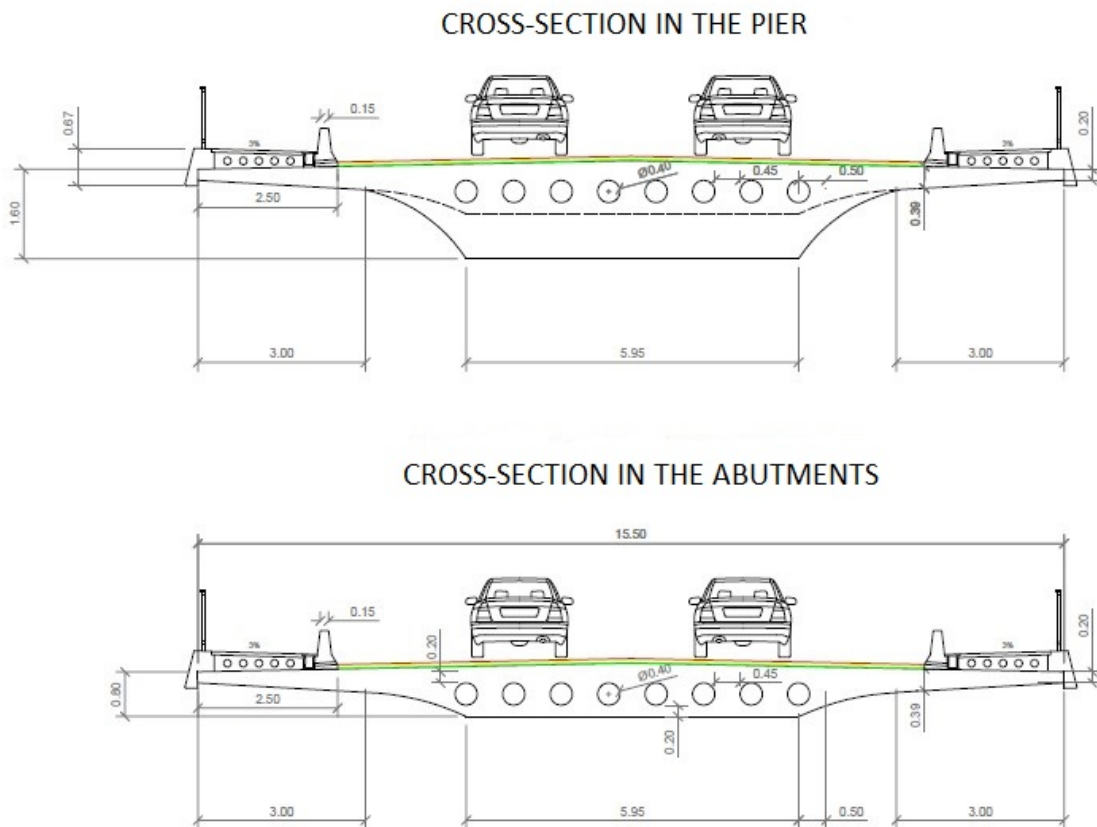
Figure 5: Representation of the bridge cross-section

The deck of the bridge consists of a solid concrete slab with lightnings, variable cross-section depth, and pre-stressed concrete. Figure 5 represents these geometric features with the cross-section depth increasing from the abutments to the pier.

The benefit of the variable depth approach is the optimization of material and a major aesthetic appeal of the bridge. To determine the variable depth geometry, two design conditions have been used:

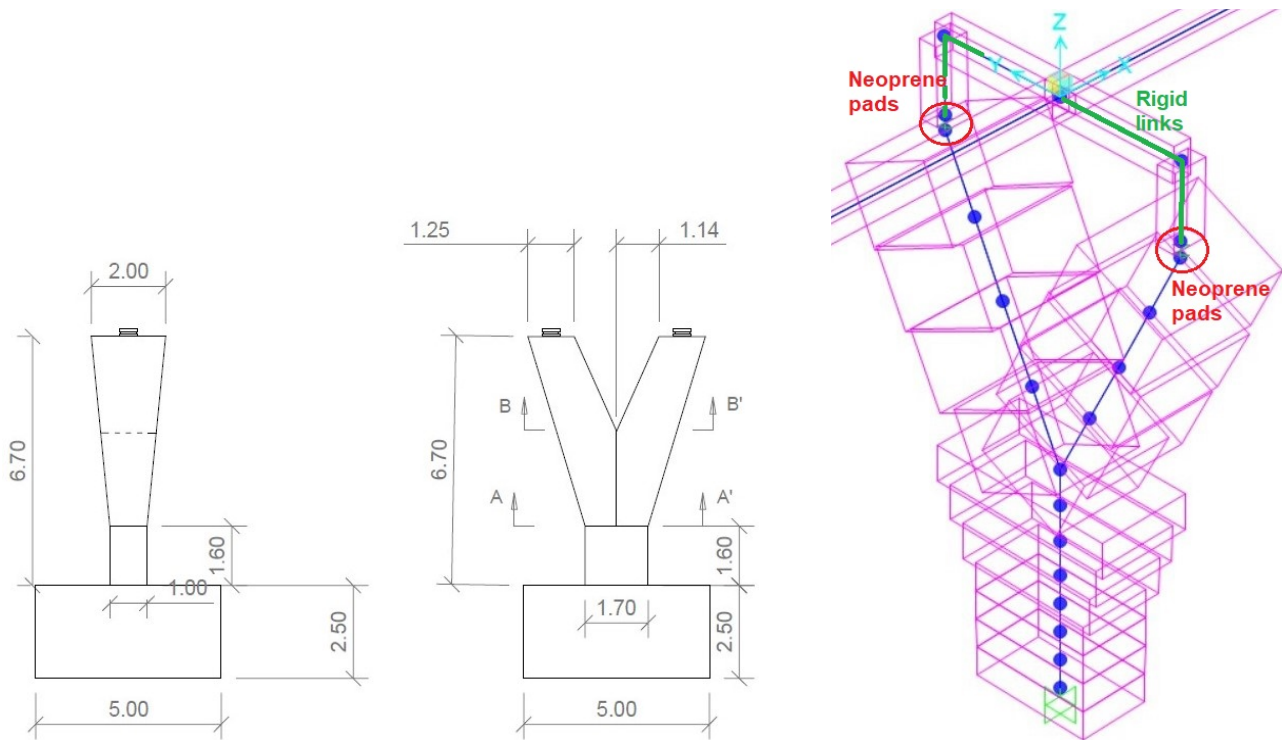
Figure 6: 3D pier geometry (left) and finite element model (right)

The piers regards among the most critical elements for bridge structures in earthquake conditions [14, 11, 15, 16]. This becomes more evident in two-span bridges such that one under study, where the pier essentially affects the structural equilibrium. The geometry is based mainly on both the architectural and structural aspects. The pier cross section changes with the height in two different shapes. It is trapezoidal in the elevation with major base at the top and Y-shaped in the transverse section, wherein each arm has a support device. Additionally, from a structural point of view, the base area ( $1.70 \text{ m}^2$ ) has been chosen to fit the foundation. Thus, a rectangular shape ( $1.00 \times 1.70 \text{ m}$ ) has been chosen with the longest side in the direction of the cross section. The height of the pier is 6.70 m. The bifurcation of the Y-shaped arms allows to increase the distance between the supports of the deck in order to have greater stability. The type of pier foundation has been chosen as a rigid spread footing (Figure 6). It has been assumed that the soil has good mechanical characteristics already close to the surface. Thus, Figure 6 provides an overview of the pier geometry along with the FE model, which is further discussed at Section 4.

Elastomeric bearings NZ 700x700x5(10+3) and NZ 600x600x7(12+3) have been chosen as support device in the pier and the abutments, respectively.

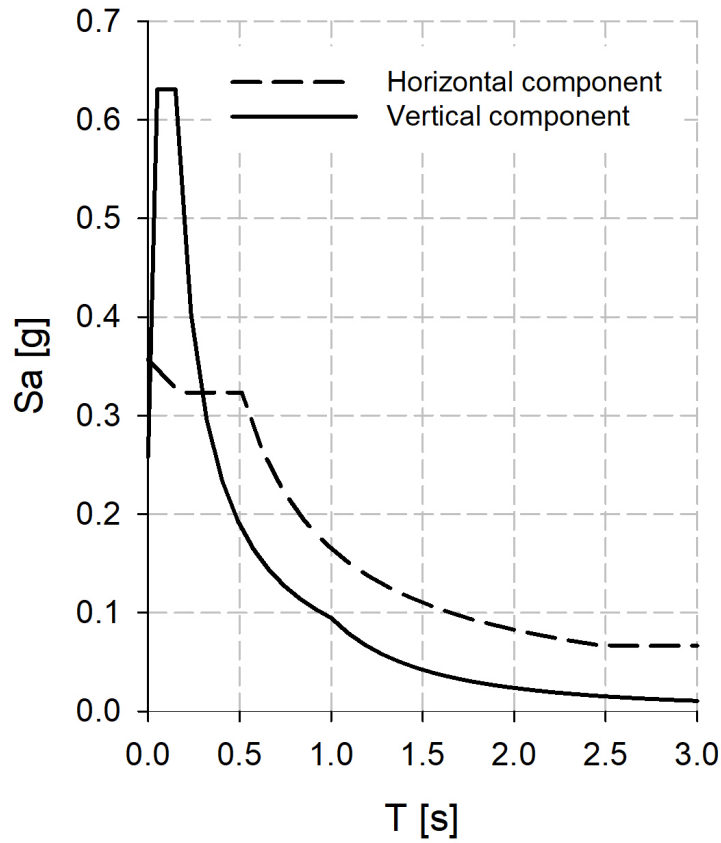
Figure 7: Horizontal and vertical component of the response spectra

The motorway overpass is assumed located in Sicily, the largest island in Southern Italy. In particular, a site close to the Strait of Messina has been selected as characterized by a high seismic hazard. According to the current Italian standard for constructions, it belongs to the first seismic category, associated to the highest intensity, among four. Seismic analysis follows the Italian standard [18], and also the European standard, EN 1998-2 Eurocode 8 [19]. It has been performed according to the actions related to SLV (Life-saving limit state), that belongs to ultimate limit state, as prescribed by NTC2018 for static linear analysis. It must be verified that the individual structural elements and the whole structure have sufficient strength capacity to satisfy the demand for the SLV (Life-saving limit state). The standards prescribe a ductile behavior for the cross-section of the structural elements. The inelastic dissipative behavior must be regarding the flexural type, with the exclusion of possible mechanisms of shear failure, because this failure is brittle and thus, ductility would not be fulfilled. For this reason, the “capacity design” criterion is used [18]. Therefore, an adequate behavior factor,  $q$ , is chosen according to the table of the standard, Eurocode 8 [19]. In this case, a ductile category is chosen to ensure structure ductility in order to prevent the earthquake actions. The response spectra (Figure 7) have been obtained using the Italian NTC2018 regulation [18]. In addition, the horizontal PGA is equal to  $0.332 \text{ g}$ , the vertical PGA is  $0.258 \text{ g}$ , and thus it is quite high. Consequently, this highlights the importance of an accurate seismic analysis. Once the earthquake parameters are known, they can be inserted into the software SAP2000 as the typology of the “response spectrum” load. Accordingly, they can be combined as the standard suggests, i.e. the situation in

- $E_{xd}$  = earthquake longitudinal component
- $E_{yd}$  = earthquake transverse component
- $E_{zd}$  = earthquake vertical component

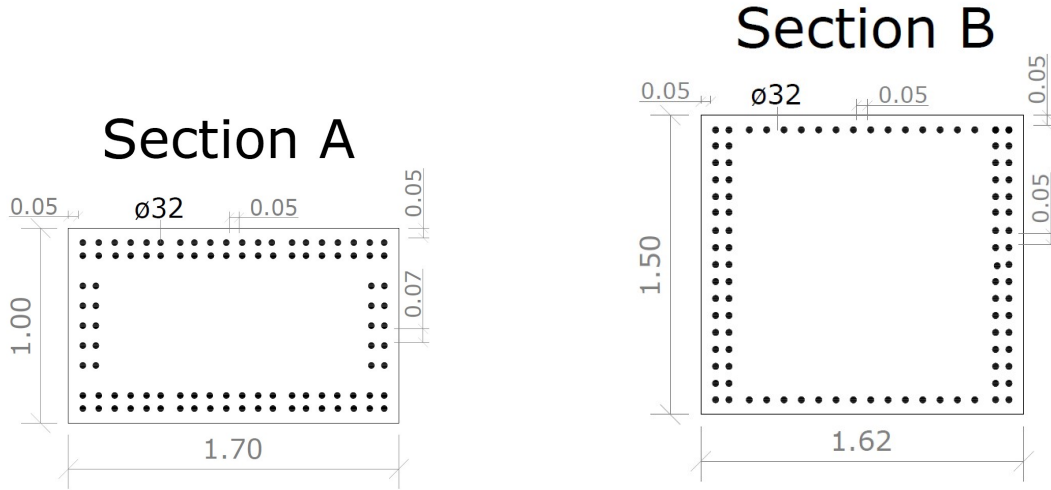
Figure 11: Longitudinal reinforcement in Section A and B (see also Figure 6).

Computation of steel reinforcement area regards only the pier because it represents the most seismic-affected element. For this reason, longitudinal and transverse steel reinforcement is required. The reinforcement located at the base has been designed by means of the *capacity design* criterion. In addition, longitudinal and transverse

reinforcement are characterized by a  $\phi 32$  and  $\phi 14$  diameter bar, respectively. Figure 11 illustrates only the longitudinal reinforcement to highlight better this configuration. The concrete cover is equal to:  $d_c = 50 \text{ mm}$ . The materials used in the RC pier are reported in Table 2.

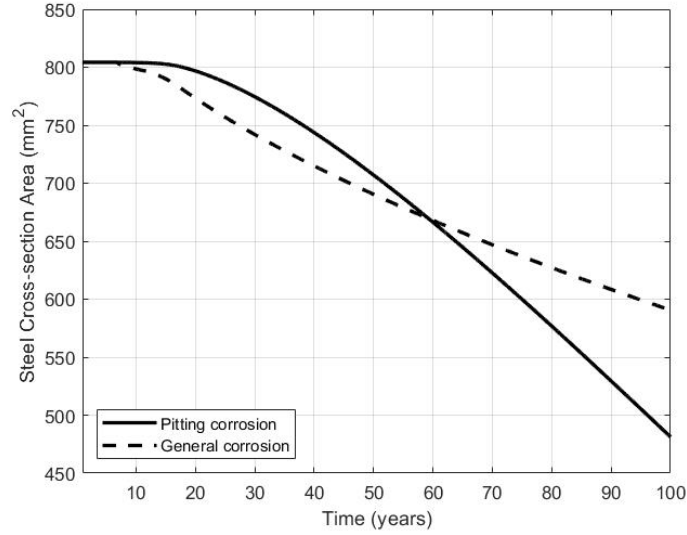
Figure 12: Comparison of pitting and general corrosion

In this paper, the loss percentage regarding the area of reinforcement is around 26.57% and 40.17% in the case of general and pitting corrosion analysis, respectively, as shown in Figure 12. The obtained results are in good agreement with those from [17] highlighting a significant reduction in cross-sectional area in atmospheric zone. In terms of percentage, the lost area of reinforcement is around 53.06% according to [17], in case of pitting corrosion. This depends on the lowest distance from the sea. In addition, [17] selected a case study on the seaside (0 km from the sea). In contrast, in the bridge case study of this paper the distance is 1 km. Thus, Table

3 numerically reports the experimental data on  $A(t)$  which decrease with time in both situations. It can be seen from Figure 12 that the steel cross-sectional area reduction of pitting corrosion exceeds the general corrosion after 60 years and then, the gap between them increases quickly with time.

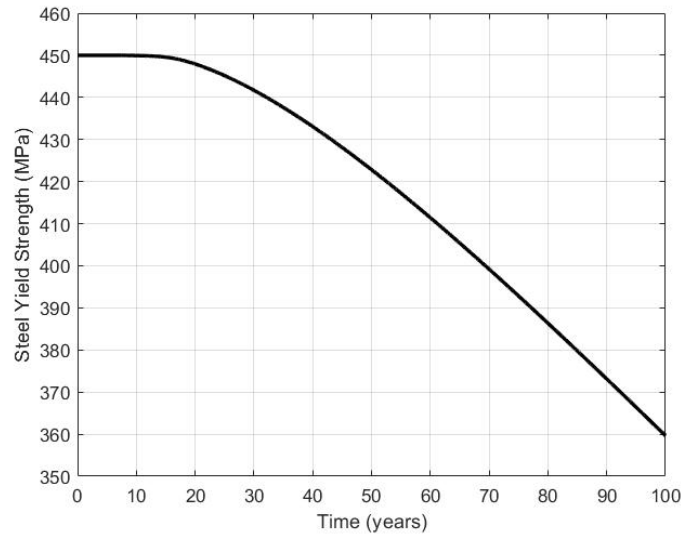
Figure 13: Reduction in yield strength of steel bars

The loss percentage regarding the yield strength of steel bars is shown in Figure 13. It is estimated about 20% over the service life of the bridge (100 years). The reduction of the residual capacity of corroded reinforcement depends on both the local attack penetration on the reinforcement surface and stress concentration in the pitting

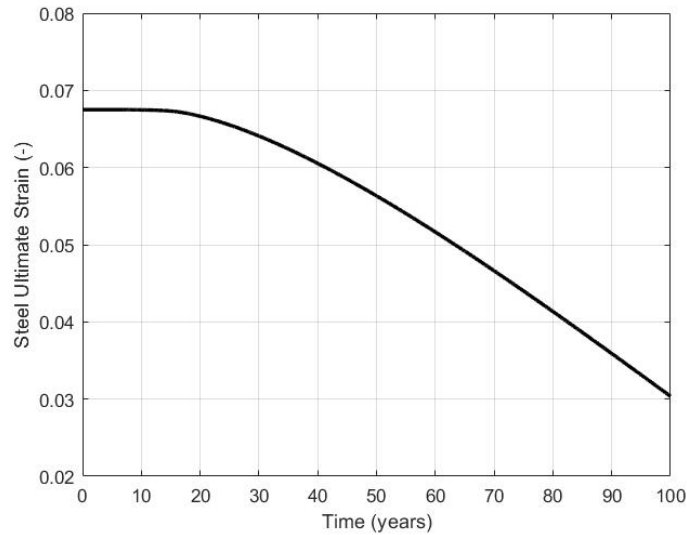
Figure 14: Reduction in ultimate strain of steel bars

The reduction of  $\varepsilon_u(t)$ , which changes with time, is 54.96% in terms of percentage (Figure 14). This means that more than half of the initial ultimate strain is lost during the service life of the bridge. In fact, the ultimate strain of corroded reinforcement decreases up to 0.0304, as shown in Figure 14.

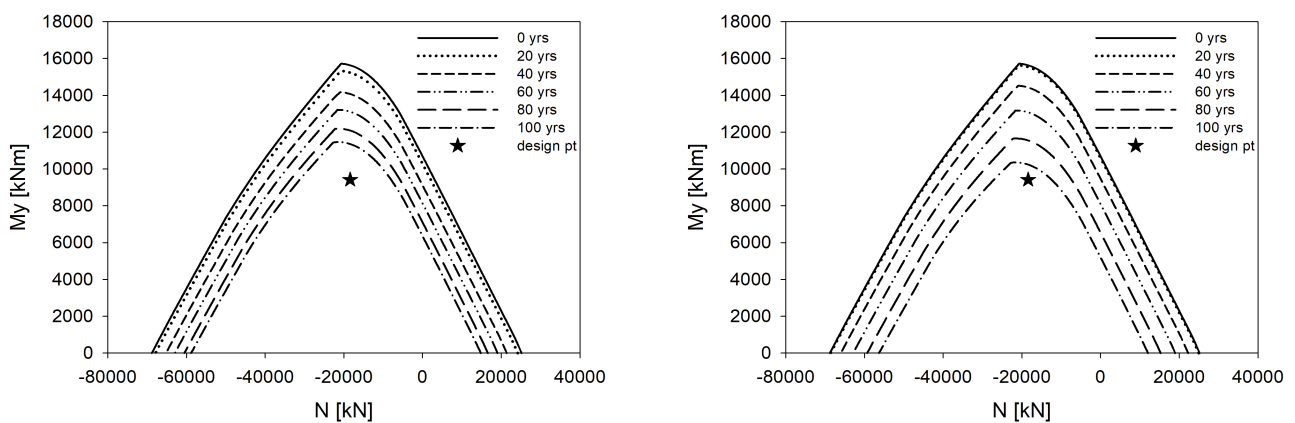
Figure 15: Interaction domain  $M_y - N$  of Section A due to general (left) and pitting (right) corrosion

As discussed above, the structural capacity of the bridge can be affected by degradation due to corrosion. This section aims to assess the structural capacity over the service life of the bridge. Additionally, the reduction of the ductility performance has been considered to check the effect of seismic action on the motorway overpass along 100 years. Structural analysis is based on the use of interaction and Bresler's domains. An interaction domain is a safety zone represented by the geometric locus of M-N pairs that define the strength limits of the cross-section of a structural member under combined compression and bending [40]. Figures 15-16 show the interaction domains for the most significant situations, which change with time related to 0, 20, 40, 60, 80, 100 years of the service life of the bridge case study. In contrast, the star symbol represents the design point.

The analyses highlighted a significant critical condition for the case study, which has been also verified in several existing RC structures exposed to both weather conditions and marine environment (e.g. [42]). Figure 19 shows the interaction diagram and Bresler's domain for section A simultaneously affected by general and pitting corrosion. Seismic capacity of section A is lost in 80 years of service life, while it was retained at reasonable values with respect to general and pitting corrosion considered separately (Figures 15 and 18).

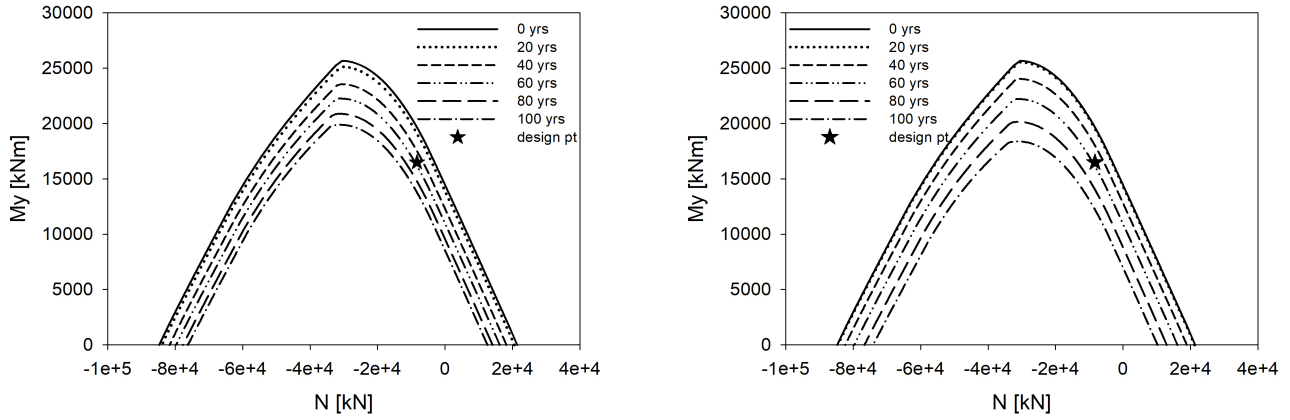
Figure 16: Interaction domain  $M_y - N$  of Section B due to general (left) and pitting (right) corrosion

Figure 16 reports the worst conditions in terms of capacity-demand that is verified at Section B. This significant result shows that under these conditions the bridge is expected to collapse after about 50 years, i.e. a period corresponding to half of the total bridge service life (100 years). Furthermore, as can be seen from Figures 16, there is also a significant similarity between the two cases of corrosion. The bridge failure occurs after about 50 years in Section B, because the bending moment is higher compared to Section A, due to the eccentricity that characterizes the Y-shaped pier arms, holding up the bridge deck. This also depends on the axial force, which is  $N = 8322 \text{ kN}$ , more or less half of that at the base of the pier ( $N = 18380 \text{ kN}$ ). Thus, the structure service life is less than the period established in the bridge design. This means that the bridge failure occurs prematurely due to general or pitting corrosion.

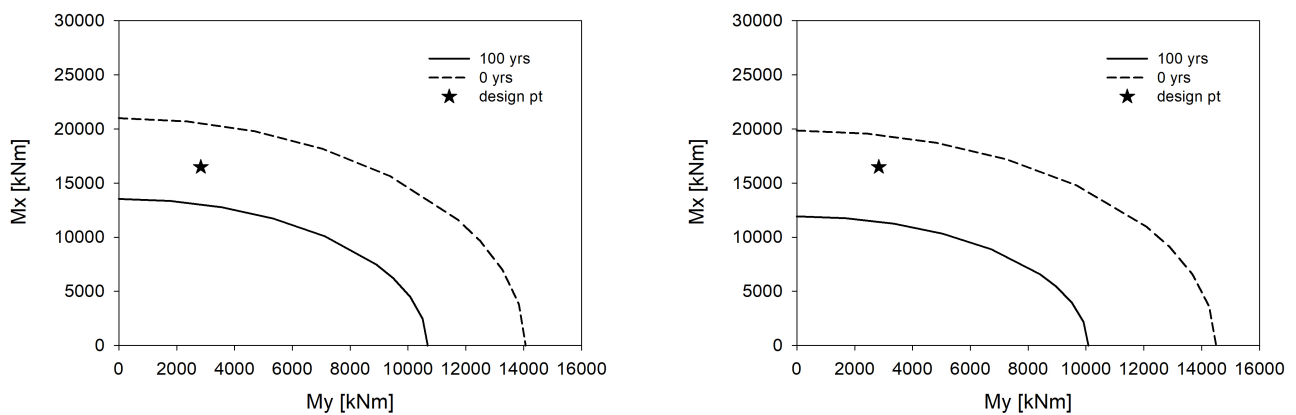
Figure 17: Bresler's domain of Section B due to general (left) and pitting (right) corrosion

In order to complete the analysis of the pier, the biaxial bending condition assessment is required. This situation accounts for the simultaneous presence of three characteristics of load:  $N$ ,  $M_x$  and  $M_y$ . The biaxial bending analysis is fundamental as a consequence of the location of the bridge in seismic zone, thus the horizontal (both in longitudinal and transverse directions) and vertical forces due to the earthquake can act simultaneously. The strength of an RC pier is considered using a Bresler's domain that is a safety domain, such as the interaction domain, considering bending moments' with a constant value of axial force  $N$  [41]. Specifically, it consists of an ellipse in which the semi-axes coincide with the resisting bending moments in both directions ( $M_{rdy} - M_{rdx}$ ). The resisting bending moment,  $M_{rd}$ , has been obtained by the point in the interaction domain outline. Thus, Bresler's domains are given here only for the most relevant situations, e.g. the initial and final condition of the pier capacity of the bridge.

Bresler's domains results (obtained at constant axial force as from the load combination in Eq. (11)) are clearly in agreement with those obtained by the interaction domains. These relationships may partly be explained by

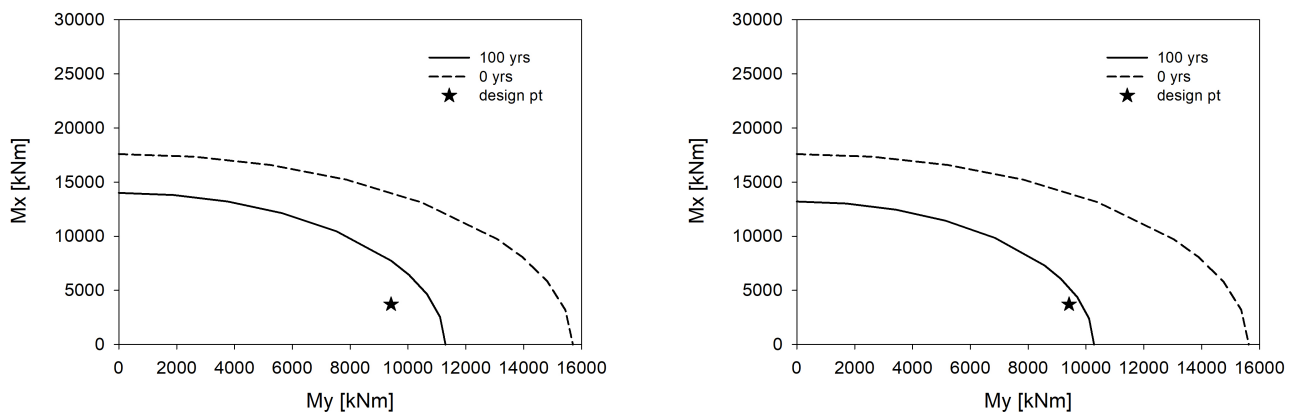
Figure 18: Bresler's domain of Section A due to general (left) and pitting (right) corrosion

the fact that the resisting bending moment has been found by means of the interaction domain. Therefore, this is further evidence of the degradation and collapse of the structure before reaching its intended service life time limit. It is highlighted for section B by Figures 17 for general (left) and pitting (right) corrosion, separately considered and investigated at 100 years of service life. The star point indicates the coordinates of the design point. The most dangerous case occurs in the case of pitting corrosion, as illustrated in Figure 17 on the right side. Biaxial bending analysis confirms an unexpected collapse of the bridge after about 50 years in section B, i.e. half of the total structure service life (100 years). Section A remains safe up to the 100 years design life (Figures 18).
