Monitoring of railway freight vehicles using onboard systems

Nicola Bosso*, Antonio Gugliotta, Matteo Magelli, Nicolò Zampieri

Politecnico di Torino, Torino 10029, Italy

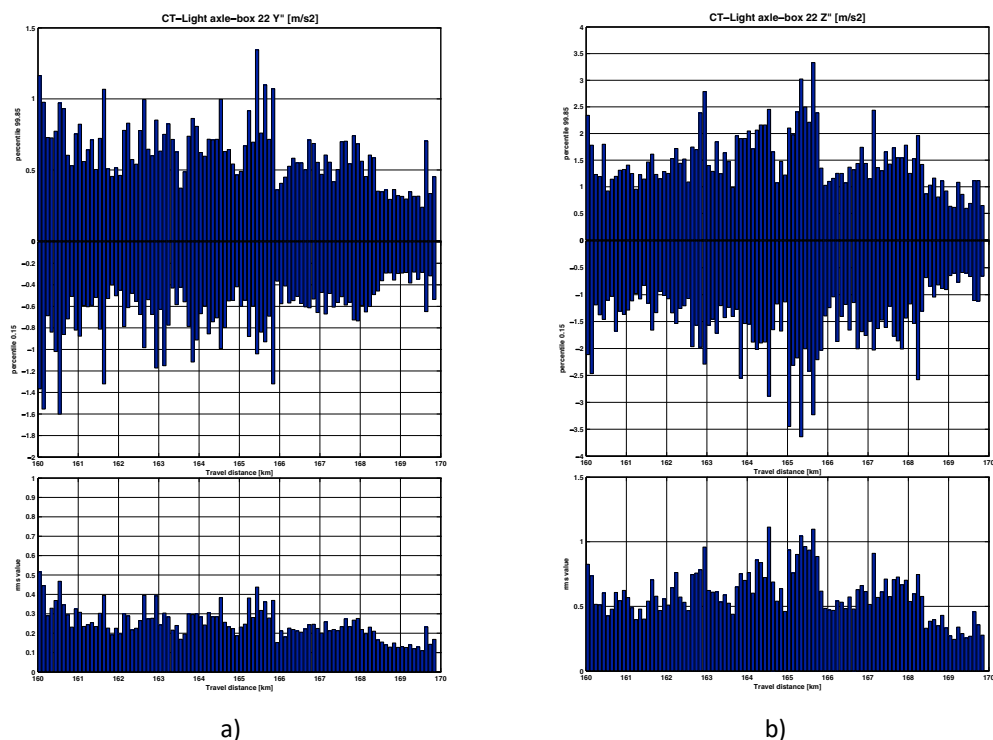
In order to highlight the quality of the new track a further comparison is carried on, comparing the axle-box lateral and vertical accelerations measured on the new Gotthard Base tunnel with the ones measured on the “traditional” Gotthard tunnel. Also in this case, the comparison is performed on the same vehicle with the same axle-load and considering a track section where the vehicle is running at 90 km/h. In Fig. 8.a is shown the axle-box 22 lateral acceleration measured on the “traditional” tunnel which can be compared with the one, measured on the Base tunnel, in Fig. 12.a. Comparing the acceleration percentiles it is evident that the “old” tunnel has higher accelerations than the “new” one, in fact the maximum acceleration in the first case is 1.3 m/s², while in the second case is 0.42 m/s². Also considering the maximum value of the r.m.s. diagram the acceleration value on the “old” tunnel is much higher (0.48 m/s² vs. 0.17 m/s²). In general, the lateral acceleration on the “traditional” Gotthard tunnel are three times higher than the ones measured on the Gotthard Base tunnel under the same conditions. The axle-box vertical accelerations on the “old tunnel”, see Fig. 14.b, have a percentile and r.m.s. peak values equal to -3.6 m/s² and 1.2 m/s², while considering the acceleration measured on the Base tunnel, see Fig. 13.a, the percentile and r.m.s. peak value are equal to -1.3 m/s² and 0.48 m/s². Therefore, the same considerations for the lateral accelerations can be extended to the vertical ones and also in this case the ratio between the accelerations measured on the “traditional” and Base tunnels is about three.

Fig. 14: Percentiles (0.15% and 99.85%) and r.m.s. values of the axle-box 22 lateral (a) and vertical (b) accelerations measured on the “traditional” Gotthard tunnel on the CTLIGHT vehicle running at about 90 km/h.

The last analysis allows to conclude that the accelerations measured on the vehicle axle-boxes, when the vehicle is running on the Gotthard Base tunnel with a speed of 120 km/h (see Fig. 12.b and 13.b), are in general lower than the accelerations that occur on the same vehicle running on the traditional tunnel with a speed of 90 km/h.
