Development of a low-cost monitoring system for open 3d printing

M S Khandpur¹, M Galati¹, P Minetola¹, G Marchiandi¹, L Fontana¹ and V Stiuso¹

Abstract. 3D printers for Rapid Prototyping and Additive Manufacturing have been widely accepted by large and small-scale industries or by many hobbyists. Due to its nature of layer by layer addition of material, identifying defects between the layers can be a crucial strategy to determine the quality of a 3D printed product by carefully monitoring the layerwise process during part building. This kind of approach gives an advantage in the applications where 3D printing of products requires high customization without compromise on part quality. In this work, a low-cost camera is installed in an open 3D printer, and computer vision algorithms are used to implement an in-situ monitoring system. The defects can be evaluated by comparing the printed layer to the deposition path of the open ISO G-code. The G-code printing file is modified to introduce the image capture step after each layer. The value of the area of missing or exceeding material is returned to the user with the corresponding images. A decision can be made to abort the job in ca

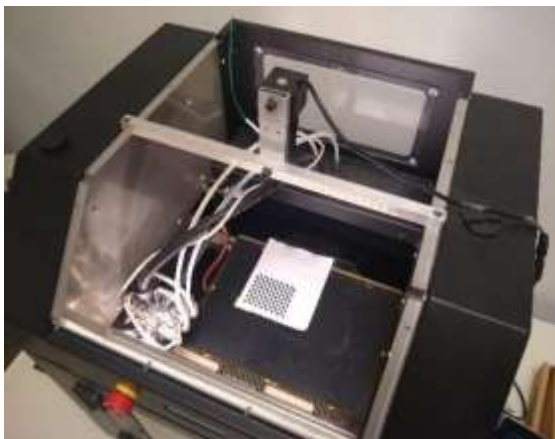
Figure 1. Printer setup with the Svpro camera and checkerboard pattern.

To acquire a picture of the current layer, the camera was installed on the top of the printer bed using an aluminium support bar. For this purpose, the top cover of the printer was removed, as shown in figure 1. With this configuration of the camera, the acquired images are always perpendicular to the print bed and part cross-section. This approach ensures minimal modification to the printing process and its subsystem, such as the print head.

The system calibration to correct the distortion in images is implemented using a checkerboard pattern printed on plain paper (figure 1). An L-shaped 3D printed reference part is used to align the checkerboard pattern with the bed axes (figure 2). Using the procedure described by Fetic et al. [12], the camera parameters are computed starting from the acquired image of the checkerboard pattern. With the information from the G-code, the system can automatically perform adjustments to select the region of interest and recognize the positional coordinates on the printing bed.
