Residual properties in damaged laminated composites through nondestructive testing: A review

Residual properties in damaged laminated composites through nondestructive testing: A review / Boursier Niutta, C.; Tridello, A.; Paolino, D. S.; Belingardi, G.. - In: MATERIALS. - ISSN 1996-1944. - STAMPA. - 14:16(2021), p. 4513. [10.3390/ma14164513]

Residual Properties in Damaged Laminated Composites through Nondestructive Testing: A Review

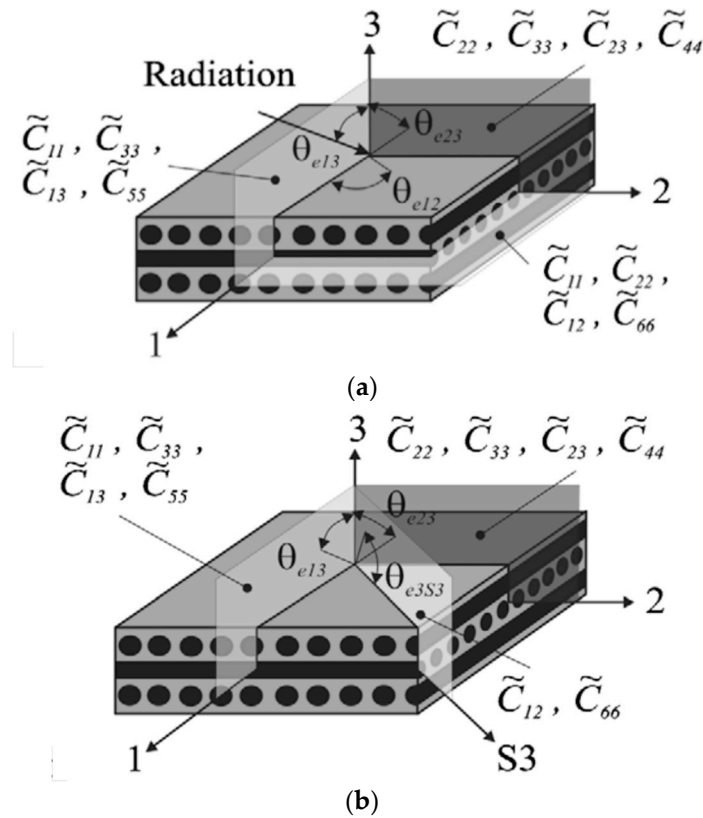
Figure 1. Determination of stiffness matrix coefficients by measurement in (a) symmetry planes and (b) non-symmetry planes [26].

Measurements in non-symmetry planes are, however, controversial due to practical problems [26]. Indeed, the determination of the time-of-flight data is complicated by the severe distinction between the phase velocity and the group velocity, i.e., the velocity of propagation of the wave packet, in non-principal planes [24]. Further, it is worth noticing

that the methodology assumes an orthorhombic symmetry in the material [25]. Therefore, apart from the special case of cross-ply symmetric laminates, material constants of angle-ply laminates cannot be determined.

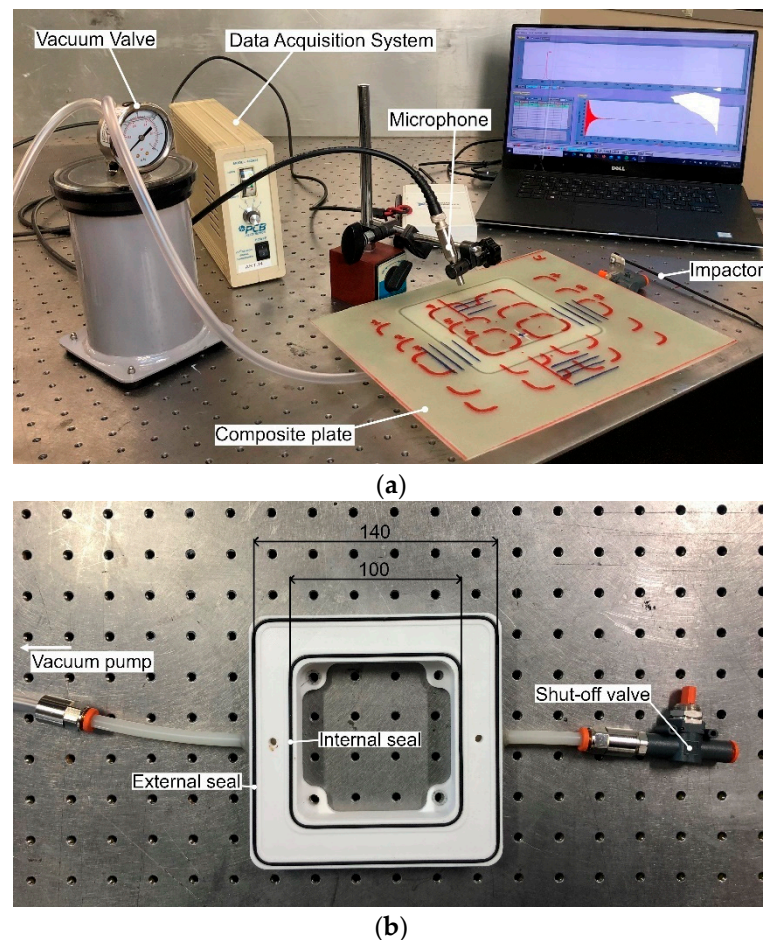
Figure 4. Experimental setup (a) and clamping device (b) of the local vibrational analysis technique.

The technique has been recently extended to the analysis of damaged laminates. In particular, as the observations performed within the nondestructive testing are usually limited to only the exposed surface of the component, an innovative clamping system has been proposed, which adopted a vacuum to obtain the clamping effect. As shown in Figure 4, the inspected region is framed by a vacuum chamber whose air is aspirated through a vacuum pump. The frame chamber is delimited by internal and external rubber seals, which prevent any air escape.
