Residual properties in damaged laminated composites through nondestructive testing: A review

Residual Properties in Damaged Laminated Composites through Nondestructive Testing: A Review

Keywords: laminated composites; nondestructive techniques; damage severity assessment; residual properties; damage index

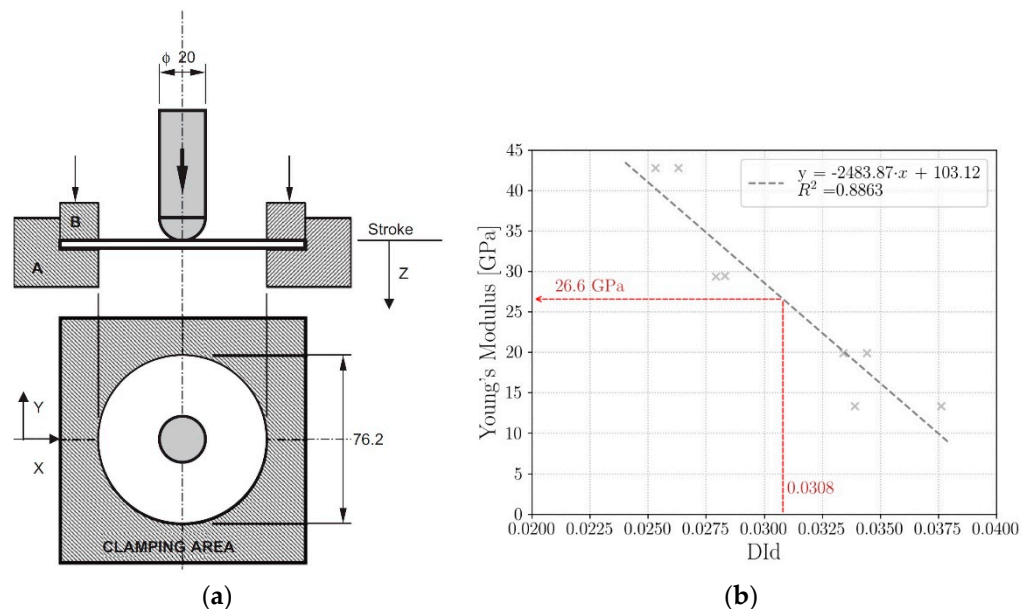
Figure 5. (a) Scheme of the testing fixture of the DI_d technique [61]; (b) relationship between the residual elastic properties and the DI_d parameter [64].

As the residual energy absorption aptitude is evaluated for a circumscribed region of the component, local elastic constants are assessed. Figure 5a shows the testing fixture. By clamping the boundaries through a properly provided uniform pressure, the impact response concerns only the circumferential region whose diameter is 76.2 mm.

The double impact set involves two impact tests on each plate. A new set of composite plates is initially impacted at increasing energy levels and then impacted again on the damaged area at the threshold impact energy E_{th} . The damage index parameter DI_d is thus calculated according to Equation (6). The double impact set allows to correlate the DI_d parameter to the impact energy. Combining this information with the results of the single impact set, where the residual elastic properties are correlated to the incident energy, the residual elastic properties can be expressed as a function of the DI_d parameter, as shown in Figure 5b.
