Procedure for technological diagnosis of oily residuals management in Cubans distributed generation power plants

Abstract

Keywords: Distributed generation power plant; environmental audit; FMEA; oily residuals.

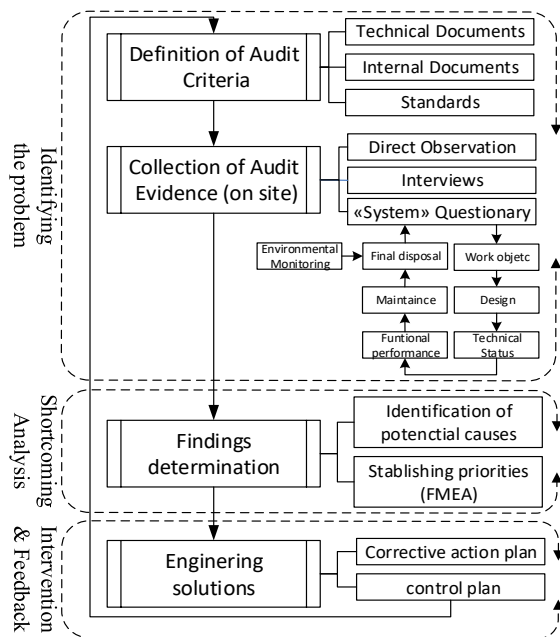
Fig. 2. Heuristic diagram of the research procedure.

The current investigation involved the implementation of a procedure based partly on the eight steps in the problem solution. These steps, applied to improvement projects, enable to reach the root causes, and do not stop at attacking effects and symptoms [9]. In addition, some adjustments were introduced to the original procedure principally with the addition of tools combined under the principle of methodological convergence. Beforehand, the environmental audit was included as a corner stone of the procedure first step (Identifying the problem). This selection guaranteed the identification of environmental risks or impacts in a systematic, independent, and documented process that allows obtaining evidence and evaluating it objectively, in order to determine the extent to which criteria are met [10]. Furthermore, the environmental audit prints much more robustness to the research than an isolated monitoring which just offer a static characterization of the situation. Consequently, it was necessary to focus on the management of oily residuals as an auditory goal. In this context, the audit was executed in accordance with the guidelines established for the audit of management systems [11]. The figure 2 shows the sequence of steps used in a heuristic diagram.
