IGF26 - 26th International Conference on Fracture and Structural Integrity

## An innovative nondestructive technique for the local assessment of residual elastic properties in laminated composites

C. Boursier Niutta<sup>a\*</sup>, A. Tridello<sup>a</sup>, G. Belingardi<sup>a</sup>, D.S. Paolino<sup>a</sup>

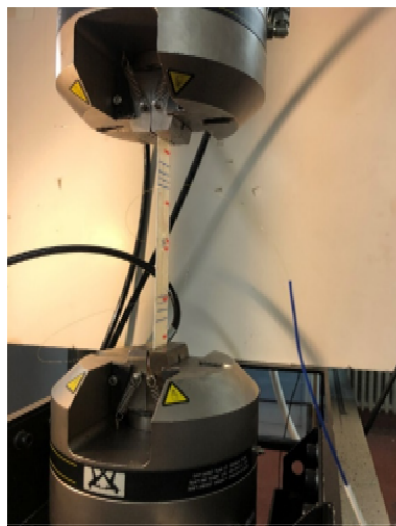
In order to validate Eq. (9), tensile tests are performed on specimens cut from the impacted plates around the damaged area. Fig. 5 shows the tensile test setup.

Fig. 5. Tensile test of specimens equipped with optic fibre.

The tensile tests are performed on a servo-hydraulic machine (Instron 8801) equipped with a cell load of 100 kN. The crosshead speed is set equal to 2 mm/min, in accordance with the recommendations of the ASTM standard D3039 [13]. Tests are performed in the elastic regime of the materials. In order to obtain a punctual measure of the strain, specimens are equipped with optic fibre. The optic fibre sensing is managed through the LUNA control system and its strain gauge is set to 0.65 mm. From the measurement of the applied load and of the induced deformation, the longitudinal Young modulus is punctually assessed.
