MIG and TIG Joining of AA1070 Aluminium Sheets with Different Surface Preparations

MIG and TIG Joining of AA1070 Aluminium Sheets with Different Surface Preparations / Fracchia, E., Bidulská, J., Bidulský, R., ACTIS GRANDE, M.. - In: MATERIALS. - ISSN 1996-1944. - ELETTRONICO. - 15:412(2022).  
[10.3390/ma15020412]

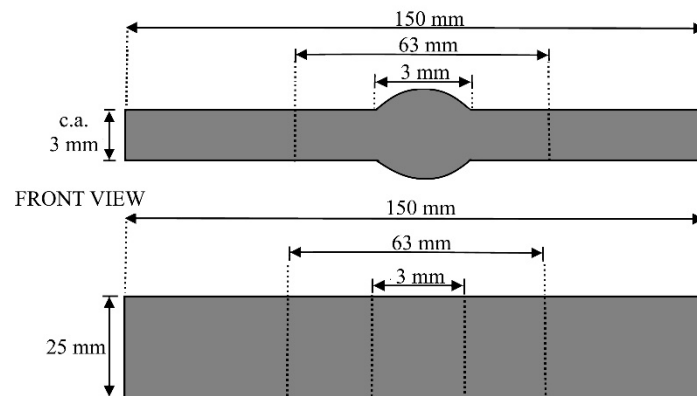
Specimens for tensile tests were milled following the UNI EN ISO 4136:2012 standard (Figure 1): gauge length 120 mm, length 150 mm, width 25 mm, thickness 3 mm. Test parameters used were preload 50 N, test speed  $8 \text{ N/mm}^2\text{s}^{-1}$  before yielding point  $R_{p0.2}$  and  $0.008 \text{ N/mm}^2\text{s}^{-1}$  after yielding point  $R_{p0.2}$ . Each welded sheet contained eleven specimens: five specimens had a protruding weld, while in the other six samples the weld was milled, as drawn in Figure 2. In fact, a protruded weld could be detrimental to the mechanical resistance, and it is commonly considered a weld-shape defect. Tensile tests were performed by a Zwick-Roell machine (Zwick-Roell BT1-FR100, Zwick Roell S.r.l., Genova, Italy).

**Figure 1.** Drawing of specimens for tensile tests. Welding length: 3 mm; gauge length: 60 + weld length; thickness: ca. 3 mm; width: 25 mm; total length 150 mm.

Tensile tests were performed on samples shown in Figures 1 and 3.

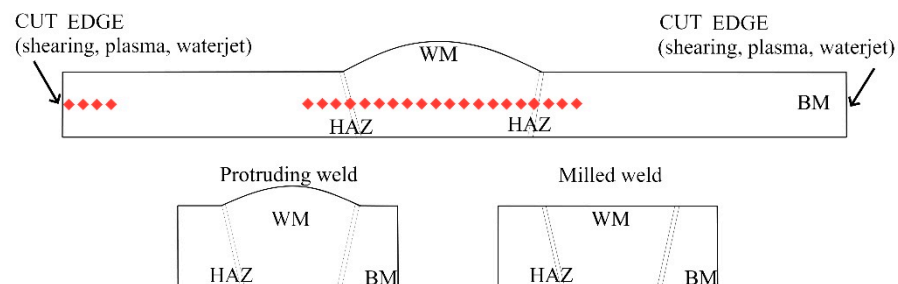
**Figure 2.** Drawing of micro-hardness measures path (red-diamond) along with BM, HAZ and WM and near the edges. Representation of the weld in the protruded and in the milled state.

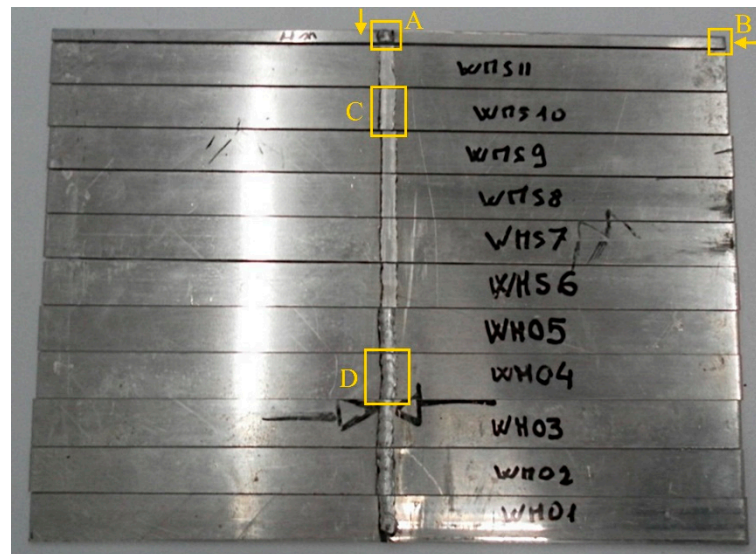
**Figure 3.** Sheets after waterjet cutting and MIG welding. The welded sheets were cut to obtain tensile test specimens and samples for microstructural observation and micro-hardness measures. A: Sample for weld observation and micro-hardness; the arrow indicates the side of observation. B: Sample for edge observation and micro-hardness; the arrow indicates the side of observation. C: Milled weld. D: Protruding weld.

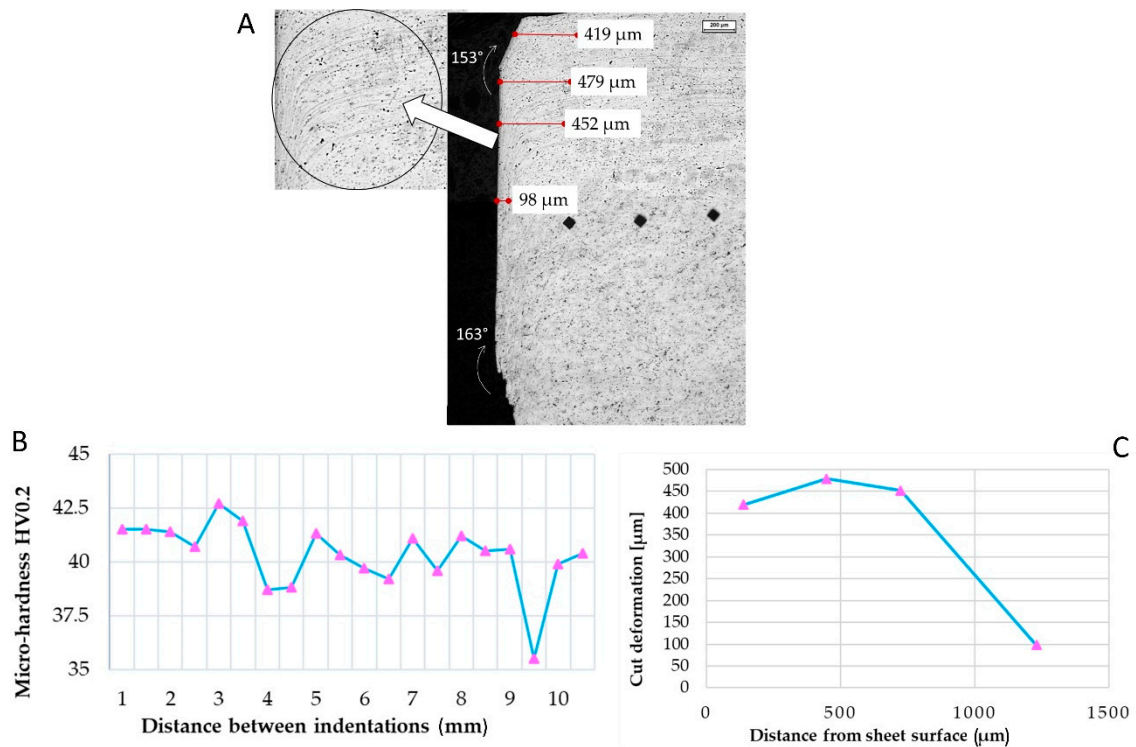
The aluminium sheets after the shearing process appear to have almost linear edges, as clearly noticeable from Figures 4A and 5. The sheet microstructure is oriented along the rolling direction (horizontal direction); after the chemical etching, the distortion of the microstructure at the edges appears evident.

**Figure 4.** (A) Microscope image of the shearing cutting trace on AA1070 sheet. (B) Distortions in the first 1200  $\mu\text{m}$  were documented. (C) Micro-hardness measured along the first 10 mm starting from the cut edge. Marker: 200  $\mu\text{m}$ .

Some microstructural measures were performed through image analysis software (LEICA QWin, version 3.5, Leica Microsystems, Heerbrugg, Switzerland) to evaluate the microstructural distortions. Shearing caused damage to the sheet's edges and material removal. Deformation angles were  $27^\circ$  (top sheet) and  $17^\circ$  (bottom sheet), while distortions decreased from 419 on the top to 98  $\mu\text{m}$  in the middle of the sheet (Figure 4B).

Micro-hardness measured along the edge after shearing did not show an increase caused by plastic deformation near the edge; the micro-hardness resulted almost constant along with the sheet (Figure 4B).

In terms of weldability, this configuration may affect the filler metal penetration, causing inadequate welding penetration during the welding process. On the other hand, despite the sheet edge shown in Figure 4 not being wholly planar, there was a proper welding penetration in both the welding processes (TIG and MIG). After TIG, specimens prepared by shearing resulted in the best mechanical values (along with water jet). On the other hand, mechanical tests showed similar behaviour for shearing-cut specimens and plasma-cut specimens after MIG processing.

Krinninger et al. [27] underlined that aluminium alloys' adhesive tendency (galling) is possible. Hence, the cutting surface in Figures 4 and 5 do not display the galling, while the cutting surfaces result in being relatively planar.

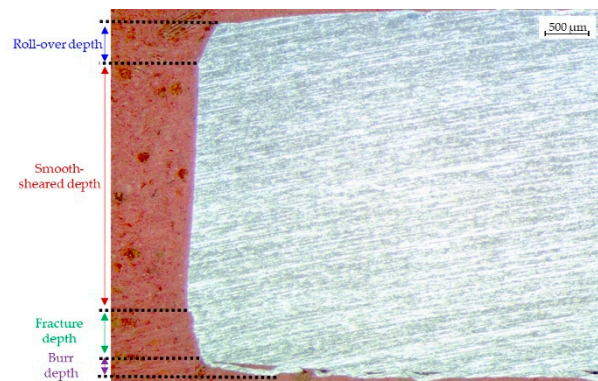
**Figure 5.** Different zones of the edges after shearing.

Conversely, various authors studied sheets' shearing, such as Hambli et al. in [24] and Tekiner et al. [25]. Mainly, they highlight four different zones after the shearing, as shown in Figure 5; the clearance between the punch and the die will affect the precision of the sheet shape and extension of these zones.

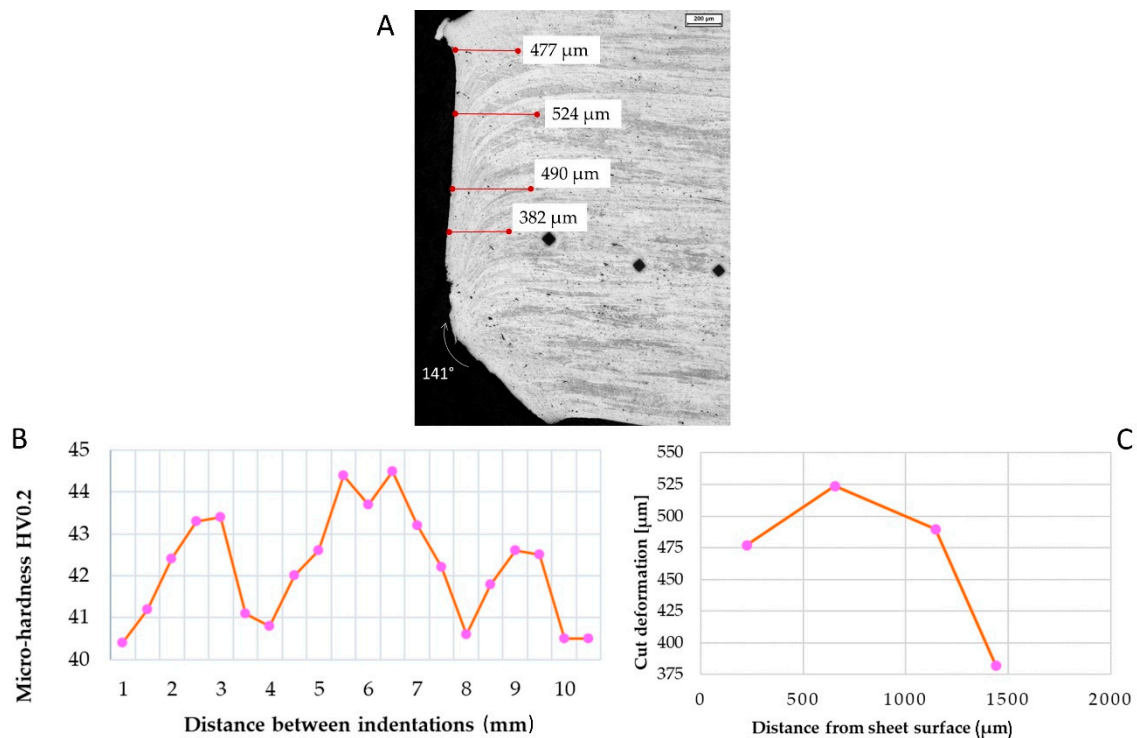
As for the water jet (Figure 6A), the initial distortion remained almost constant, with a measured value of 382  $\mu\text{m}$  in the middle of the sheet (Figure 6C). The bottom part of the sheet showed an intense deformation and material removal; an angle of  $141^\circ$  was measured. Only short variations in micro-hardness were documented (Figure 6B).

**Figure 6.** (A) Microscope image of the water jet cutting trace on AA1070 sheet. (B) Distortions in the first 1500  $\mu\text{m}$  were documented. (C) Micro-hardness measured along the first 10 mm starting from the cut edge. Marker: 200  $\mu\text{m}$ .

In [32], Wang et al. studied the kerf taper in aluminium alloy 6061, arguing that reducing the cutting speed causes the reduction of the kerf taper. Slow cutting speeds can produce a reverse taper, as seen in Figure 6, where the cut's kerf width is wider at the bottom than at the top. The jet stream removed more material at the bottom of the sheet than at the top. The reverse taper can also occur when cutting very soft materials [33]. On the other hand, literature highlights that multipass cutting [34] may increase surface finishing by obtaining flat surfaces.

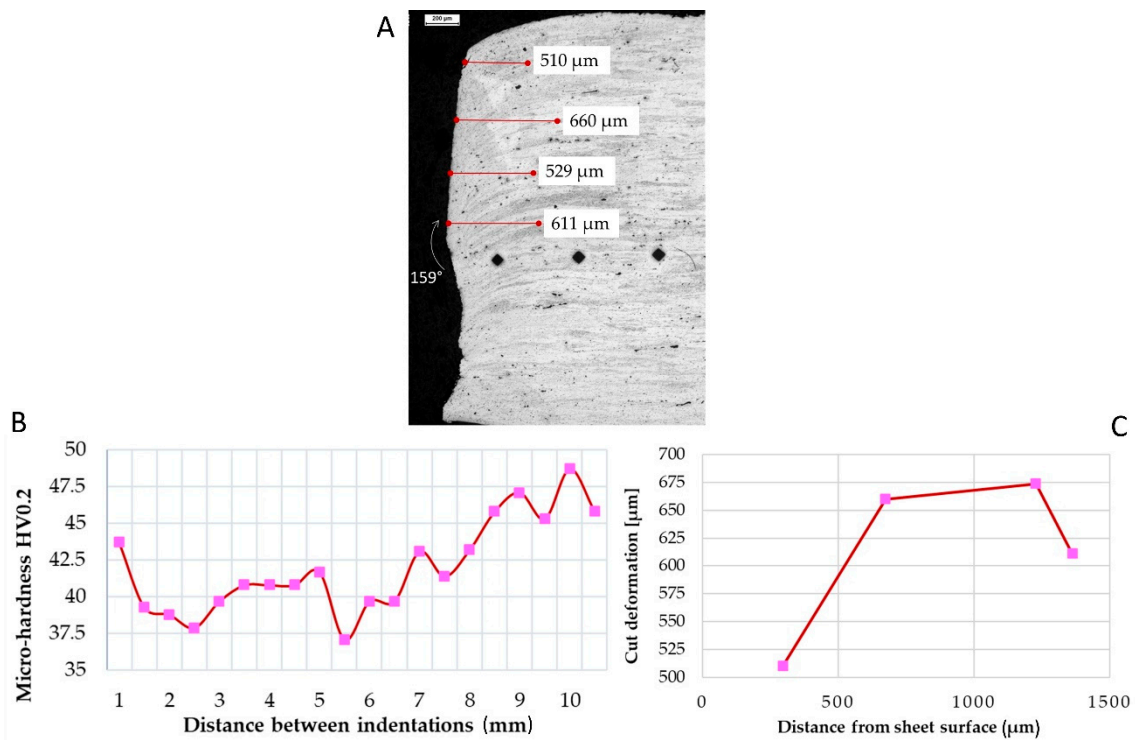
Plasma cutting (Figure 7A) caused higher specimen edge and microstructure orientation distortions. The distortion near the surface was 510  $\mu\text{m}$  and at the mid-thickness 611  $\mu\text{m}$  (Figure 7B).

A slight increase in micro-hardness was detected near the sheet's edge (Figure 7B).

Furthermore, significant damage was caused during the cutting process, with material removal in the lower half of the sheet, with a measured angle of  $159^\circ$ , while  $180^\circ$  was expected for a plain surface. Almost 100  $\mu\text{m}$  of material was removed during the cut, causing a potential lack in penetration of the welding seam.

**Figure 7.** (A) Microscope image of the plasma cutting trace on AA1070 sheet. (B) Distortions in the first 1400  $\mu\text{m}$  were documented. (C) Micro-hardness measured along the first 10 mm starting from the cut edge. Marker: 200  $\mu\text{m}$ .

From the literature, plasma cutting is considered the worst in terms of microstructural modification; moreover, heat-affected zones may develop if plasma power is too high [12]. Figure 7 shows the sheet microstructure after the plasma process. High microstructural distortions were noticed in the first half-width of the sheet. A consistent material removal was observed in the lowest part of the sheet, with a measured angle of 159° (21° of deformation in respect to the planar surface). With regards to micro-hardness, the first indentation (near the sheet edge) resulted in ca. 44 HV0.2, probably caused by strain hardening, then the micro-hardness decreased. In the first 7 mm, a slight heat-affected zone was noticed, micro-hardness decreased to 37 HV0.2; away from the edge, the micro-hardness increased up to 45–47 HV0.2.

Near the edges, different cutting processes caused different effects on both microstructures and micro-hardness measured. Plasma cutting affects the micro-hardness near the edges: the first micro-hardness value was slightly higher (ca. 40 HV0.2), while in the next 7 mm, the plasma effect occurs, resulting in a HAZ (see Figure 7).

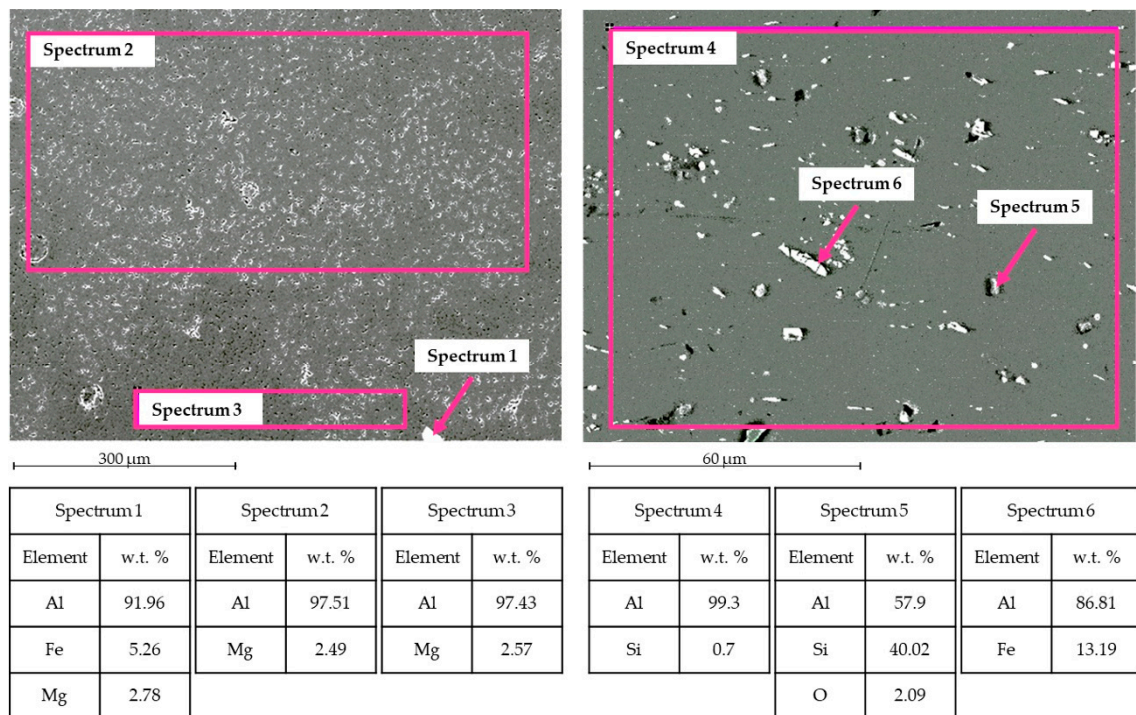
Figure 8 shows SEM-EDS analysis for TIG welding. In the WM, Al and Mg were observed, as expected, in the filler metal ER5356. Some intermetallic phases were observed, for instance, the phase Al-Fe-Mg [15] in Spectrum 1. In the HAZ zone, Al-Si and Al-Fe intermetallic phases were noticed [16].

**Figure 8.** TIG welding analysis. Left side: SEM image and EDS in WZ. Right side: SEM image and EDS in HAZ.

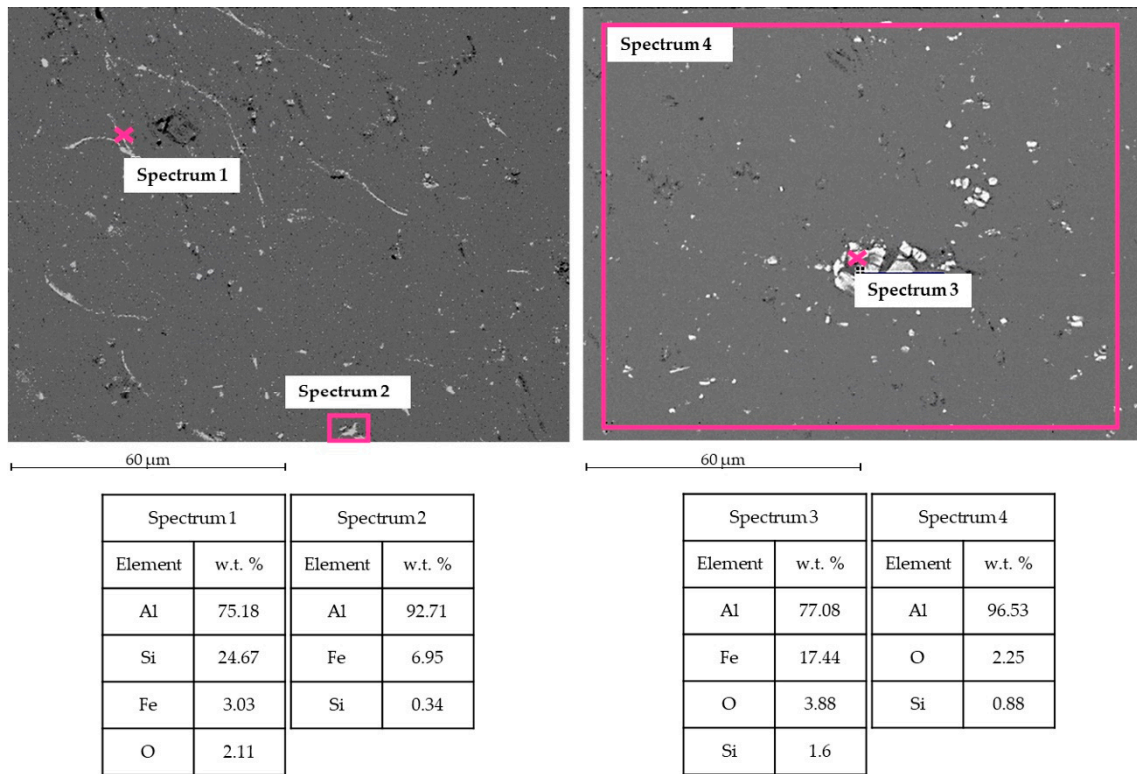
Figure 9 shows SEM-EDS analysis for MIG welding. Into the WM, it was possible to observe the presence of Al and Si, typical elements for the filler metal ER4043. Some intermetallic phases are found; for instance, in Spectrum 1 and Spectrum 3, the phase

Al-Fe-Si is in the form of acicular phase  $\beta$  and polygonal phase  $\alpha$  [17]. Even Al-Si and Al-Fe phases occur in the HAZ zone.

Figure 9. MIG welding analysis. Left side: SEM image and EDS in WZ. Right side: SEM image and EDS in HAZ.

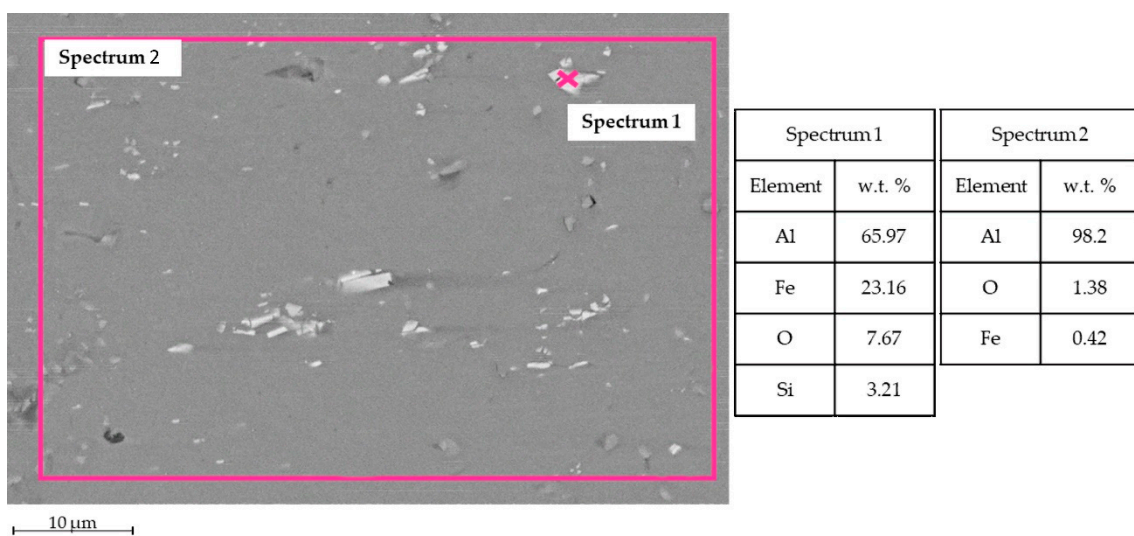
The base metal contains a certain amount of Si and Fe, as shown in Figure 10. It is well known that, if Fe exceeds the solid solubility limit of 0.05 wt %, it forms intermetallic phases Al-Fe [18]. Due to the H16 starting structure, these phases show an elongated shape.

Figure 10. Base metal (BM) AA1070 H16.

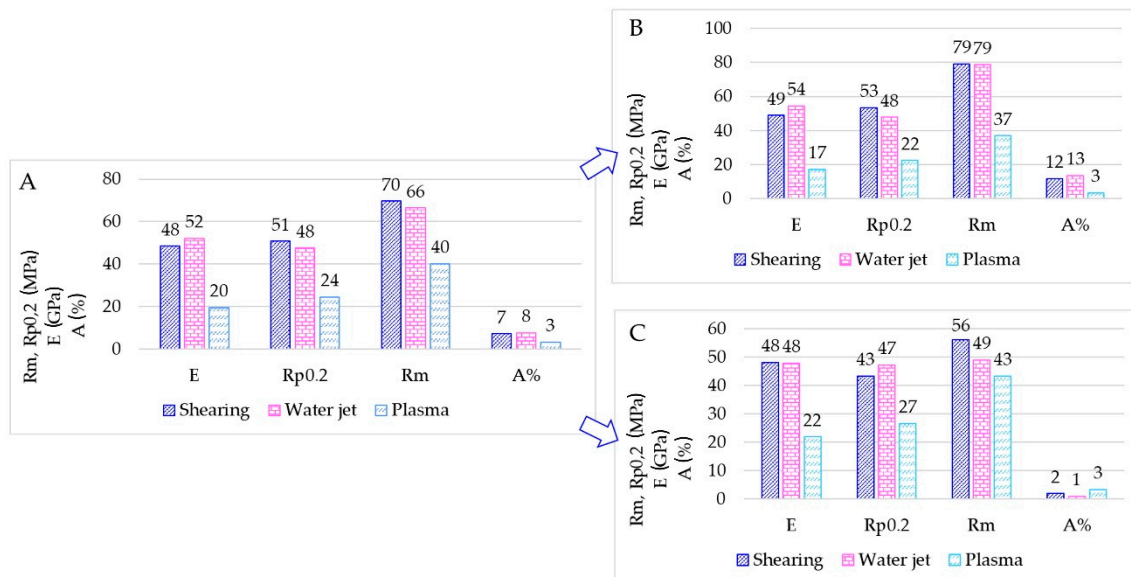
Results for TIG welding are summarized in Figure 11 through bar charts. The bar charts represent the average tensile properties measured (Figure 11A), the average tensile properties for the specimens as-welded (Figure 11B) and finally, the average tensile properties for the specimens having the milled weld (Figure 11C).

**Figure 11.** (A) Overall bar chart for TIG-welded sheets. (B) Bar charts for as-welded samples. (C) Bar charts for milled samples.

The average elongation at rupture A% in TIG-welded specimens is affected by the very low A% in the milled specimens. Mechanical properties observed (Rm, tensile strength; Rp0.2, yield strength) for sheared and water jet cutting appear similar.

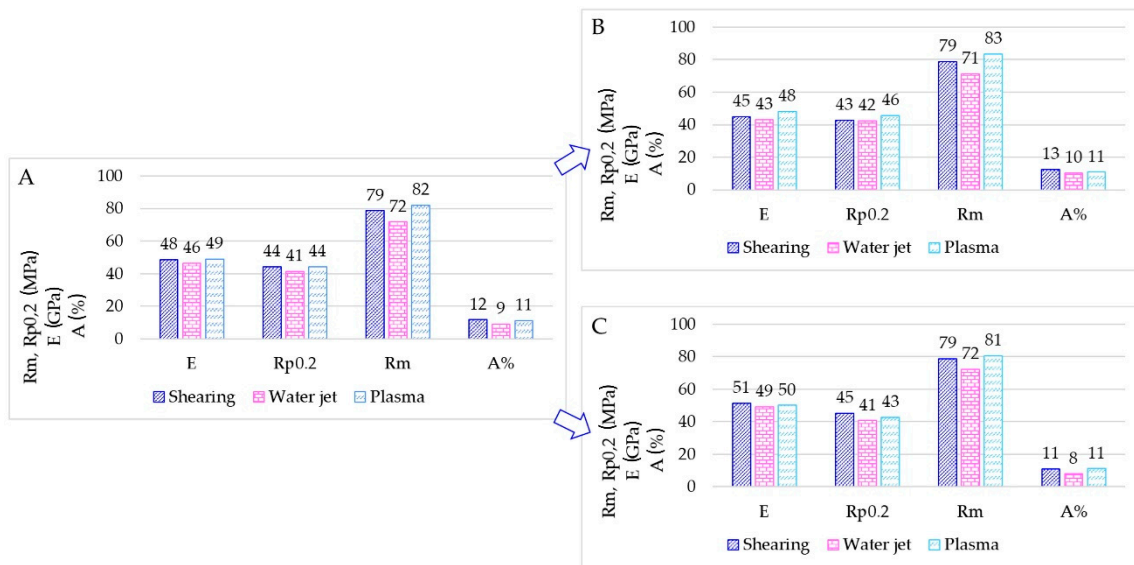
The average mechanical values of MIG-welded specimens are shown in Figure 12. Mechanical properties observed appear similar for each kind of sheet edge preparation, and the A% appear similar with or without the weld milling.

**Figure 12.** (A) Overall bar chart for MIG-welded sheets. (B) Bar charts for as-welded samples. (C) Bar charts for milled samples.

Moreover, porosities inside the weld cause a decrease in hardness near the BM values. On the contrary, in MIG welded specimens, specimens after water jet cutting (orange-bullet marker in Figure 14B) show low micro-hardness in WM. This behaviour is in line with the mechanical results shown in Figure 12 (the worst in MIG welding specimens).

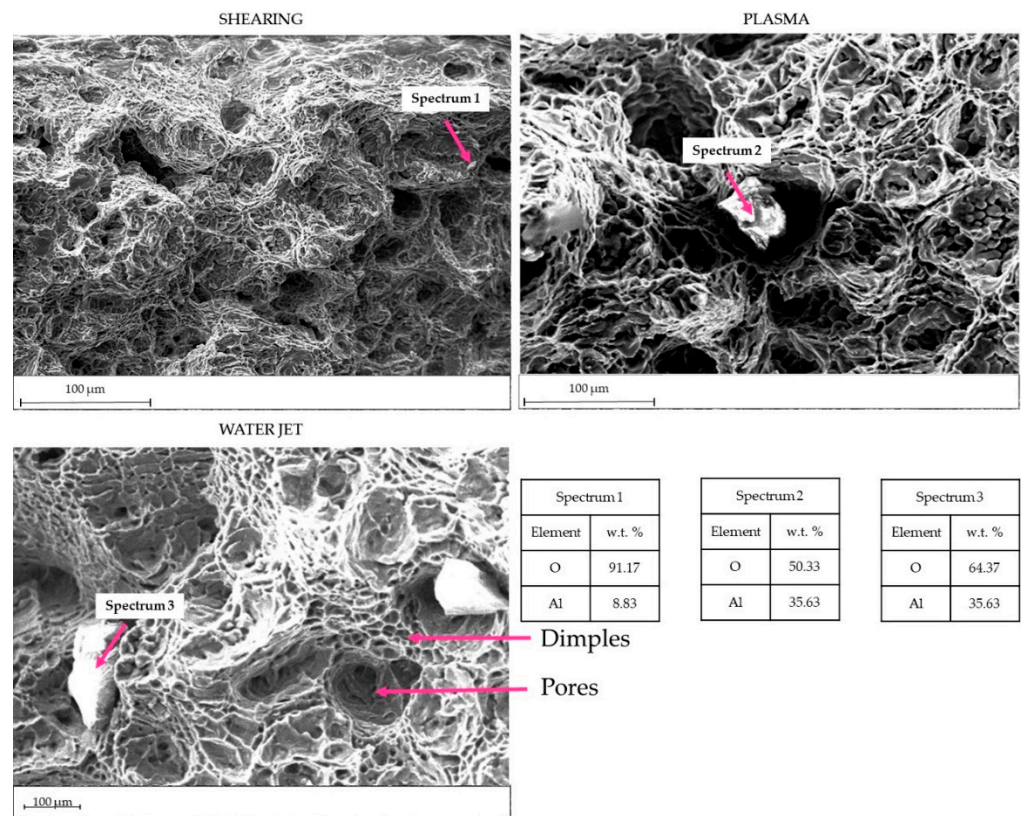
To assess these hypotheses, SEM observations were performed. The fracture surfaces were observed using SEM (Figure 13). Ductile fractures were noticed in all the specimens; all fractures were located in the welded part. Some welding appears non-penetrating along the entire thickness of the sheet. Furthermore, the weld seams appear rich in gas porosities [19] and in dendrites that negatively affect the mechanical strength. A high amount of oxide scale was observed, particularly in the water jet and plasma specimens (Figure 13—Spectrum 2 and Spectrum 3).

**Figure 13.** Surface fractures in three TIG-welded tensile specimens. Oxides were detected of variable sizes.

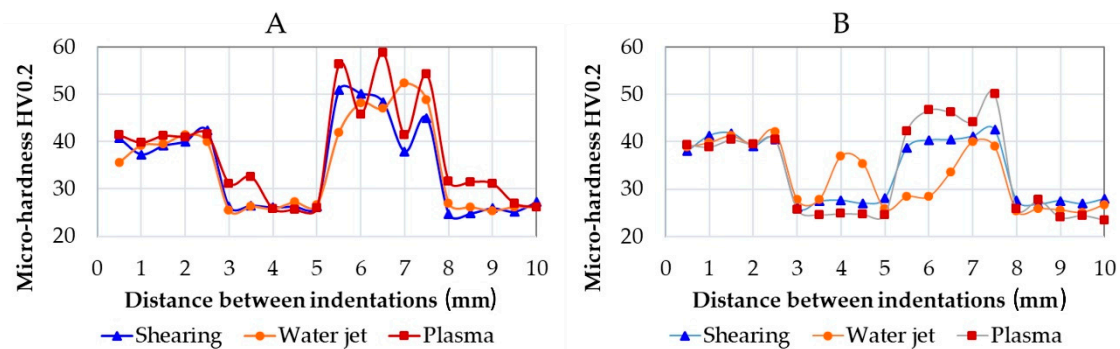
The WM has a dilution ratio that depends on the welding process. WM comprises AA1070 base metal and ER5356 filler metal for TIG welding and AA1070 and ER4043 for MIG welding. The micro-hardness in the welded samples was measured as drawn in Figure 2, and results are shown in Figure 14. The different dilution ratios may affect the average micro-hardness. Furthermore, in the WM, the micro-hardness is subjected to a certain variation caused by defects or hardening phases. In TIG welding, specimens' plasma-cuts show some inadequate penetration and porosities. This behaviour causes a variation in the micro-hardness measured (red-square marker in Figure 14A).

**Figure 14.** Graphical representation of the micro-hardness measured in TIG (A) and MIG (B) specimens.

Overall, higher micro-hardness was noticed in TIG welding with an average value of 48 HV0.2, while in MIG welding, the average value was 40 HV0.2. This result is, in turn, affected by the filler metal. In TIG welds, the micro-hardness in WM is higher than the micro-hardness in the BM; on the contrary, in MIG welds, the micro-hardness resulted similar in the BM and the WM. Micro-hardness values are average values depending on the intermetallic phases. Considering that the number of intermetallic phases is low in alloy AA1070, hardness in BM is almost the hardness of the  $\alpha$ -Al phase: ca. 40 HV0.2. Furthermore, the micro-hardness in the  $\alpha$ -Al depends on the alloying elements dissolved in the solid solution [20]. Intermetallic phases detected may affect the average values:  $\alpha$ -AlFeSi and  $\beta$ -AlFeSi are respectively ca. 883 HV and 765 ([21]), Al-Mg ca. 48 HV [22], Al-Si ca. 80 HV [20].

The variation in micro-hardness inside the WM was caused by the high amount of gas porosities found in the weld pool, as observed in the surface fracture analysis in Figure 14. The reduction in the micro-hardness from the BM to the HAZ is attributable to the intermetallic Al-Fe coalescence and the grain coarsening.
