MIG and TIG Joining of AA1070 Aluminium Sheets with Different Surface Preparations

MIG and TIG Joining of AA1070 Aluminium Sheets with Different Surface Preparations / Fracchia, Elisa; Bidulská, Jana; Bidulský, Róbert; ACTIS GRANDE, Marco. - In: MATERIALS. - ISSN 1996-1944. - ELETTRONICO. - 15:412(2022).
[10.3390/ma15020412]

Abstract: In this work, AA1070 aluminium alloy sheets are joined using TIG and MIG welding after three different edge preparations. Shearing, water jet and plasma-cut processes were used to cut sheets, subsequently welded using ER5356 and ER4043 filler metals for TIG and MIG, respectively. Mechanical properties of the obtained sheets were assessed through tensile tests obtaining a relation between sheet preparation and welding tightness. Micro-hardness measures were performed to evaluate the effects of both welding and cutting processes on the micro-hardness of the alloy, highlighting that TIG welding gives rise to inhomogeneous micro-hardness behaviour. After tensile tests, surface fractures were observed employing scanning electron microscopy to highlight the relation between tensile properties and edge preparations. Fractures show severe oxidation in the w

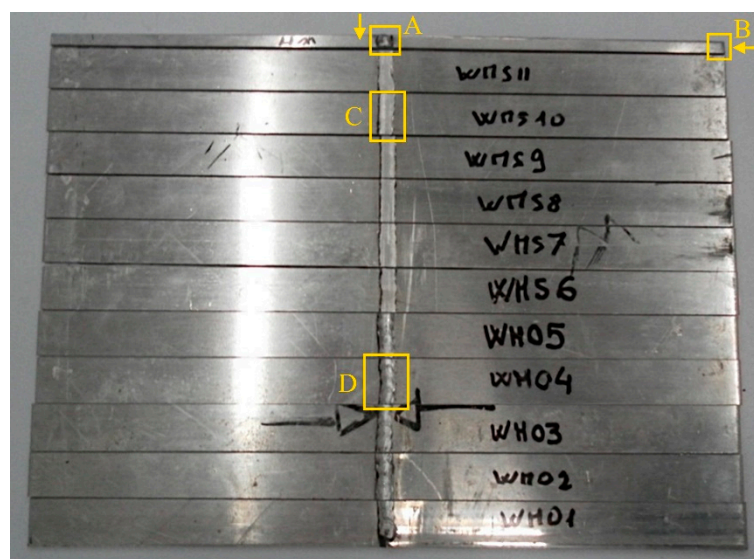
Figure 3. Sheets after waterjet cutting and MIG welding. The welded sheets were cut to obtain tensile test specimens and samples for microstructural observation and micro-hardness measures. A: Sample for weld observation and micro-hardness; the arrow indicates the side of observation. B: Sample for edge observation and micro-hardness; the arrow indicates the side of observation. C: Milled weld. D: Protruding weld.

Cross-sectional micro-hardness measurements were performed on the welded samples using a Vickers micro-hardness tester, LEICA VMHT (Leica Microsystems, Heerbrugg, Switzerland), as shown in Figure 2. The parameters applied were 200 gf and 15 s. The number of specimens and tests are reported in Table 3, while samples' production in a single welded sheet is shown in Figure 3.

Tensile tests were performed on samples shown in Figures 1 and 3.

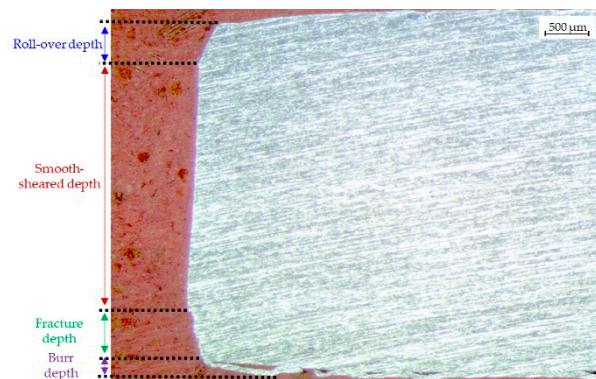
Figure 5. Different zones of the edges after shearing.

The aluminium sheets after the shearing process appear to have almost linear edges, as clearly noticeable from Figures 4A and 5. The sheet microstructure is oriented along the rolling direction (horizontal direction); after the chemical etching, the distortion of the microstructure at the edges appears evident.

Conversely, various authors studied sheets' shearing, such as Hambli et al. in [24] and Tekiner et al. [25]. Mainly, they highlight four different zones after the shearing, as shown in Figure 5; the clearance between the punch and the die will affect the precision of the sheet shape and extension of these zones.

Krinninger et al. [27] underlined that aluminium alloys' adhesive tendency (galling) is possible. Hence, the cutting surface in Figures 4 and 5 do not display the galling, while the cutting surfaces result in being relatively planar.

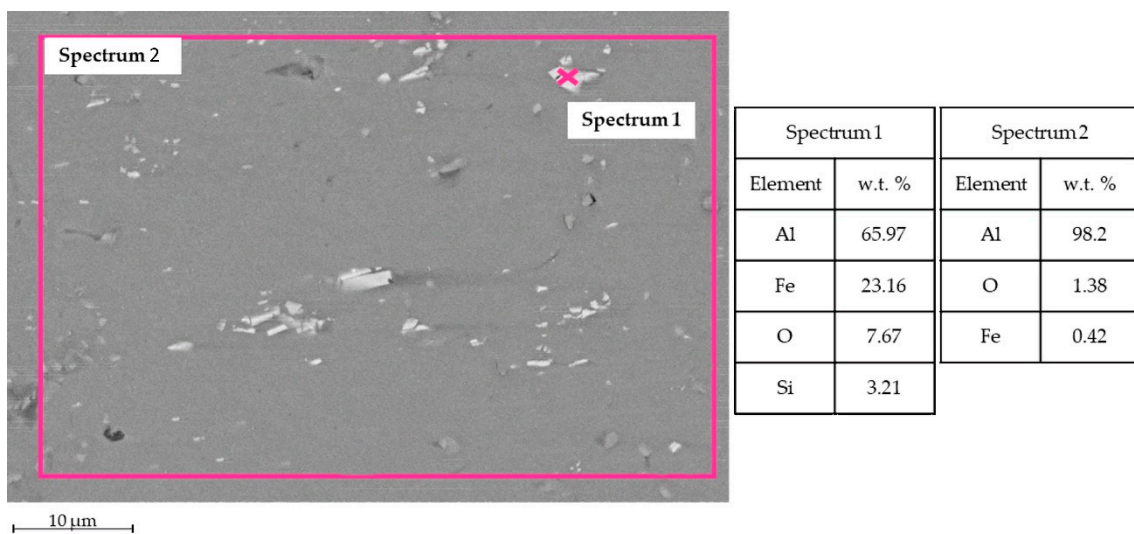
Figure 10. Base metal (BM) AA1070 H16.

The base metal contains a certain amount of Si and Fe, as shown in Figure 10. It is well known that, if Fe exceeds the solid solubility limit of 0.05 wt %, it forms intermetallic phases Al-Fe [18]. Due to the H16 starting structure, these phases show an elongated shape.
