# Disasters, Memory and Liturgy. Liturgical Spaces in the Reconstruction Process of Historical Churches Damaged by Earthquakes

Giulia De Lucia· Politecnico di Torino (Turin, Italy), giulia.delucia@polito.it

CÓMO CITAR: De Lucia, Giulia. 2019. «Disasters, Memory and Liturgy. Liturgical Spaces in the Reconstruction Process of Historical Churches Damaged by Earthquakes». *Actas de Arquitectura Religiosa Contemporánea* 6: 194-207.  
<https://doi.org/10.17979/aarc.2019.6.0.6239>.

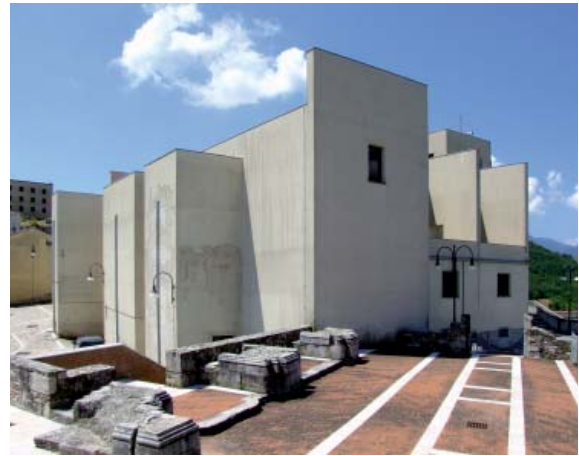
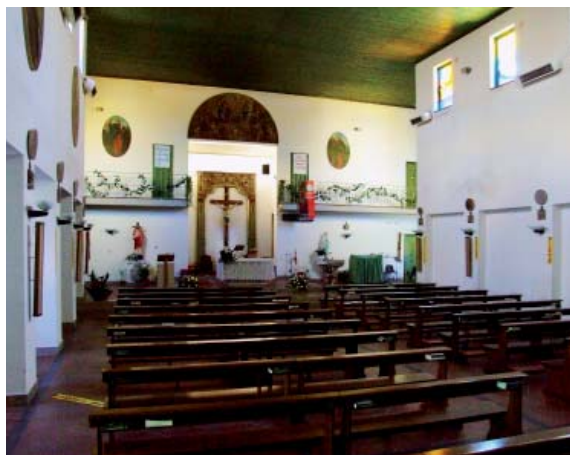
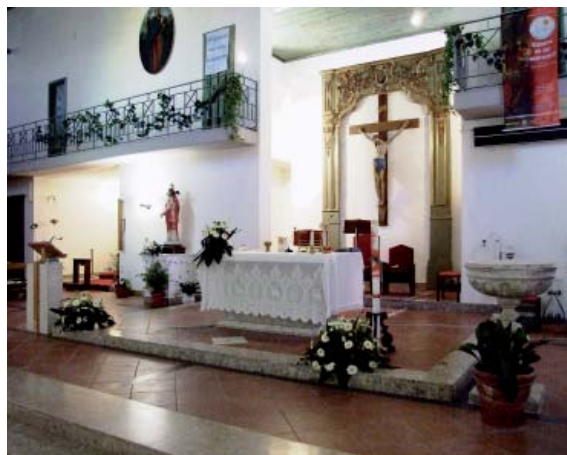
Fig. 03-04. Giorgio Grassi. Chiesa Madre, Teora (Italy), 1981-83/2011.

Fig. 05-06. Giorgio Grassi. Chiesa Madre, Teora (Italy), 1981-83/2011.

—The last one is the case of the Teora town. In this case, pre and post-earthquake coexist. Due to the high level of seismic risk of this area, the settlement

reconstruction was planned in compartments, totally changing the historical conformation of the towns. Some part of the historical settlement could not be rebuilt. For this research is interesting the case of the new church, designed by Giorgio Grassi over the same area of the old church. In this way, the Mother Church of Teora is linked to the past and the memory of the settlement. The destroyed church was left as a ruin and it is used a large churchyard instead (Crespi and Deگو 2004). Also in this case the old church artistic objects have been transported into the new church (Fig. 03-06).

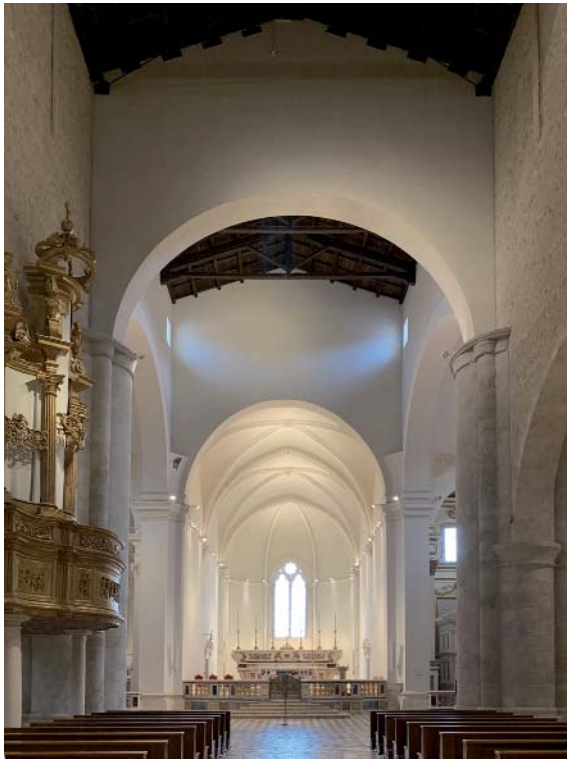
Fig. 12-13. Basilica di Santa Maria di Collemaggio, L'Aquila (Italy), 2019; after the restoration.

Fig. 14. Basilica di Santa Maria di Collemaggio, L'Aquila (Italy), 2019; after the restoration.

—The Basilica di Santa Maria di Collemaggio is one of the most relevant churches in the city. It was severely damaged by the 2009 earthquake: the transept vaults, the triumphal arch and the dome-drum system collapsed, and serious damaged were detected in the presbytery area. In this church, the restoration works have been very considerable (with an estimated cost of more than Euro 15 mln) with a courageous decision to entirely remove the baroque interior decoration, radically changing the stylistic configuration of the church, restored in its medieval features. Nevertheless, the great restoration has not considered for a liturgical reordering and the presbytery has been substantially untouched (Fig. 12-14).
