Non-Destructive Techniques for the Condition and Structural Health Monitoring of Wind Turbines: A Literature Review of the Last 20 Years

Review

Department of Structural, Geotechnical and Building Engineering (DISEG), Politecnico di Torino, Corso Duca degli Abruzzi 24, 10129 Turin, Italy; cecilia.surace@polito.it

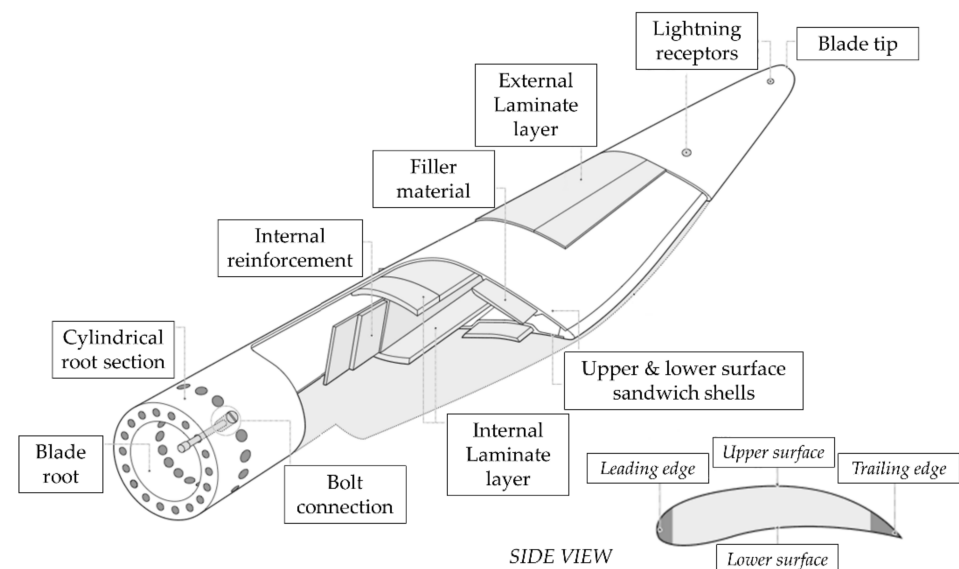
Figure 5. Key components of a typical wind turbine blade. The upper and lower surfaces are also known as the suction (or windward) and pressure (or lee) sides, respectively. The blade root bolt connection shown here is a classic T-bolt type.

The blade design is actually quite complex, with several different components and materials as pictorially described in Figure 5. This complexity makes them particularly susceptible to manufacturing defects, which indeed were estimated in Ref. [36] to account for ~51% of all blade damages (with debonding and voids in skin core being the most common defects at 20% and 18%, respectively).

The blade tip and trailing edge (refer to Figure 5) are generally designed and shaped to minimize aerodynamic noise, which makes them thin and particularly prone to the occurrence of mechanical damage. A full-scale static test showed that a 40 m-long E-glass/epoxy composite WT blade can bear tip deflections up to 11 m under flap-wise loading before structural collapse [47]. This large flexibility, however, may cause the blade tip to hit the HAWT tower under exceptional wind conditions. Due to its cross-section, the blade is much stiffer edge-wise. In conclusion, seven categories of damage are considered as the most common ones in composite blades; these are reported in Table 1.

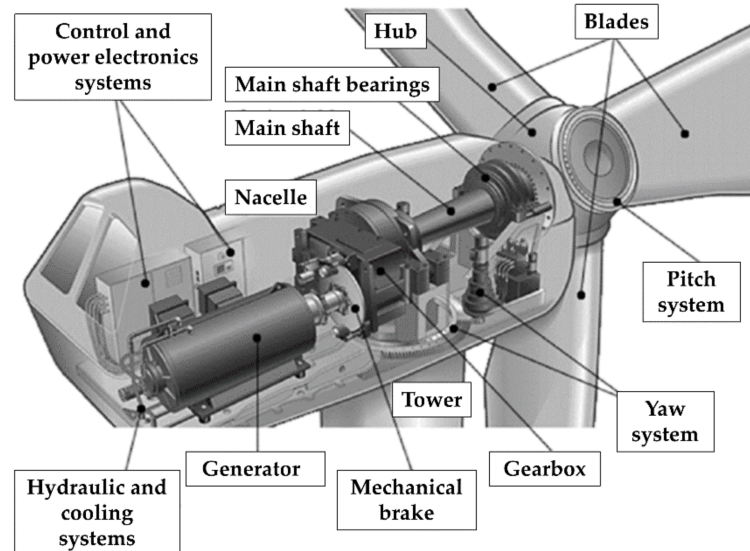
Figure 6. Mechanical and electrical components inside the nacelle of a conventional HAWT.

Positioned on the top of the tower, the nacelle is a cover housing, intended to shelter all the mechanical and electrical components installed inside from the external environment. These mechanisms include (for a conventional HAWT) the gearbox, rotor shaft, brake, and generator, all assembled together (Figure 6, adapted from Ref. [37]). These pieces

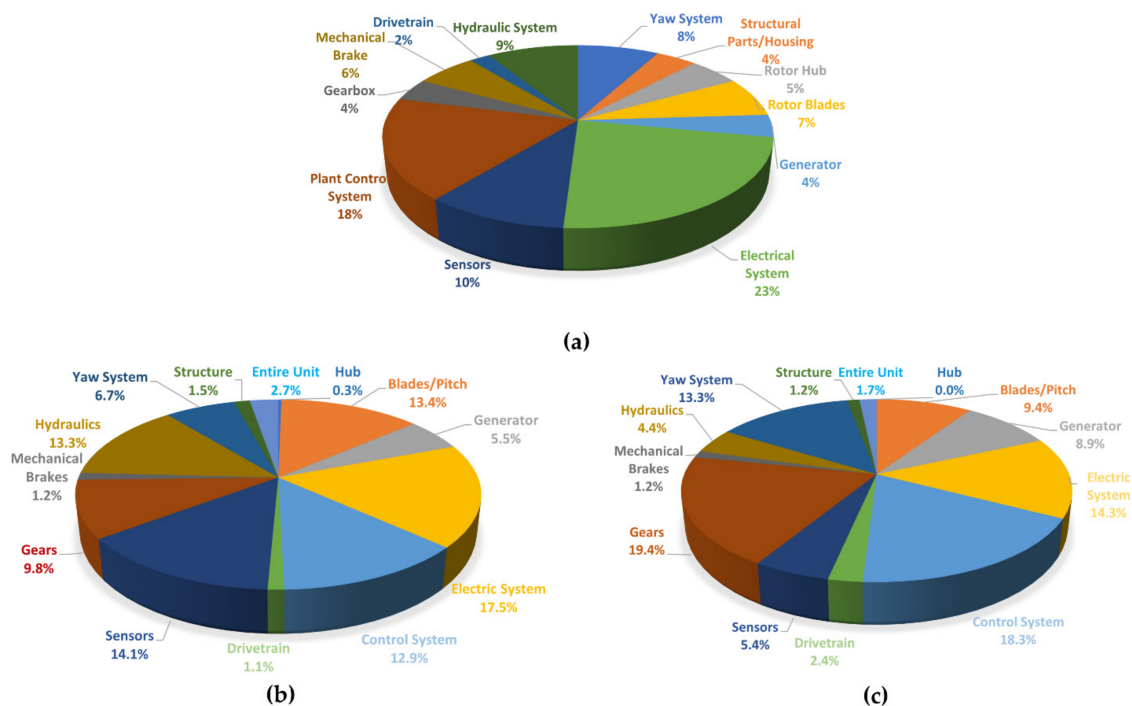
Figure 7. Damage and failure statistics. (a) Percentage of unforeseen malfunctions as recorded in Germany for 1500 wind turbines. Based on data retrieved from Ref. [42], collected over 15 years (34,582 events). (b,c) percentage distribution of the total number of failures and downtime for WTs. Based on data retrieved from Ref. [43], collected from several sources in Sweden, totalling about 600 WTs from 2000 to 2004 (1202 events, 156,202 h). The nomenclature used in the original sources is reproduced for all charts.

In general terms, structural components are much less likely statistically to be subject to damage and failure than mechanical and electrical components. This is shown in detail in the statistics in Figure 7. For the tower, typical failure mechanisms are caused by bolt loosening induced by dynamic loads [40]. However, as can be seen from Figure 7b, WT blades are the structural elements most affected by damage. This is due to their higher complexity, particular materials, and exposition to strong dynamic loads. The static load-carrying elements (tower structure and substructure, plus foundations) are considered to be less damage-prone. Among the many potential causes of their catastrophic collapse, the structure of the metallic tower is subject to all the classic risks of thin-walled shells, e.g., buckling. Even concrete-made towers may suffer total collapse due to damage at the base (at least one case was reported in Germany in 2000 [41]).

Recalling Figure 7b,c, one can see that the mechanical failures (including brakes, gears, drive train, and generator) are preponderant in terms of both total failures and downtime. For this reason, the majority of scientific research focuses on the CM of these components housed inside the nacelle.

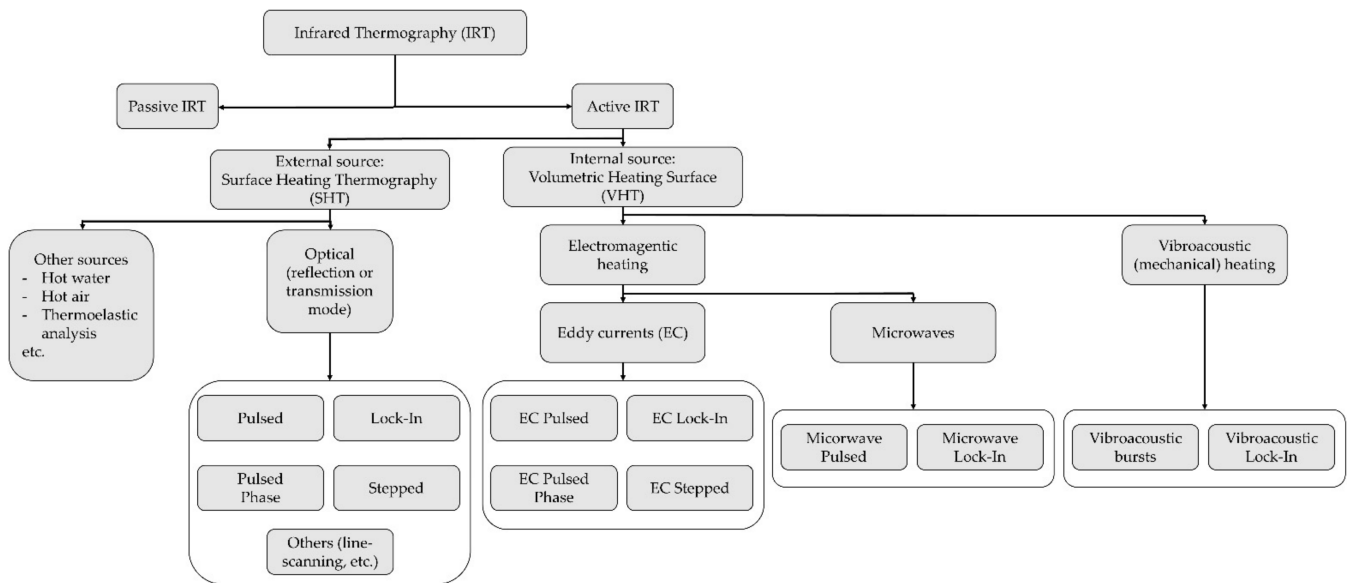
Figure 10. The main IRT techniques available as of 2021.

Some VHT approaches include EC pulsed [163], pulsed phase [162,164], stepped [165], and lock-in [166] thermography, as well as microwave pulsed and lock-in thermography [167]. Most of these strategies can be performed with ultrasonic waves too; another less widespread alternative is the ultrasound-burst-phase thermography [168]. The links between these VHT techniques and their SHT counterparts, mentioned before, are graphically displayed in Figure 10.

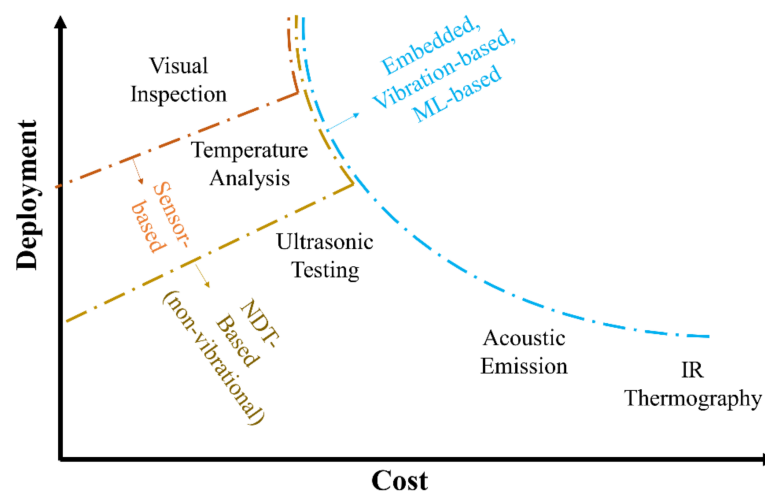
Figure 13. Qualitative distribution of costs and deployment levels of different NDTs. Based on data from Refs. [329–331].

Regarding the prevalence of these techniques, as reported in Figure 13 (adapted from Ref. [328], based in turn on data from several sources [329–331]), visual inspection remains the most widespread approach. Temperature analysis is also very common, most probably due to the very low cost of physical temperature sensors. UT, AE, and IRT are all (in general) more expensive and thus less frequently deployed. Therefore, it is understandable that the trend is quite clearly decreasing with increasing operational costs. Permanent monitoring apparatuses, on the other hand, represent an outlier relative to this general trend. The reason behind this larger-than-expected deployment despite the higher costs derives from the perceived usefulness of embedded systems. Moreover, the total costs account for both the installation—which is relatively expensive for a global system—and the operating expenses, which instead are relatively convenient. Thus, a vibrational-based, ML-based SHM apparatus becomes more and more convenient throughout the years, when the structure/system as well becomes more prone to damage due to ageing and normal use and consumption. However, as mentioned in Section 3.5, global and continuous monitoring is intended to enable condition-based maintenance. Therefore, it is not an alternative but rather a complement to the local damage assessment capabilities of the NDE approaches reviewed here.
