Static behaviour of in scale masonry vaults under imposed settlement of the supports

ABSTRACT: The European architectural heritage is heavily characterized by the use of unreinforced masonry spatial structures, like vaults, which represent vulnerable elements in historical buildings. In recent years, the use of in-scale models to investigate the structural behaviour of vaults has largely increased in scientific research. In-scale models allow to overcome the difficulty of performing destructive tests on real structures and allow to investigate the complex three-dimensional failure mechanisms derived by different kinds of load, including the settlement of the supports. In this study, an experimental campaign is carried out on 1:5 in-scale models of barrel vaults with different brick laying techniques, to investigate their structural behaviour under settlement of the supports. Two brick patterns are tested: radial and vertical, with bed joints respectively orthogonal and parallel to the head arch plane. Models are built with cement blocks and low cohesion mortar, to simulate the typical historic masonry behaviour. Two tests for each brick arrangement are carried out on the models, w

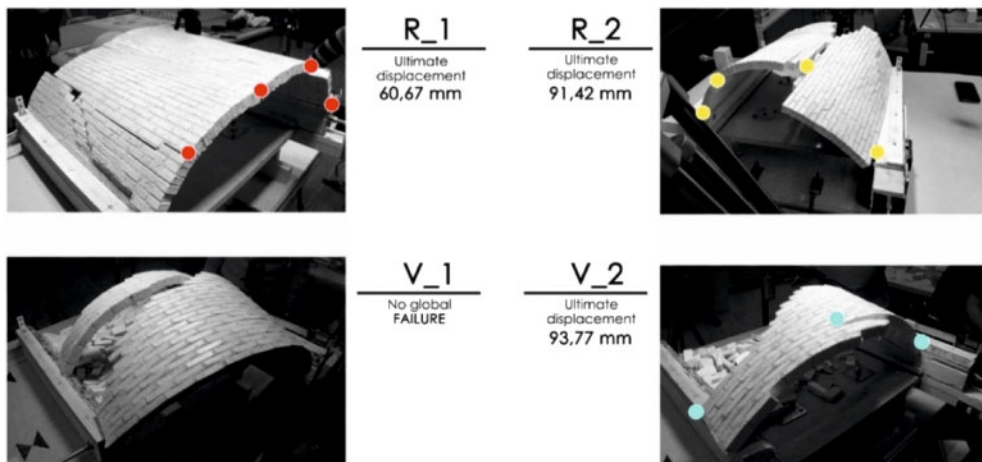
Figure 5. Collapse mechanisms of the tested models.

The high-speed and high-resolution cameras provide images of the collapse mechanisms of the tested models. In Figure 5 a selection of images of the failure, from the most representative perspective, is reported. Differently from arches, vaults involve complex three-dimensional failure mechanisms. The latter are quite different for vaults with different brick pattern, but also between vaults with the same brick arrangement.

The R models show a four-hinge mechanism, even though they reach the collapse at quite different ultimate displacements (60.67 mm in R_1 and 91.42 mm in R_2). The hinges run across the whole depth of the model following the longitudinal joints, with two of them placed at the abutment interface and one in the proximity of the key bricks. On the contrary, the V models show a different behaviour, characterized by the local collapse of some arches and by the rigid rotation of the separated portions of the vault. The rigid rotation of the vault on the abutment is particularly evident in the V_1 model, which reaches the end of displacement range (fixed at 150 mm) without a global failure. The V_2 model collapses at 93.77 mm of imposed displacement with a three-hinge mechanism, developed among the arches still in compression, with the slipping of the structure from one of the abutments.
